# HEAD SHEAVE REPORT

# Head Sheave Inspection Report

| Area / system | Main Shaft | Asset / asset group | Sheave Wheels |
| Report number | IRS32-Wessels-160726 | Revision | 1.2 |

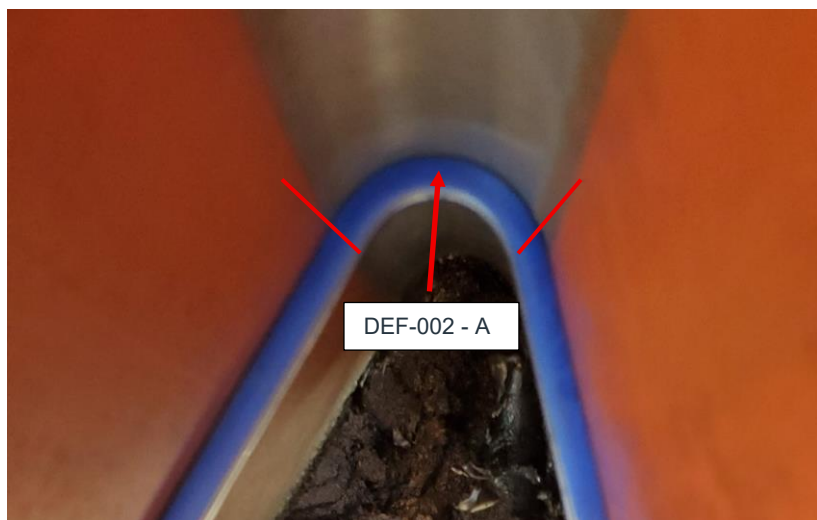
**Photo ID**  
PHOTO-OL-001

The recorded ~1 mm wear represents approximately 2.70% of the 37 mm nominal rope diameter. The reported diameter-to-rope ratio is approximately 99:1. The notes compare the value with an indicative 3.7 mm to 4.6 mm screening range or upper limits.

The recorded wear ~1mm wear is small relative to the nominal rope diameter and below the indicative threshold stated in the notes. The groove profile still provides adequate clearance and support for a 37 mm steel rope without risk of crushing or pinching the strands.

**Caption**  
Profile positioned in the Overlay Sheave groove. The field notes record ~1 mm wear.

| Observation | Engineering assessment | Recommended action |
|---|---|---|
| Profile is visible against the groove profile; the notes record ~1 mm wear at position DEF-002-A. | The value is within acceptable wear limits<br>The value of ~1 mm of wear, the profile sits within its normal operating limits and is below the replacement or repair thresholds.<br>The groove profile still provides adequate clearance and support for a 37 mm steel rope without risk of crushing or pinching the strands. | Clean, repeat and document the measurement using an identified gauge. |

| Finding ID | Condition rating | Severity | Priority | Recommended action | Responsible discipline | Verification requirement |
|---|---|---|---|---|---|---|
| DEF-002 | Good | Level 1 | P4 - monitor | Clean the groove, repeat the profile check at defined positions, record the gauge and readings, and compare against the approved criterion. | Mechanical maintenance / competent inspector | Post-cleaning photographs, gauge ID, measurement sheet and approved criterion comparison |

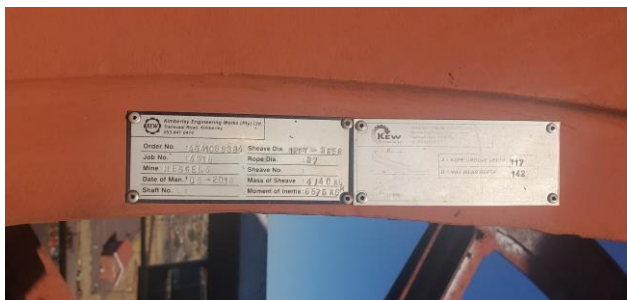
PHOTO-UL-002

Kimberley Engineering Works identification and groove-data plates used to populate the asset data sheet.

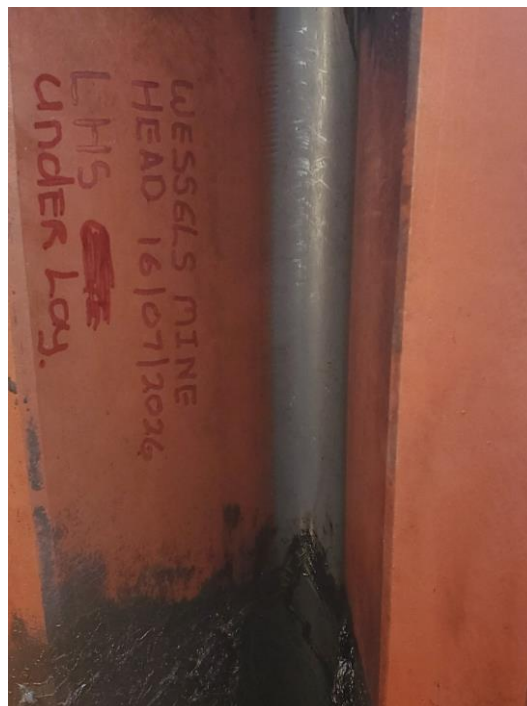
PHOTO-UL-003

Contextual view of the Underlay Sheave groove and adjacent surface.
