# UPPER GANTRY GUIDE SHEAVES

# Upper Gantry Guide Sheaves Inspection Report

| Client | South32 | Mine / site | Wessels Mine |
| Report number | IRS32-Wessels-180726_1 | Revision | 1.3 |

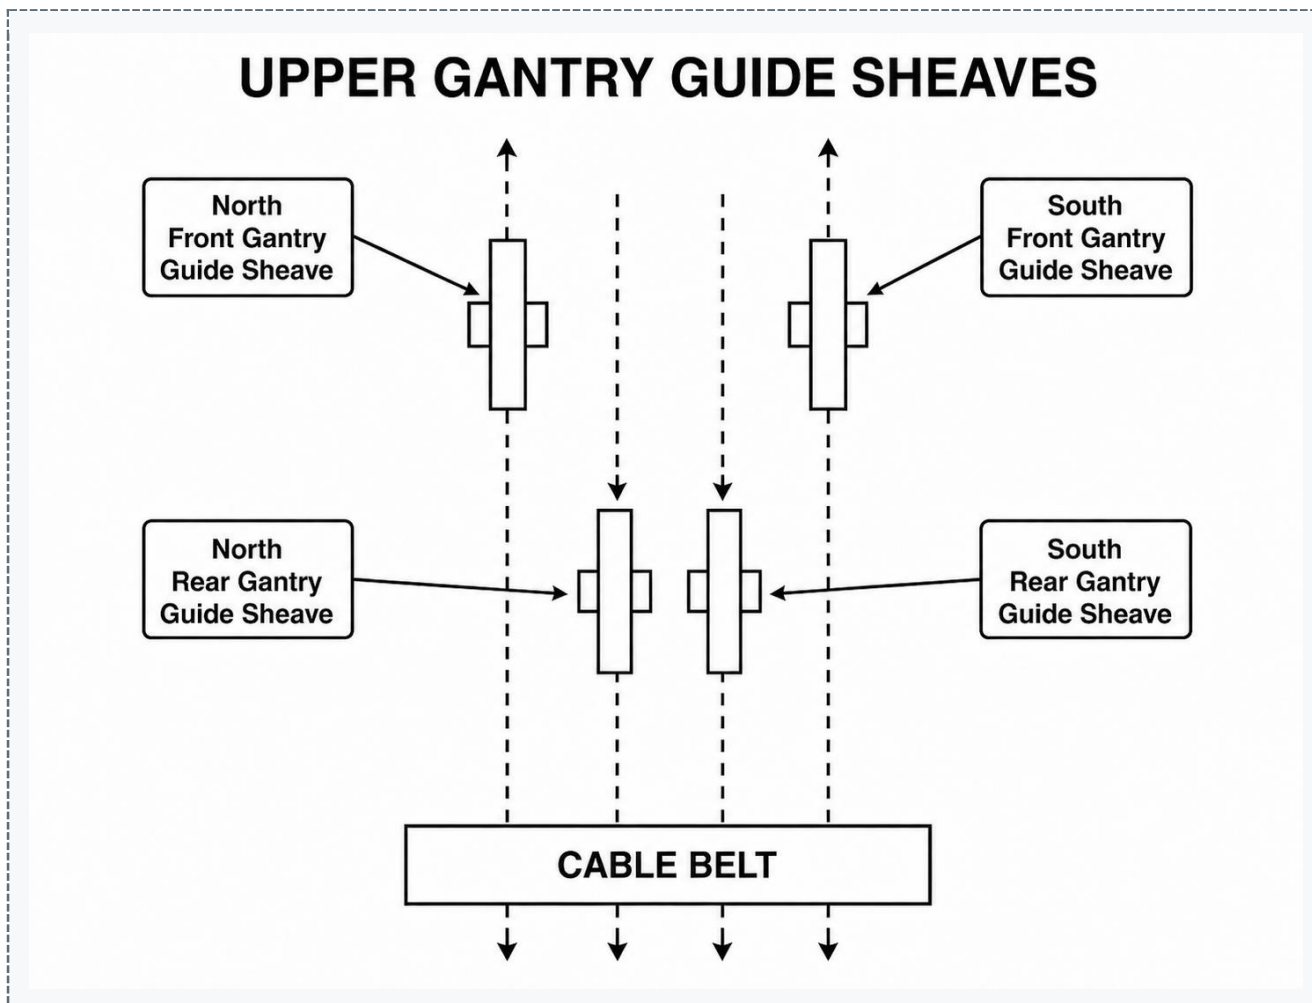
Figure 1 - Upper Gantry Guide Sheaves reference arrangement - UGGS-REF001

UGGS-REF001 - Upper Gantry Guide Sheaves reference arrangement (Rev 1.0) is an ISS-generated schematic compiled from the supplied notes for inspection orientation. It is included for reference only and is not to scale.

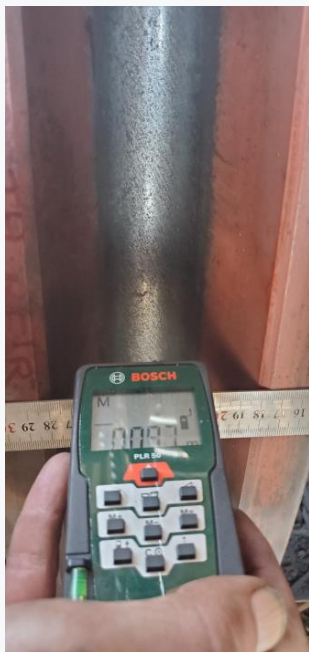
**Photo ID**  
URGN-002

URGN-002 records a groove-depth reading of 0.097 m (97 mm). URGN-005 records nominal rope-groove depth A = 90 mm and maximum wear depth B = 120 mm. URGN-003 documents the groove/profile condition. The photographed groove surface appears continuous within the visible inspection area, with no gross localized material loss or open discontinuity evident in the supplied close-up.

Recorded groove depth: 97 mm. This represents an approximately 7 mm increase from the photographed 90 mm nominal groove depth, leaving approximately 23 mm before the photographed OEM maximum wear depth of 120 mm is reached. The recorded depth therefore represents approximately 23.3% of the available 30 mm nominal-to-maximum depth allowance. Evidence: URGN-002 and URGN-003. Only one groove-depth measurement position is presently evidenced.

| Observation | Engineering assessment | Recommended action |
|---|---|---|
| Rear North groove-depth measurement showing 0.097 m (97 mm). Recorded measurement: 97 mm. | Using the photographed KEW plate as the reference, 97 mm is approximately 7 mm deeper than the 90 mm nominal groove depth. This represents about 23.3% of the 30 mm nominal-to-maximum depth allowance and leaves approximately 23 mm before the 120 mm plate maximum. The recorded single reading is therefore below the photographed maximum wear depth. This is provisional because circumferential variation and profile-gauge conformance have not been established. | Repeat groove-depth readings at indexed circumferential positions using a documented datum and equipment ID. Trend results against the verified 120 mm maximum wear depth. |

| Defect Ref ID | Condition rating | Severity | Priority | Recommended action | Responsible discipline | Verification requirement |
|---|---|---|---|---|---|---|
| DEF-001 | Good | Level 1 - Minor | P4 | Repeat groove-depth readings at indexed circumferential positions using a documented datum and equipment ID. Trend results against the verified 120 mm maximum wear depth and record the profile-gauge identification/criterion. | Mechanical / inspection | Repeat measurements / verified criteria and close-out record |

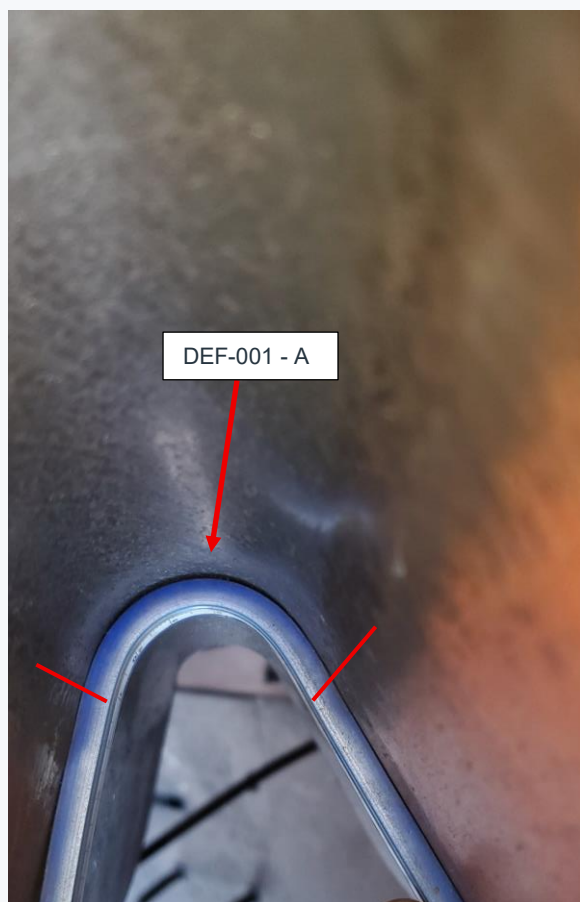
Photo URGN-003 records approximately 1.5 mm of local groove-profile wear at position DEF-001-A. The OEM nameplate identifies a nominal 1,900 mm sheave operating with a 45 mm rope. The supplied photographs document the visible groove profile and rope-contact surface.

Approximately 1.5 mm of local groove-profile wear was recorded at position DEF-001-A. This represents approximately 3.3% of the nominal 45 mm rope diameter and is retained as a supplementary condition-monitoring value for future comparative trending. The recorded profile wear does not supersede the photographed OEM groove-depth criteria or the requirement to assess continued groove-profile conformity.

Groove / rim condition: The visible groove profile remains generally uniform and serviceable, with no evident significant profile deformation, localized material loss or pronounced asymmetric side-wall wear within the photographed area.

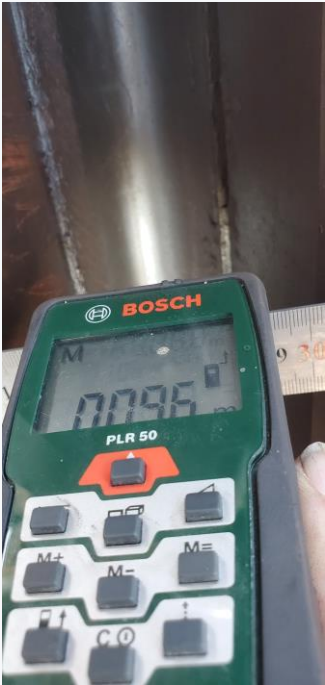
Figure 4 - Rear Gantry Guide Sheave South evidence - URGS-002 / DEF-002

| Observation | Engineering assessment | Recommended action |
|---|---|---|
| Rear South groove-depth measurement showing 0.096 m (96 mm). Recorded measurement: 96 mm. | Using the photographed KEW plate as the reference, 96 mm is approximately 6 mm deeper than the 90 mm nominal groove depth. This represents about 20.0% of the 30 mm nominal-to-maximum depth allowance and leaves approximately 24 mm before the 120 mm plate maximum. The single recorded reading is below the recorded maximum wear depth. | Repeat indexed groove-depth readings and trend against the verified 120 mm limit. Confirm the current asset identity in the Wessels register and retain the plates as traceability evidence. Record profile-gauge identification/criterion for future inspections. |

| Defect Ref ID | Condition rating | Severity | Priority | Recommended action | Responsible discipline | Verification requirement |
|---|---|---|---|---|---|---|
| DEF-002 | Good | Level 1 - Minor | P4 | Repeat indexed groove-depth readings and trend against the verified 120 mm limit. Confirm the current asset identity in the Wessels register and retain the plates as traceability evidence. Record profile-gauge identification/criterion for future inspections. | Mechanical / inspection | Repeat measurements / verified criteria and close-out record |

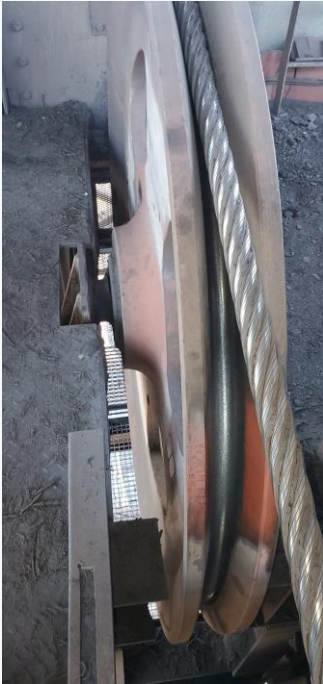
**Photo ID**  
URGN-001

| Observation | Engineering assessment | Recommended action |
|---|---|---|
| Overview of rear north guide sheave | Context view confirms the visible sheave arrangement and general inspection context only; it does not establish internal component condition or dimensional acceptance. | Retain as contextual evidence and correlate with detailed groove/profile evidence. |

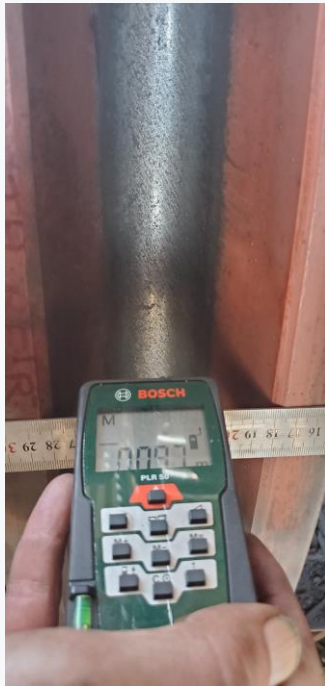
URGN-002

| Observation | Engineering assessment | Recommended action |
|---|---|---|
| 0.097 m / 97 mm groove-depth reading | Using the photographed KEW plate as the reference, 97 mm is approximately 7 mm deeper than the 90 mm nominal groove depth. This represents about 23.3% of the 30 mm nominal-to-maximum depth allowance and leaves approximately 23 mm before the 120 mm plate maximum. The recorded single reading is therefore below the photographed maximum wear depth. This is provisional because circumferential variation and profile-gauge conformance have not been established. | Repeat groove-depth readings at indexed circumferential positions using a documented datum and equipment ID. Trend results against the verified 120 mm maximum wear depth and record the profile-gauge identification/criterion. |

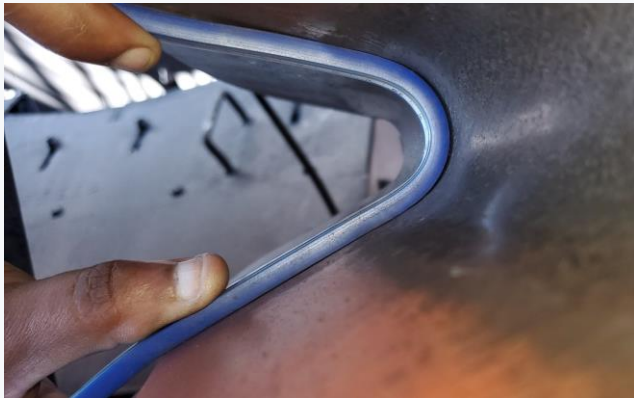
URGN-003

| Observation | Engineering assessment | Recommended action |
|---|---|---|
| Rear north groove-profile/contact condition | Using the photographed KEW plate as the reference, 97 mm is approximately 7 mm deeper than the 90 mm nominal groove depth. This represents about 23.3% of the 30 mm nominal-to-maximum depth allowance and leaves approximately 23 mm before the 120 mm plate maximum. The recorded single reading is therefore below the photographed maximum wear depth. This is provisional because circumferential variation and profile-gauge conformance have not been established. | Repeat groove-depth readings at indexed circumferential positions using a documented datum and equipment ID. Trend results against the verified 120 mm maximum wear depth and record the profile-gauge identification/criterion. |

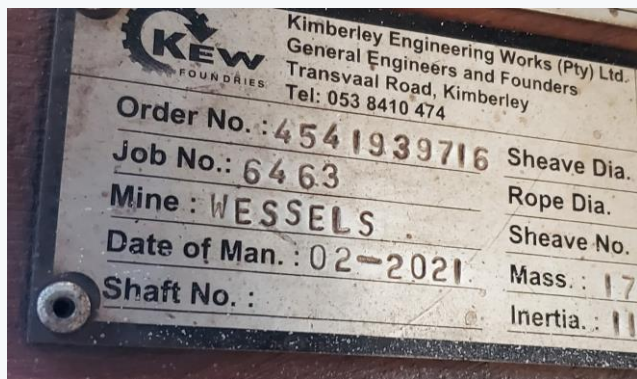
URGN-004

| Observation | Engineering assessment | Recommended action |
|---|---|---|
| KEW identification plate | Identification information is legible and has been transferred to the asset data sheet. It should be reconciled with the current Wessels asset register as part of the asset-record verification process. | Retain the plate photograph in the controlled asset record and verify the current asset identity/location. |

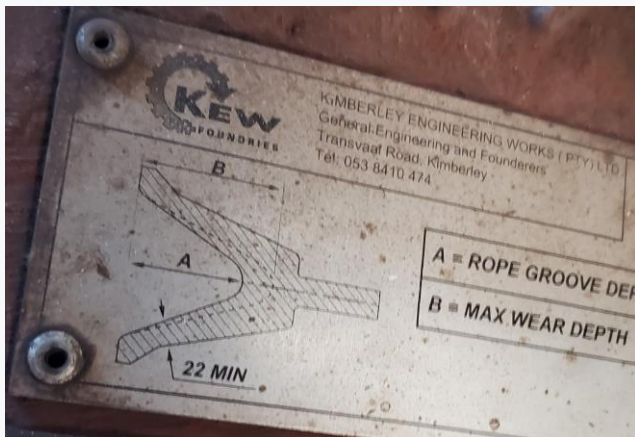
URGN-005

| Observation | Engineering assessment | Recommended action |
|---|---|---|
| KEW groove specification: A=90 mm, B=120 mm | The plate provides the photographed manufacturer groove-depth reference used for the rear-sheave groove-depth comparison. | Retain as the reference basis unless superseded by a verified OEM drawing or client criterion. |

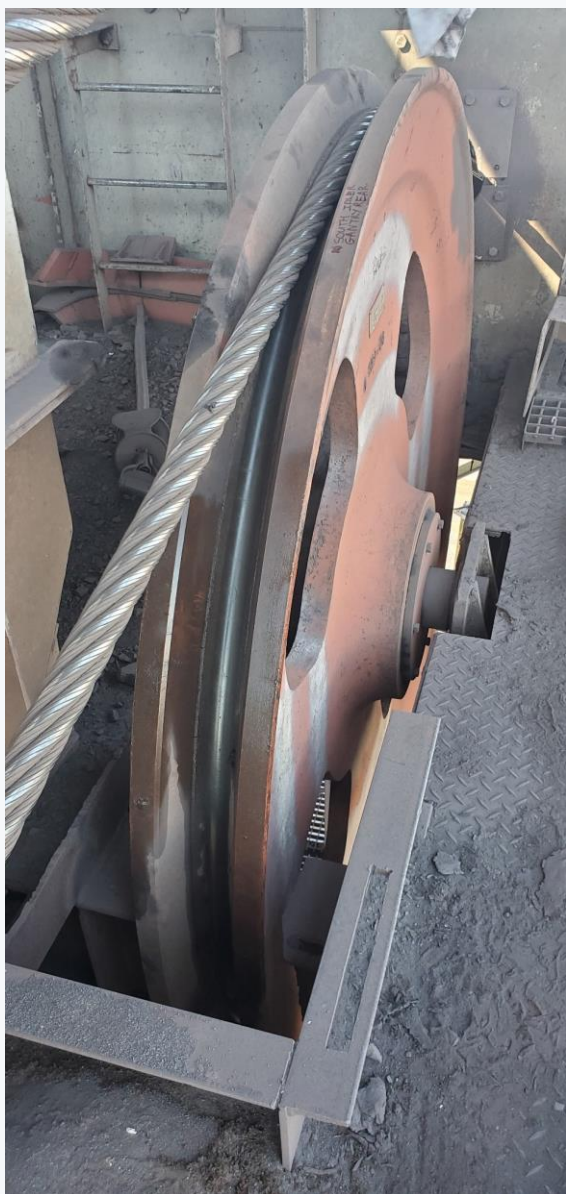
URGS-001

| Observation | Engineering assessment | Recommended action |
|---|---|---|
| Overview of rear south guide sheave | Context view confirms the visible sheave arrangement and general inspection context only; it does not establish internal component condition or dimensional acceptance. | Retain as contextual evidence and correlate with detailed groove/profile evidence. |

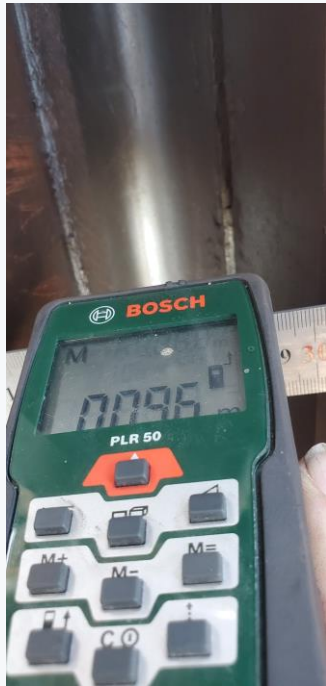
URGS-002

| Observation | Engineering assessment | Recommended action |
|---|---|---|
| 0.096 m / 96 mm groove-depth reading | Using the photographed KEW plate as the reference, 96 mm is approximately 6 mm deeper than the 90 mm nominal groove depth. This represents about 20.0% of the 30 mm nominal-to-maximum depth allowance and leaves approximately 24 mm before the 120 mm plate maximum. The single recorded reading is below the photographed maximum wear depth. The historical Samancor/Hotazel identification should be reconciled with the current Wessels asset register as part of the asset-identity verification process. | Repeat indexed groove-depth readings and trend against the verified 120 mm limit. Confirm the current asset identity in the Wessels register and retain the plates as traceability evidence. Record profile-gauge identification/criterion for future inspections. |

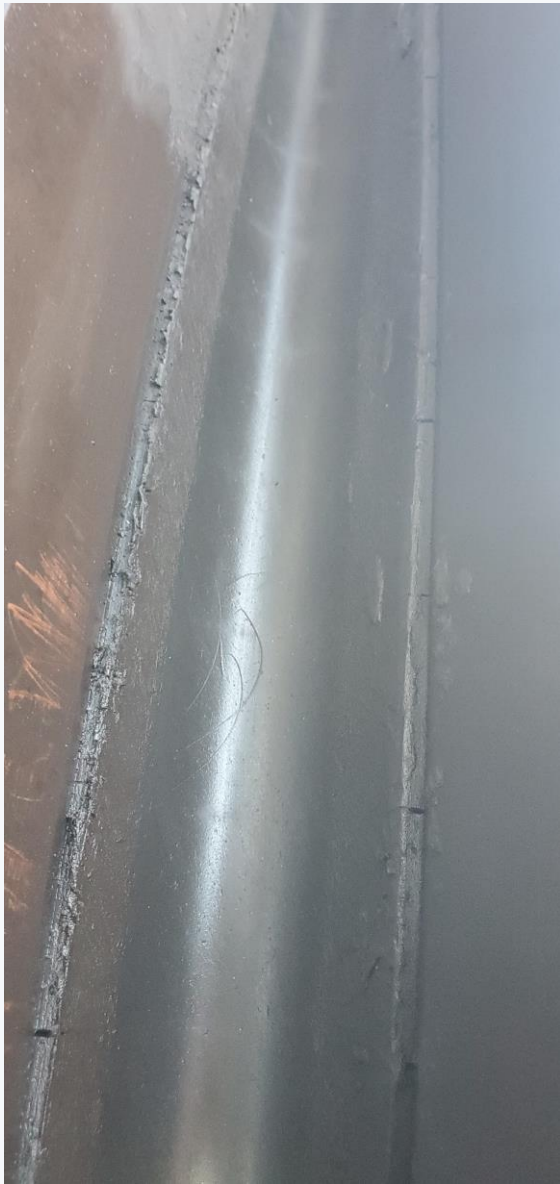
URGS-003

| Observation | Engineering assessment | Recommended action |
|---|---|---|
| Rear south groove-profile/contact condition | Using the photographed KEW plate as the reference, 96 mm is approximately 6 mm deeper than the 90 mm nominal groove depth. This represents about 20.0% of the 30 mm nominal-to-maximum depth allowance and leaves approximately 24 mm before the 120 mm plate maximum. The single recorded reading is below the photographed maximum wear depth. | Repeat indexed groove-depth readings and trend against the verified 120 mm limit. Confirm the current asset identity in the Wessels register and retain the plates as traceability evidence. Record profile-gauge identification/criterion for future inspections. |

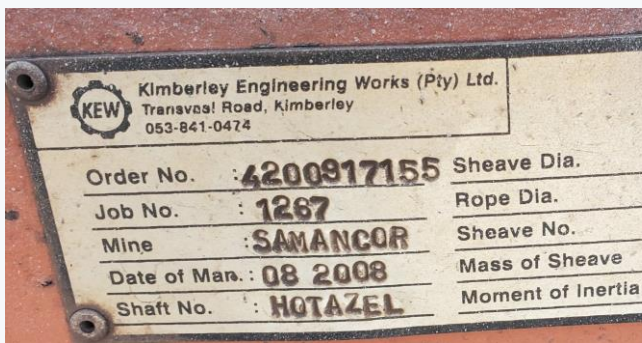
URGS-004

| Observation | Engineering assessment | Recommended action |
|---|---|---|
| KEW identification plate; records Samancor / Hotazel | Identification information is legible and has been transferred to the asset data sheet. It should be reconciled with the current Wessels asset register as part of the asset-record verification process. | Retain the plate photograph in the controlled asset record and verify the current asset identity/location. |

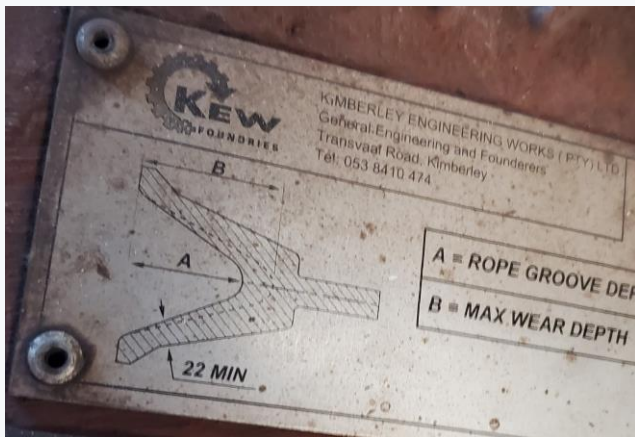
URGS-005

| Observation | Engineering assessment | Recommended action |
|---|---|---|
| KEW groove specification: A=90 mm, B=120 mm | The plate provides the photographed manufacturer groove-depth reference used for the rear-sheave groove-depth comparison. | Retain as the reference basis unless superseded by a verified OEM drawing or client criterion. |

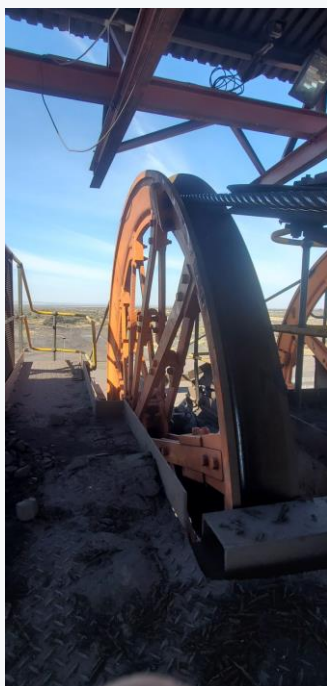
UFGN-001

| Observation | Engineering assessment | Recommended action |
|---|---|---|
| Overview of front north guide sheave | Context view confirms the visible sheave arrangement and general inspection context only; it does not establish internal component condition or dimensional acceptance. | Retain as contextual evidence and correlate with detailed groove/profile evidence. |

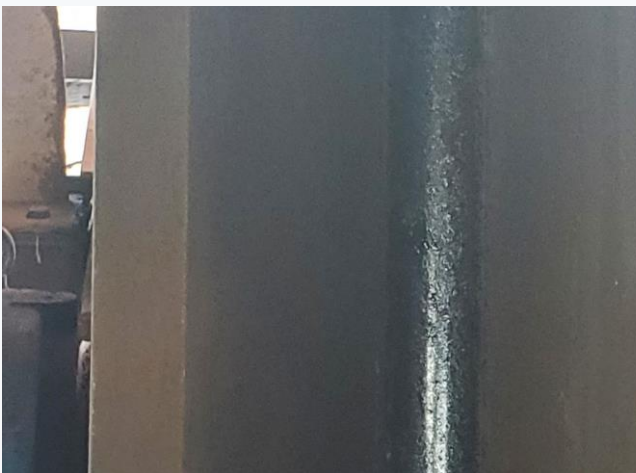
Figure 19 - Front Gantry Guide Sheave North evidence - UFGN-002 / DEF-003

| Observation | Engineering assessment | Recommended action |
|---|---|---|
| <p>Front North groove-profile/contact condition. The groove profile appears generally symmetrical with no evident abnormal side-wall loading in the photographed area. Pronounced longitudinal scoring is visible along the base of the groove within the rope-contact band.</p> | <p>The recorded groove depth of 121 mm is 4 mm deeper than the historical 117 mm minimum and remains approximately 21 mm below the historical 142 mm maximum. This occupies approximately 16.0% of the 25 mm historical minimum-to-maximum depth range. The dimensional comparison is provisional pending validation of the historical ISS record against Wessels Mine records. The generally symmetrical groove profile does not show evident abnormal side-wall loading; however, the pronounced scoring along the groove base represents localized surface deterioration within the primary rope-contact zone and should be monitored for progression. No immediate re-machining is indicated from the supplied evidence.</p> | <p>Recheck the groove depth and profile at the next scheduled inspection and trend the measured condition against the current 121 mm baseline. Monitor the groove-base scoring for progression and validate the historical 117/142 mm dimensional reference against the Wessels Mine records.</p> |

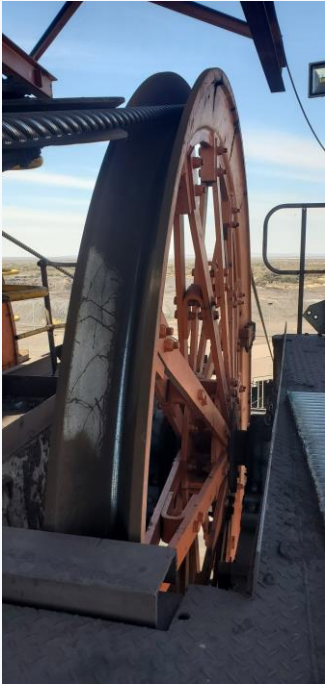
**Photo ID**  
UFGS-001

| Observation | Engineering assessment | Recommended action |
|---|---|---|
| Overview of front south guide sheave | Context view confirms the visible sheave arrangement and general inspection context only; it does not establish internal component condition or dimensional acceptance. | Retain as contextual evidence and correlate with detailed groove/profile evidence. |

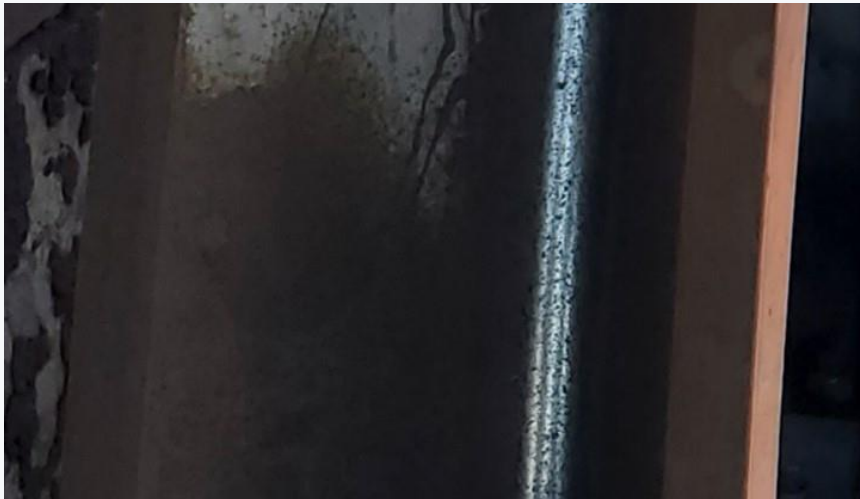
UFGS-002

| Observation | Engineering assessment | Recommended action |
|---|---|---|
| Front South groove-profile/contact condition. The groove profile appears generally symmetrical with no evident abnormal side-wall loading in the photographed area. Pronounced longitudinal scoring is visible along the base of the groove within the rope-contact band. | The recorded groove depth of 123 mm is 6 mm deeper than the historical 117 mm minimum and remains approximately 19 mm below the historical 142 mm maximum. This occupies approximately 24.0% of the 25 mm historical minimum-to-maximum depth range. The dimensional comparison is provisional pending validation of the historical ISS record against Wessels Mine records. The generally symmetrical groove profile does not show evident abnormal side-wall loading; however, the pronounced scoring along the groove base represents localized surface deterioration within the primary rope-contact zone and should be monitored for progression. No immediate re-machining is indicated from the supplied evidence. | Recheck the groove depth and profile at the next scheduled inspection and trend the measured condition against the current 123 mm baseline. Monitor the groove-base scoring for progression and validate the historical 117/142 mm dimensional reference against the Wessels Mine records. |

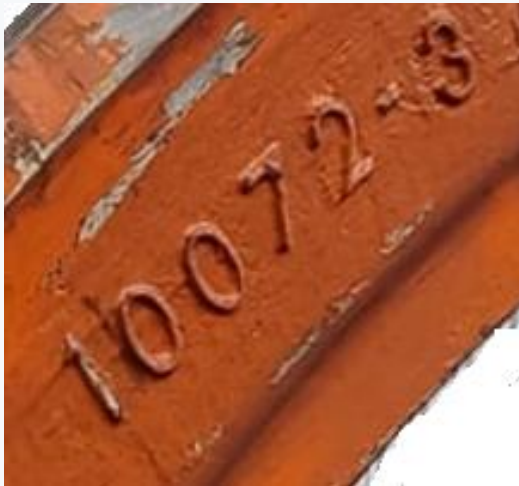
UFGN-003

| Observation | Engineering assessment | Recommended action |
|---|---|---|
| Visible identification marking 10072-3 recorded on the Front Gantry Guide Sheave North. | The marking provides physical identification/traceability evidence for the inspected sheave. It is not an OEM specification plate and does not independently establish dimensional acceptance criteria. Historical ISS records associate the front sheave configuration with a 3,658 mm diameter, 45 mm rope and 117/142 mm groove-depth reference; this association must be validated against the Wessels Mine asset records. | Retain the photograph in the controlled asset record and cross-reference identification 10072-3 with the Wessels Mine asset register and historical sheave documentation. |
