# Combined-Product Spillage Inspection Assessment Report

South32 Wessels Mine · Surface and Underground Conveyor / Process Areas

Audit report · engineering assessment · maintenance recommendations

| Report number | S32WPPSR-01 | Inspection date | July 2026 |

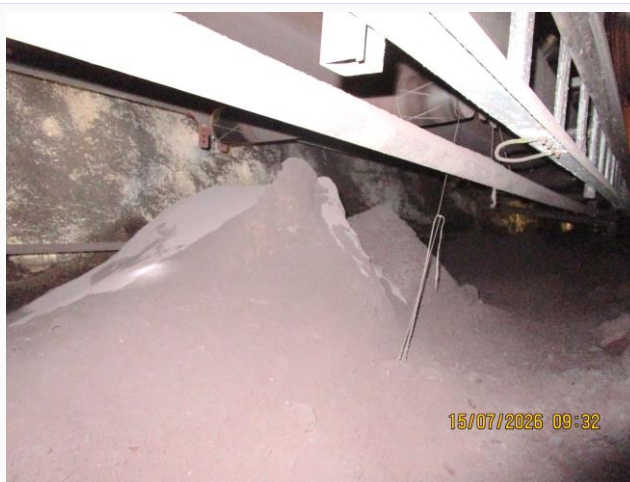
UGUC05\_04\_03\_02\_01-REF-006 — severe local accumulation along the continuous underground conveyor route.

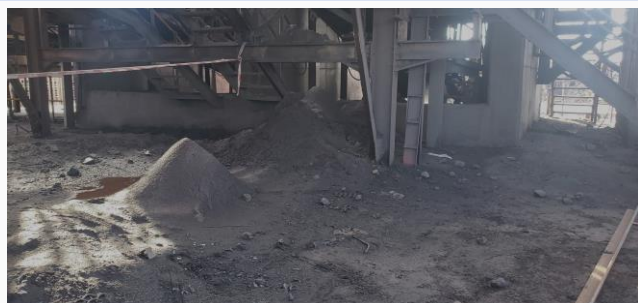
CV04-REF-005 — wider surface-plant view showing multiple accumulated fines piles beneath and around the conveyor structure.

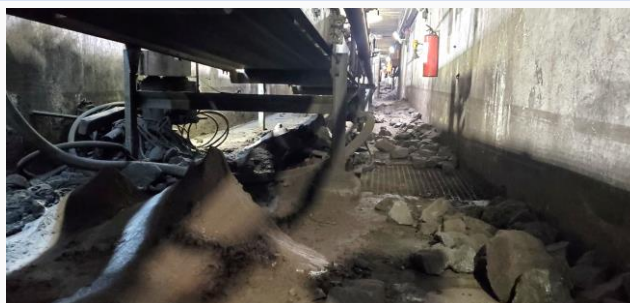
W10-REF-006 — mixed coarse product and fines distributed below the conveyor around components within the restricted tunnel area.

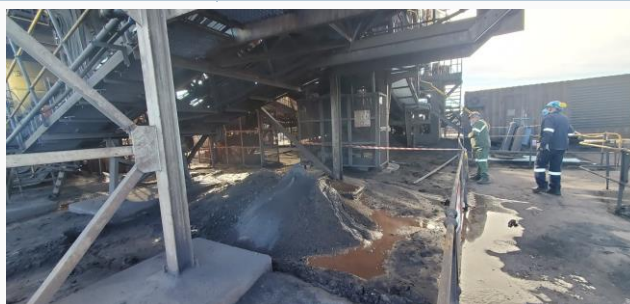
CV01-REF-004 — wider view of wet-fines/slurry accumulation and standing water around the conveyor structure.

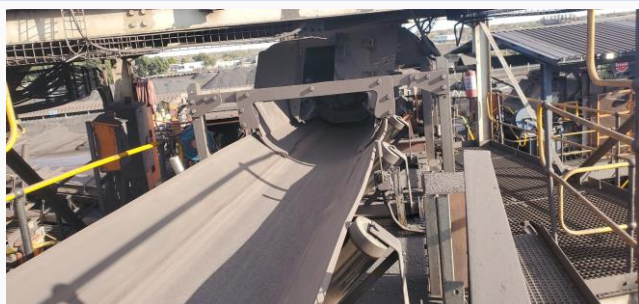
CV03-REF-002 — clean-condition comparator demonstrating that not every inspected conveyor was a significant spillage location.

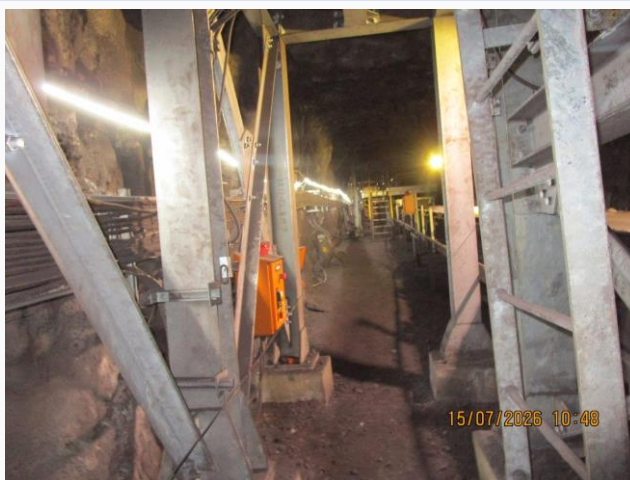
UG5B-REF-006 — wider comparator supporting a localized rather than uniformly widespread U5B condition.

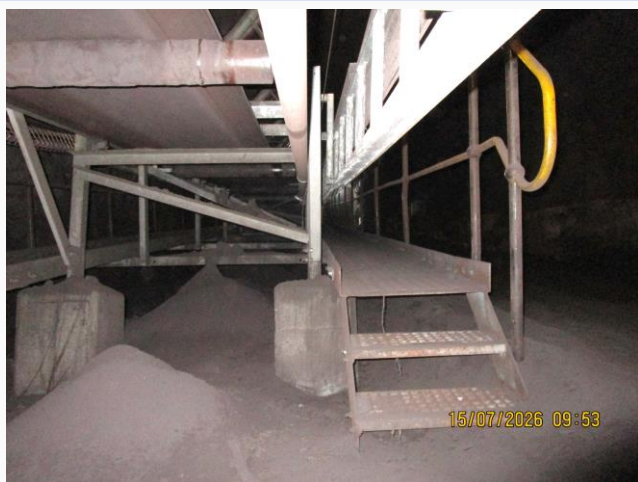
UGUC05\_04\_03\_02\_01-REF-010 — wider longitudinal accumulation supporting recurrence along the underground route.

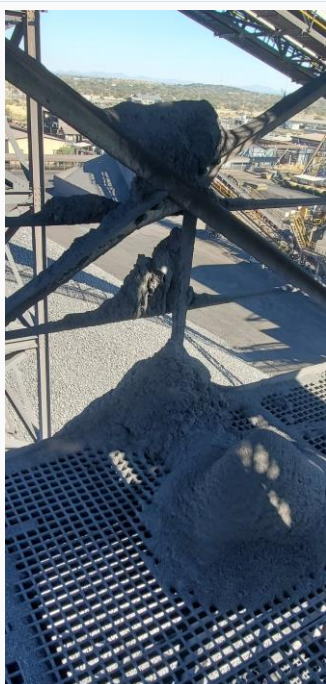
CV15-REF-004 — large fines deposits on grating/cross-bracing around the CV15 discharge region.

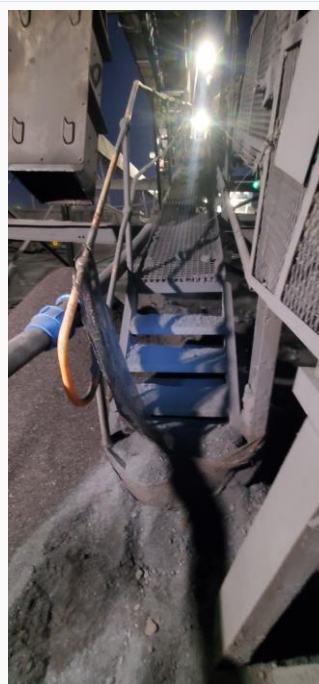
LoadoutStationSample1-REF-002 — substantial fines accumulation around the Sample Conveyor 1 tail/access area.

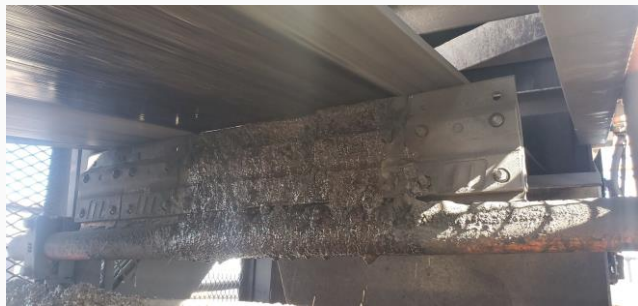
Active wet-material fallout was recorded during operation, while the surrounding deposits provide visible evidence of the consequence of material not being fully retained within the process. CV09 is therefore a particularly useful location for demonstrating the difference between simply cleaning the belt and controlling what happens to the material after it has been removed. Because both the cleaner arrangement and the resulting fines-loss condition are clearly represented at this location, CV09 also provides a particularly suitable pilot location for proving an improved cleaner-and-containment approach before considering wider application elsewhere in the system.

CV09-REF-003 — principal still showing the cleaner/open local arrangement.

The proposed functional objective is to remove residual fines before the belt enters the return run, with the cleaner acting while the belt is positively supported by the head pulley and with the cleaning stages located inside the existing head/discharge chute. In this arrangement, material removed by the cleaner can fall naturally into the existing combined-product discharge flow instead of escaping into the surrounding plant or requiring a separate fines-recovery chute. The audit defines this required function, while the final cleaner type, mounting arrangement, chute interfaces, access provisions and other detailed geometry remain subject to verified site dimensions and OEM/responsible-design development.

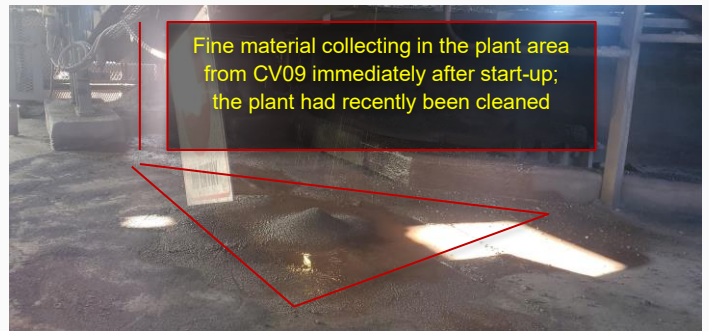
CV09-REF-002 — wet-fines/slurry consequence below the discharge/cleaner region.

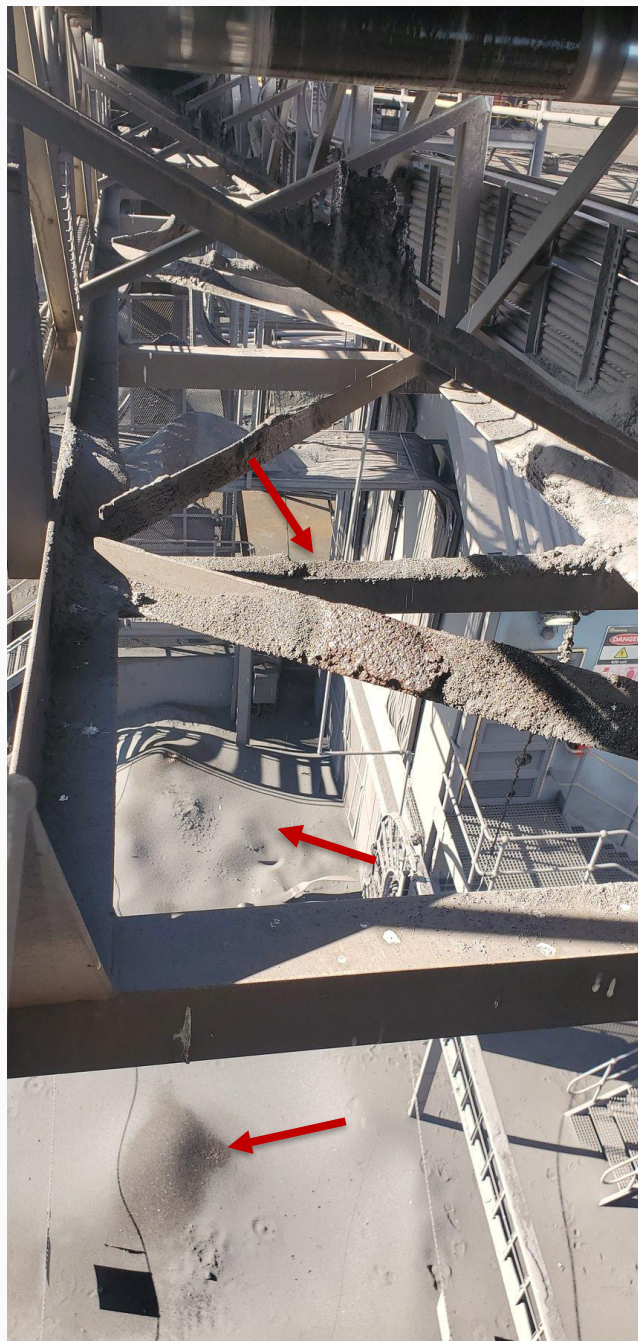
CV09-REF-005 — wider fines/material accumulation around the structure, supporting the broader consequence of material escaping and being redistributed outside the intended process path.

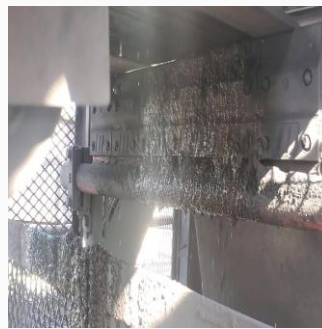
CV09-REF-008 — representative frame from inspection video showing contaminated cleaner/chute geometry relevant to the containment-boundary issue and pilot concept

The recommended programme combines system-level source control with targeted local actions. CV09 remains the preferred pilot for demonstrating a pulley-supported cleaner-and-containment function inside the head/discharge chute so that residual fines are removed before the return run and cleaner-removed material remains in the existing discharge flow. Once that function has been demonstrated under representative operation, the relevant head/discharge locations across the inspected conveyor route should be systematically reviewed against the same functional standard and progressively adapted where the local geometry, operating duty and maintenance requirements confirm applicability.

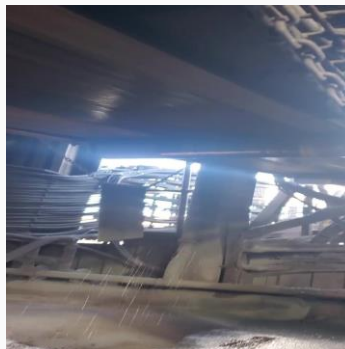
CV09-REF-006 — representative frame from inspection video showing active wet-material fallout during operation.

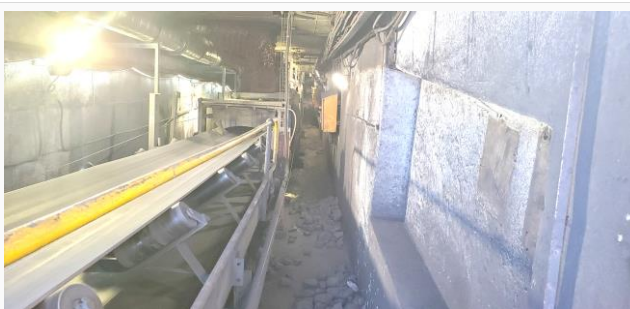
W10-REF-010 — long tunnel view establishing the confined topology and restricted access.

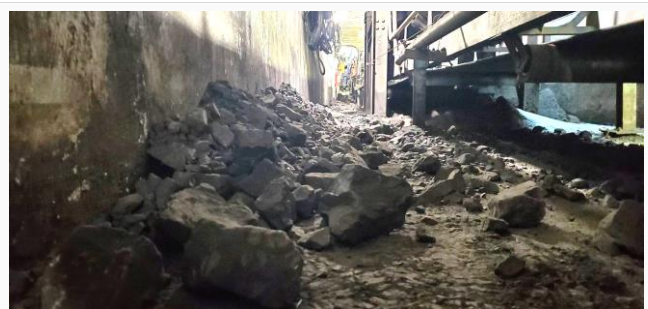
W10-REF-002 — principal coarse/mixed-product consequence in the access route.

| <b>OBSERVATION</b> | Coarse and mixed product has moved outside the intended carrying path and accumulated within the restricted W10 tunnel area. The photographs demonstrate both the scale of the accumulated consequence and the limited access available around the conveyor. |

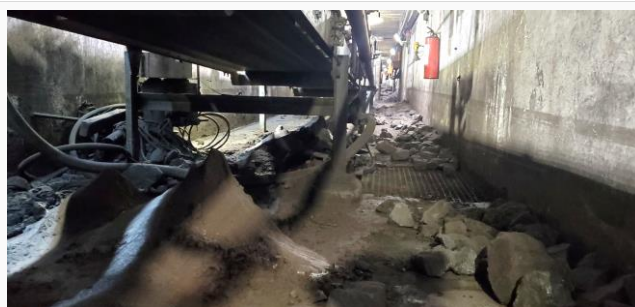
W10-REF-006 — product distributed below the conveyor around components, explaining local geometry.

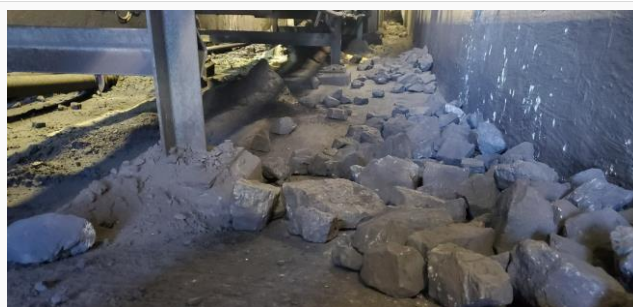
W10-REF-009 — product immediately beside support steel; useful context for local side-containment feasibility.

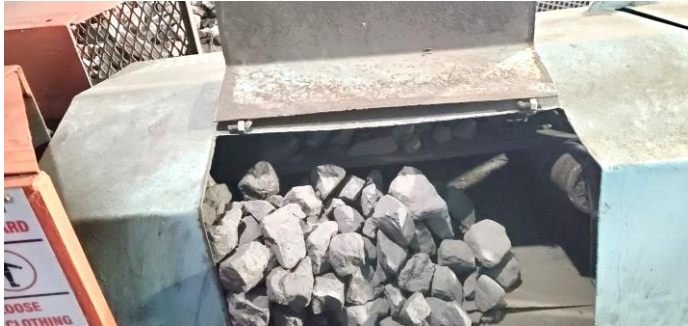
At Sample Conveyor 2, the photographs show coarse/lump product occupying a substantial proportion of the available belt carrying width, together with material outside the intended carrying path. The REF-004 and REF-005 views also support a captured lateral belt-offset condition. The available evidence does not establish the magnitude, persistence or initiating cause of that offset, nor does it establish that the conveyor was operating above a quantitative design-capacity limit. Feed quantity and variation, product-size distribution, loading position, belt position and the congested entry/guide area should therefore be considered as interacting conditions requiring representative operating verification.

**LoadoutStationSample2-REF-004** — Coarse/lump product occupying a substantial proportion of the available Sample Conveyor 2 carrying width. When read with REF-005, the belt/roller relationship also supports the captured lateral belt-position condition.

The appropriate next step is therefore to assess representative feed, product size and loading position together with the belt-position/tracking condition. Quantitative tracking/alignment checks and inspection of relevant mechanical or interference contributors can then be used to identify any primary condition requiring correction before the proposed side-skirt/spill-seal arrangement is finalized around the corrected operating condition.

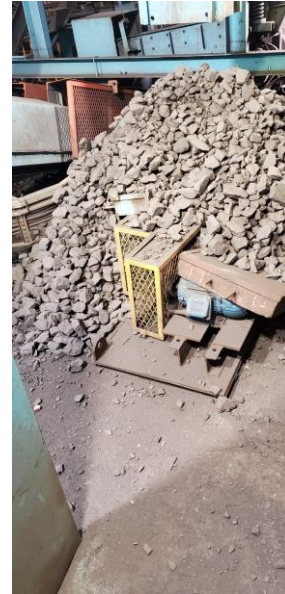
**LoadoutStationSample2-REF-001** — Wider view of coarse/lump-product accumulation around Sample Conveyor 2, showing the surrounding consequence of local product loss.

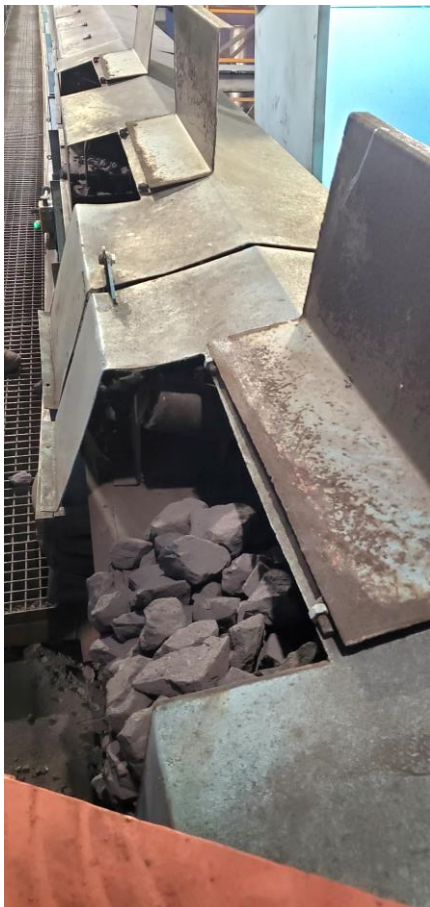
**LoadoutStationSample2-REF-005** — Complementary view of the Sample Conveyor 2 belt/roller relationship, with a substantial portion of the roller exposed. Read with REF-004, this supports a captured lateral belt offset; the magnitude remains unmeasured.

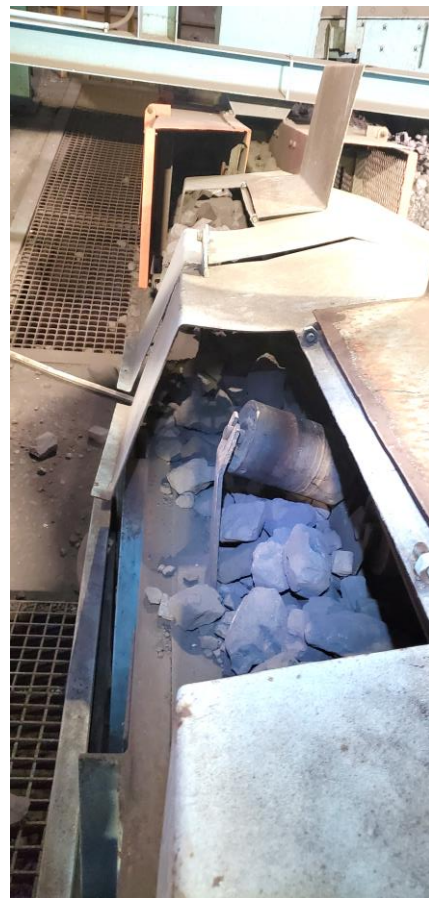
**LoadoutStationSample2-REF-007** — Representative loading and product-size view showing coarse product relative to the limited Sample Conveyor 2 carrying width.

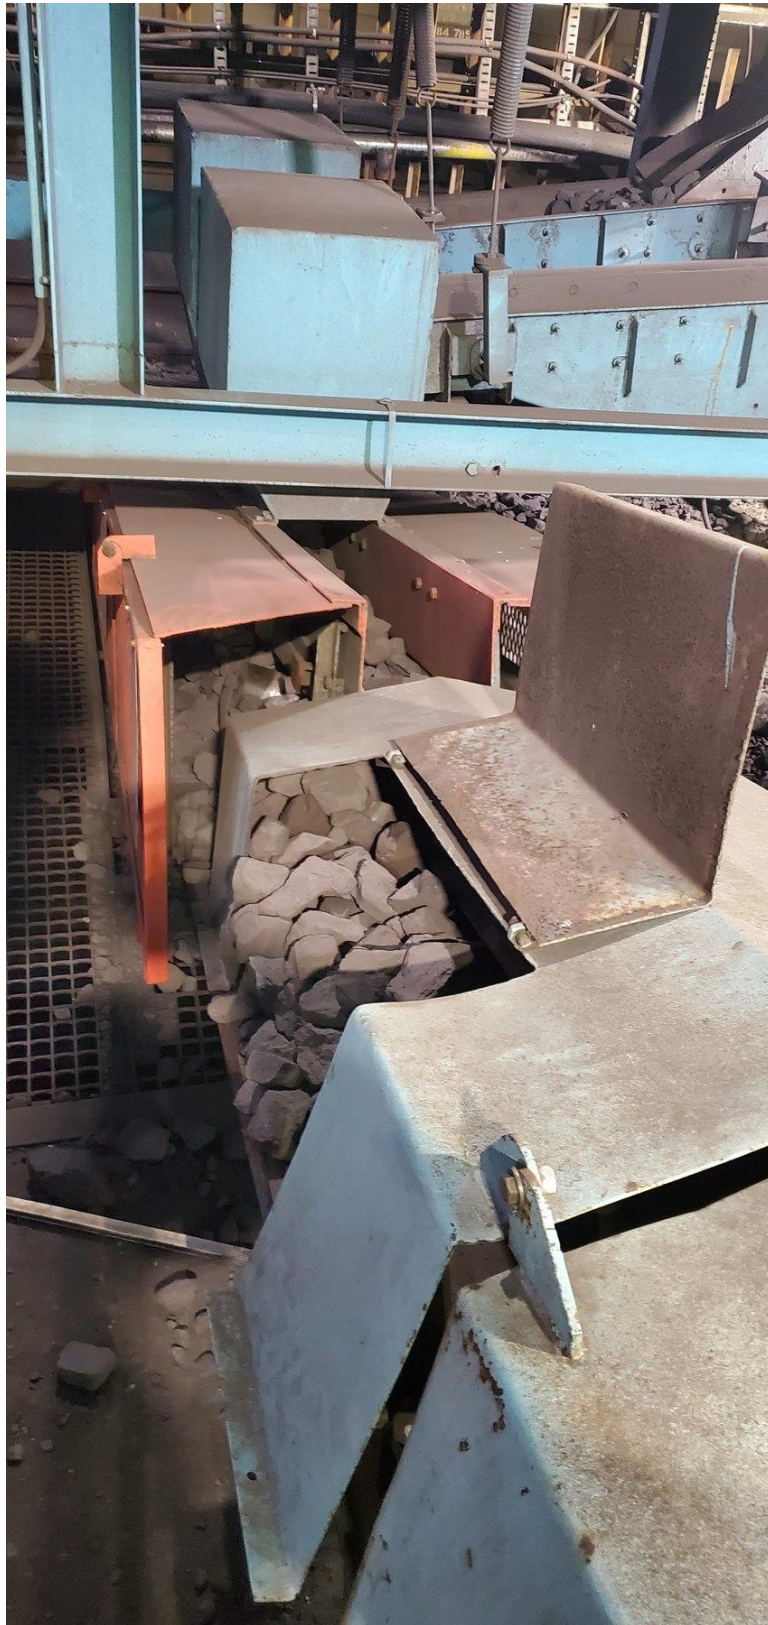
**LoadoutStationSample2-REF-006 — Sample Conveyor 2 entry/guide area showing accumulated and displaced product around the local covers and outside the intended carrying path. The view provides context for the interacting feed, product-size, belt-position and containment conditions.**

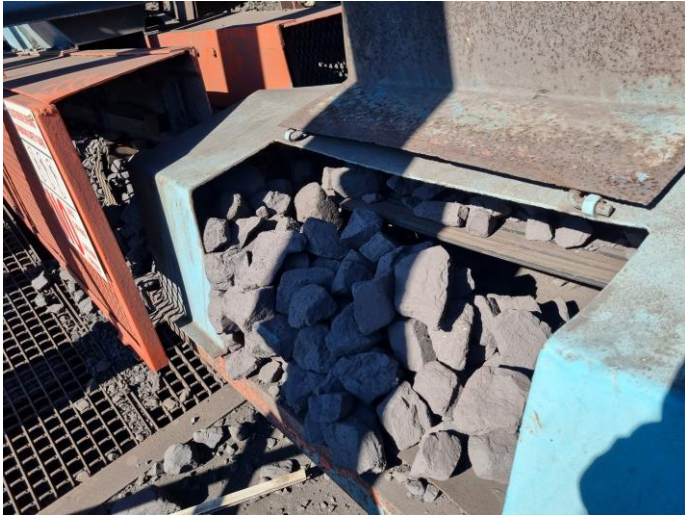
**LoadoutStationSample3-REF-002** — Feed/loading view showing coarse product relative to the limited Sample Conveyor 3 carrying width, with material also visible outside the intended carrying path.

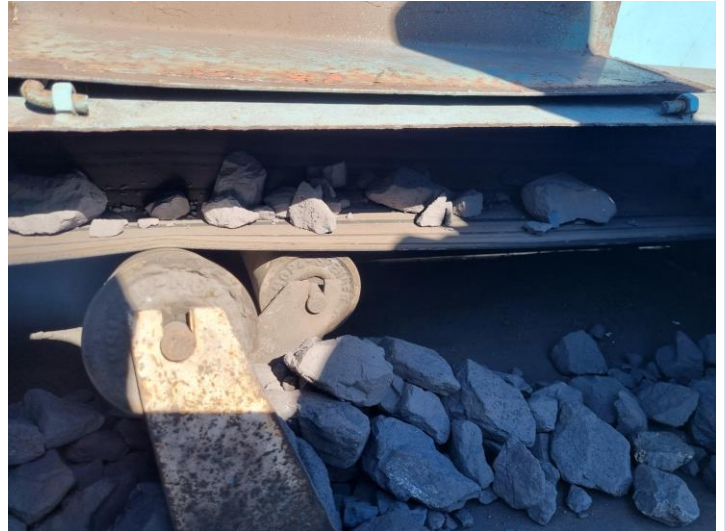
**LoadoutStationSample3-REF-003** — Supporting view showing smaller fragments retained on the belt while larger pieces are visible outside the intended carrying path.

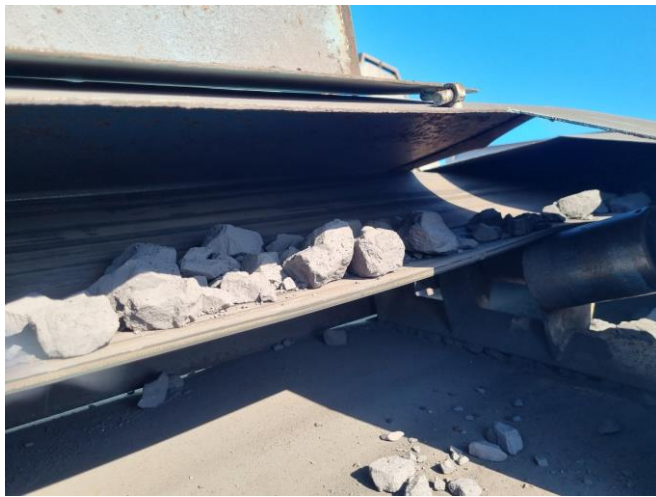
**LoadoutStationSample3-REF-004** — Wider relationship view showing product size, belt position, available carrying margin and material outside the intended carrying path within the same local area.

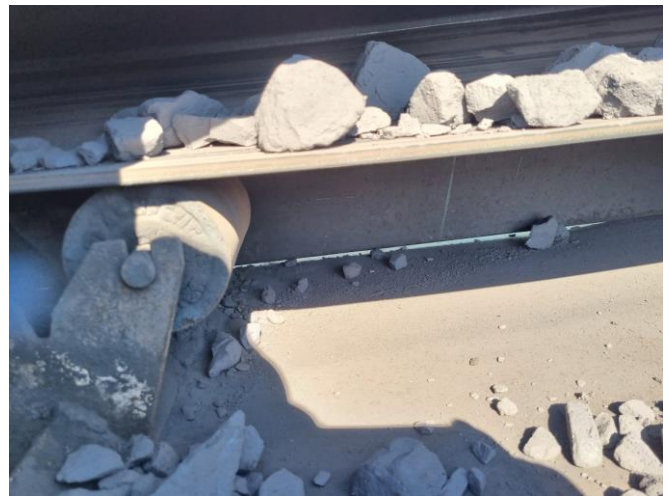
**LoadoutStationSample3-REF-005** — Additional view showing large coarse product occupying much of the available Sample Conveyor 3 carrying width.

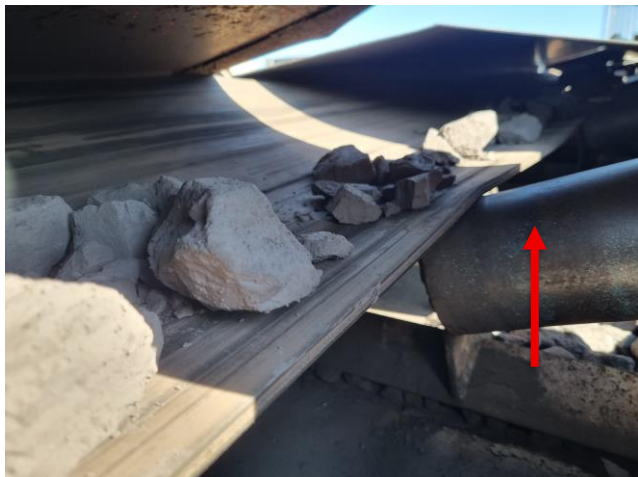
**LoadoutStationSample3-REF-006 — Sample Conveyor 3 belt/roller view showing a substantial portion of the roller exposed and supporting a visually substantial captured lateral belt offset.**

| <b>OBSERVATION</b> | Coarse product occupies a significant proportion of the available carrying width and substantial surrounding product accumulation is visible. The REF-006/REF-007 pair also supports a visually substantial captured lateral belt offset, although its magnitude has not been measured. |

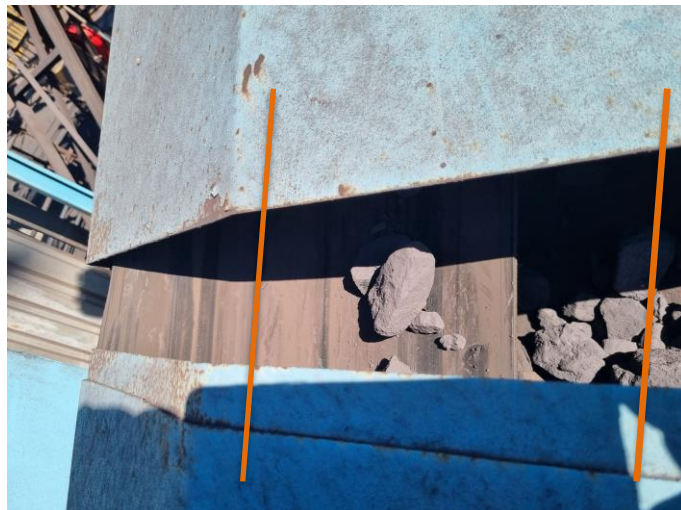
**LoadoutStationSample3-REF-007 — Complementary Sample Conveyor 3 view showing the captured lateral belt displacement. The magnitude of the offset remains unmeasured.**

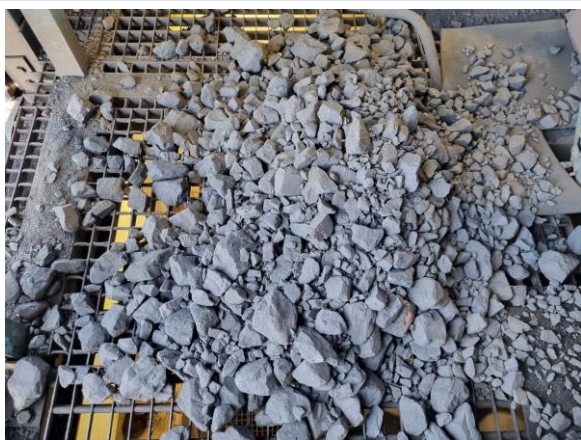
**LoadoutStationSample3-REF-012 — Wider view of mixed-size product accumulation on the surrounding grating/access area adjacent to Sample Conveyor 3.**

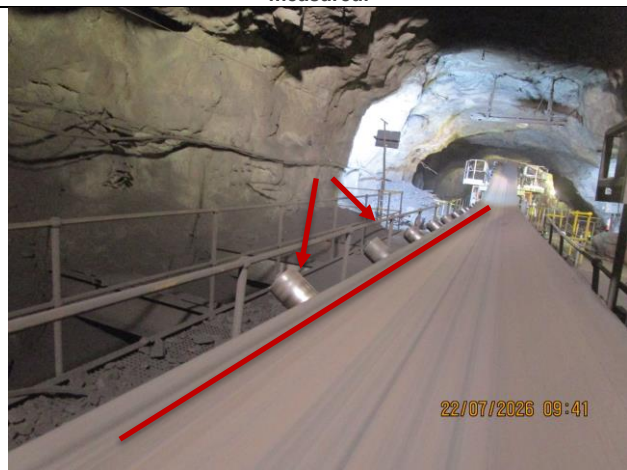
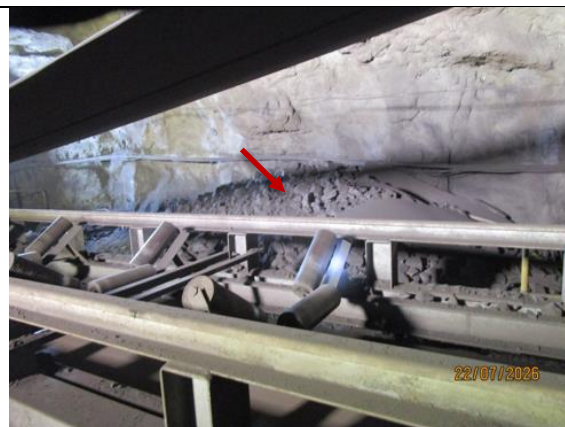
UGU4-REF-009 — Longitudinal view showing the belt displaced laterally relative to the carrying-idler/support geometry.

UGU4-REF-007 — Larger/coarse product accumulated predominantly along one side of the U4 Tripper Car conveyor

UGU4-REF-004 — Wider view showing the lateral belt-position condition extending toward the tripper-car region.

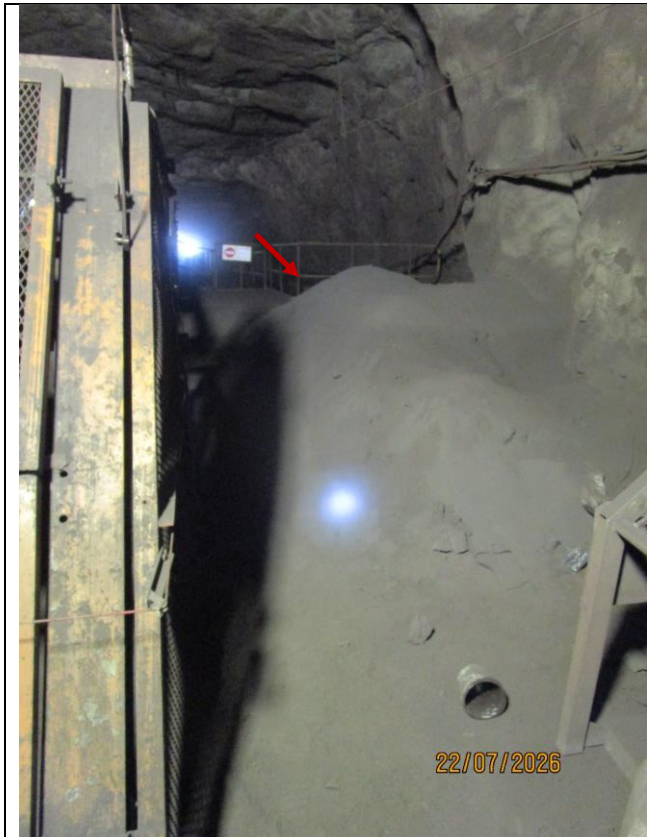
The one-sided coarse-product accumulation should be distinguished from the substantial fines deposits also present around U4. REF-005 and REF-006 show this second condition. Although both forms of accumulation occur within the same tripper-car installation, they need not share the same immediate mechanism and should therefore be assessed separately.

UGU4-REF-005 — Substantial fines/product accumulation beside the U4 Tripper Car, providing context for the separate fines/carryback condition.

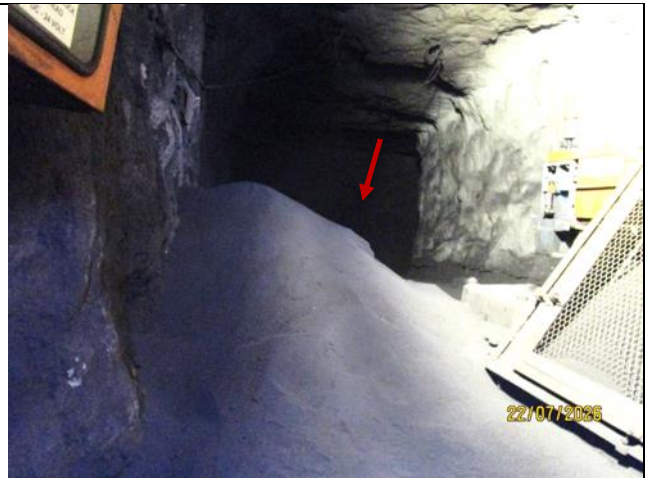
UGU4-REF-006 — Large fines accumulation in the head-pulley/tripper discharge area, showing the extent of the separate fines-related condition at U4.

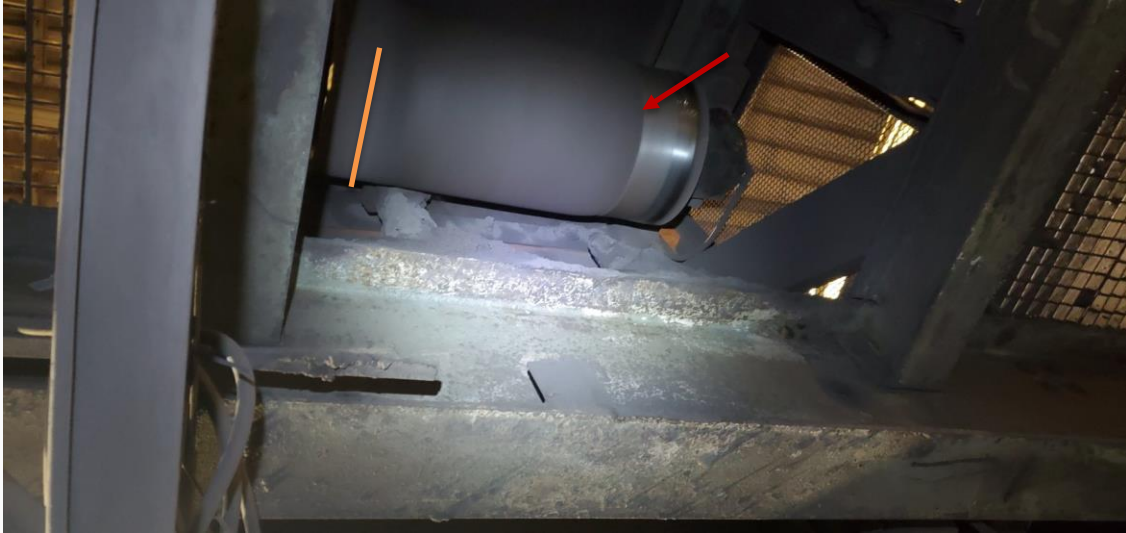
LoadoutStationL3-REF-001 — Tail-end view showing an asymmetric belt/pulley relationship consistent with an alignment or tracking concern. The magnitude of the condition remains unmeasured.

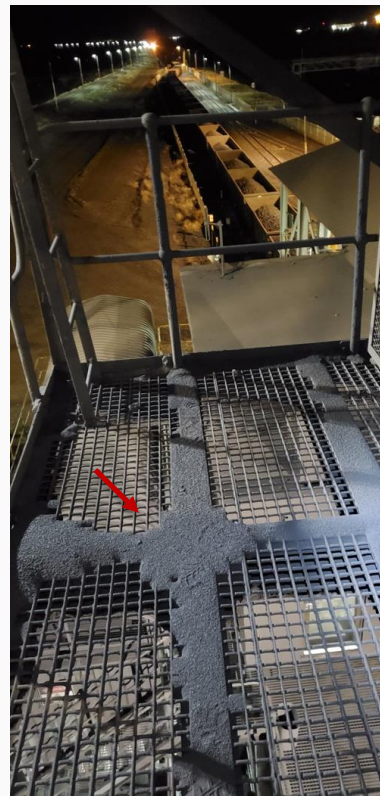
LoadoutStationL3-REF-007 — Close view showing substantial fine-material accumulation on the guarding and adjacent structure at L3.

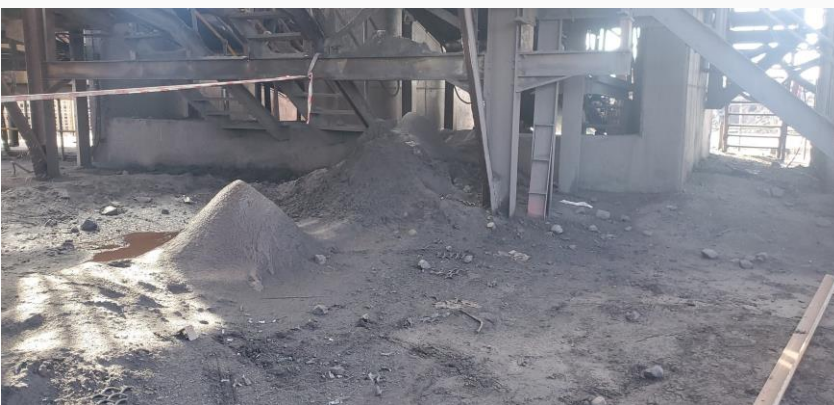
**CV04-REF-005** — Wider view showing multiple fines accumulations beneath and around CV04, illustrating the broader distribution of material at this location.

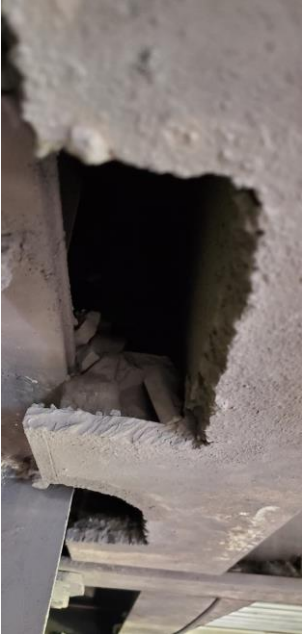
| <p>Screen-REF-009 — Wider view showing local cut-outs/notches in the affected support-member arrangement. The reason for the alterations and their effect on remaining structural capacity has not been established.</p> | <p>Screen-REF-010 — Close view showing a substantial cut-out in an affected support member. The physical alteration is clearly visible; structural adequacy requires assessment by the responsible structural authority.</p> |
| <b>OBSERVATION</b> | Active process-water escape is visible in the operating evidence. Substantial corrosion/deterioration and physical cut-outs/notches in support members are also visible within the Screens area. Although these conditions occur within the same operating environment, the available evidence does not establish that they arise from one common cause. |

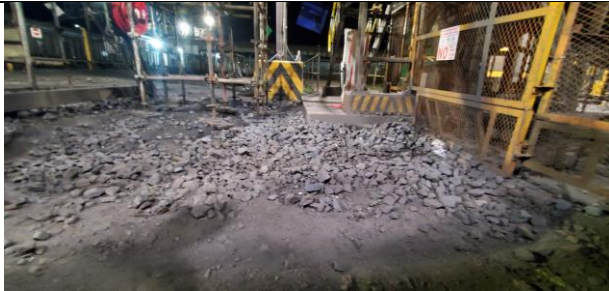
**LoadoutStationL1-REF-013** — Broad view showing extensive material and fines accumulation across the L1 conveyor/access area.

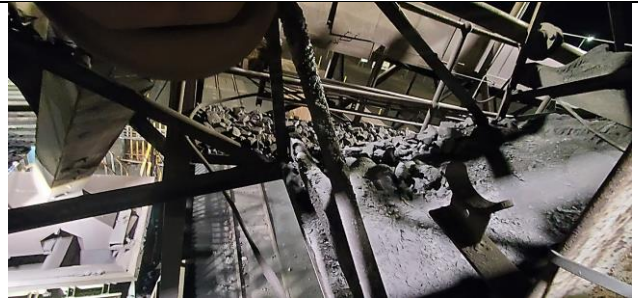
**LoadoutStationL1-REF-017** — Elevated view showing material accumulation retained on and around the L1 structural members, complementing the broader floor/access-area accumulation shown in REF-013.

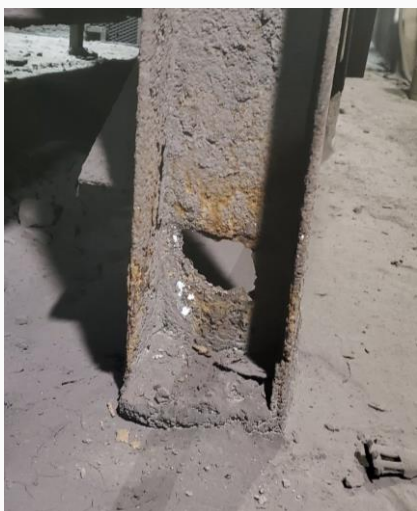
LoadoutStationL1-REF-008 — Local steel deterioration and section loss at one L1 conveyor support location.
