# Combined-Product Spillage Inspection and Engineering Assessment Report

South32 Wessels Mine · Surface and Underground Conveyor / Process Areas

| Report number | S32WPPSR-01 |
| Revision | 0.6.1 - Integrated Controlled Draft |

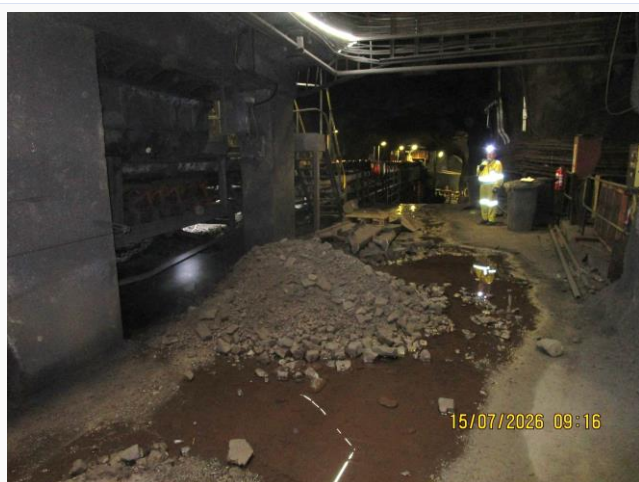
UGCrusher-REF-001 — mixed lump/fines accumulation at the underground start of the inspected conveyor ecosystem.

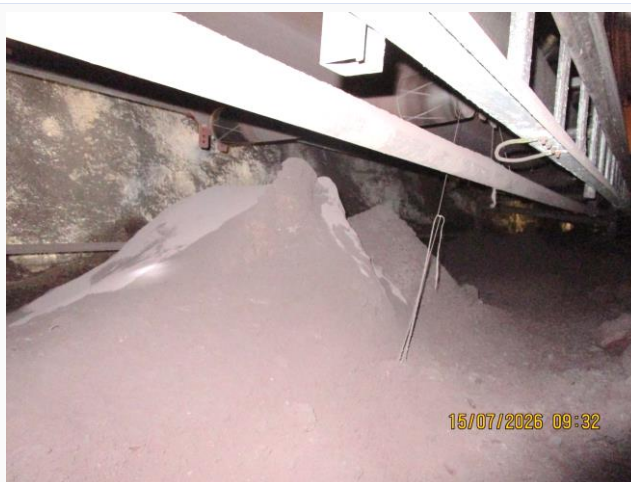
UGUC05\_04\_03\_02\_01-REF-006 — severe local accumulation along the continuous underground conveyor route.

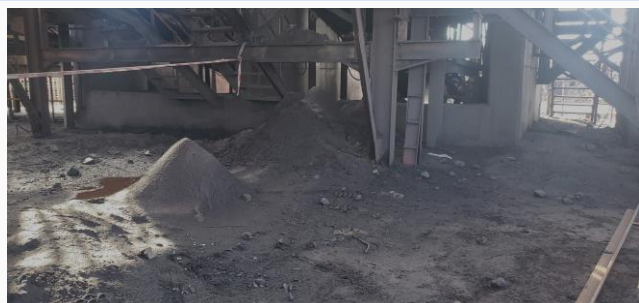
CV04-REF-005 — wider surface-plant view showing multiple accumulated fines piles beneath and around the conveyor structure.

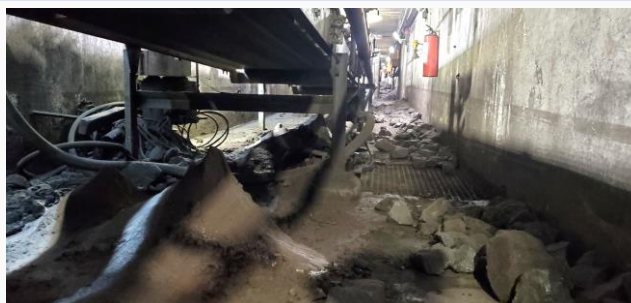
W10-REF-006 — mixed coarse product and fines distributed below the conveyor around components within the restricted tunnel area.

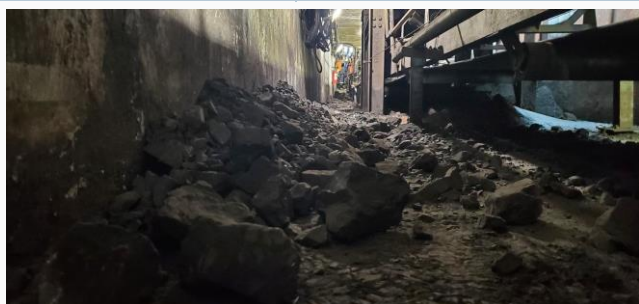
W10-REF-002 — coarse/mixed product occupying restricted tunnel access.

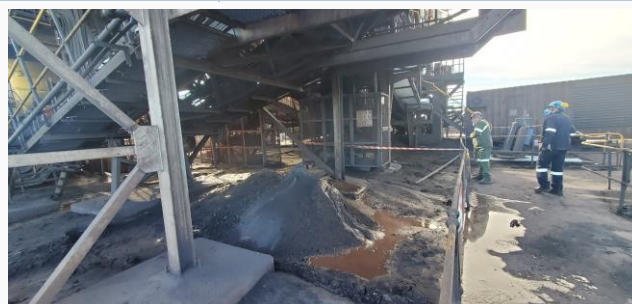
CV01-REF-004 — wider view of wet-fines/slurry accumulation and standing water around the conveyor structure.

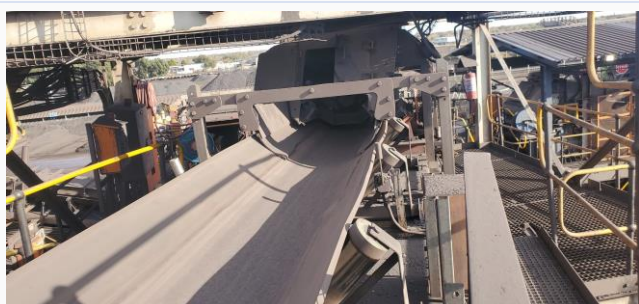
CV03-REF-002 — clean-condition comparator demonstrating that not every inspected conveyor was a significant spillage location.

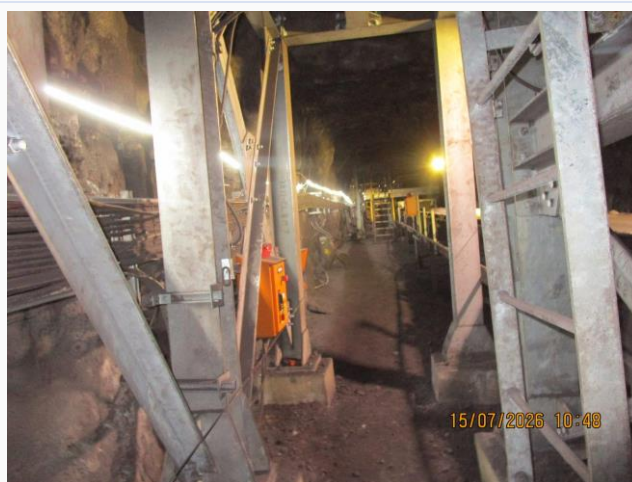
UG5B-REF-006 — wider comparator supporting a localised rather than uniformly widespread U5B condition.

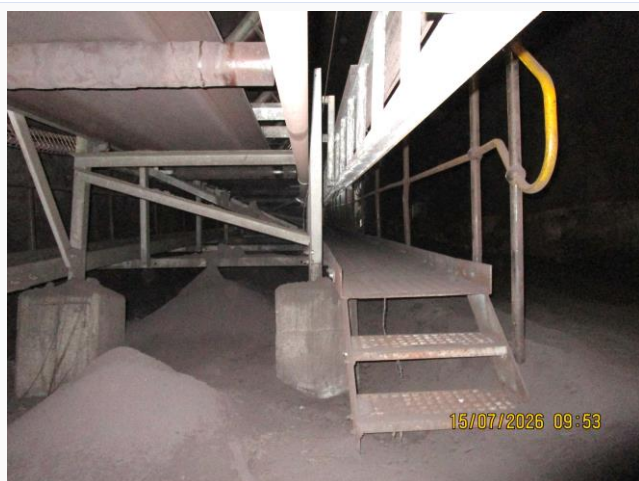
UGUC05\_04\_03\_02\_01-REF-010 — wider longitudinal accumulation supporting recurrence along the underground route.

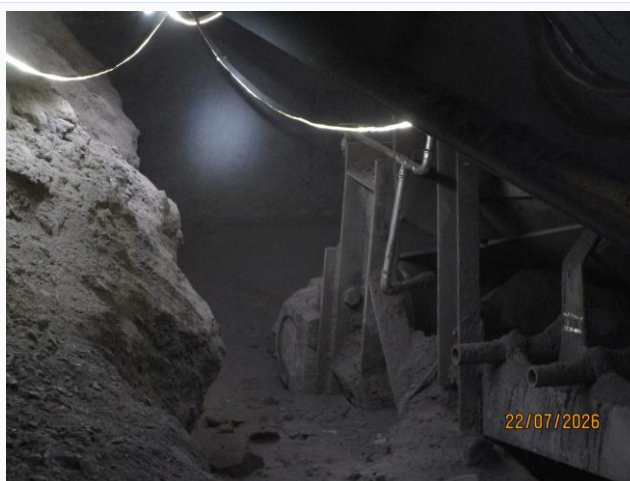
UG5A-REF-006 — widespread return-side accumulation at U5A.

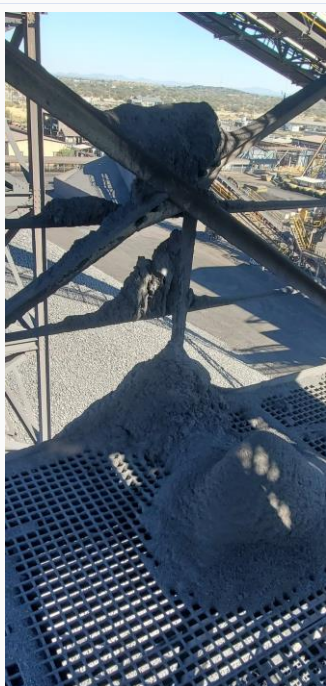
CV15-REF-004 — large fines deposits on grating/cross-bracing around the CV15 discharge region.

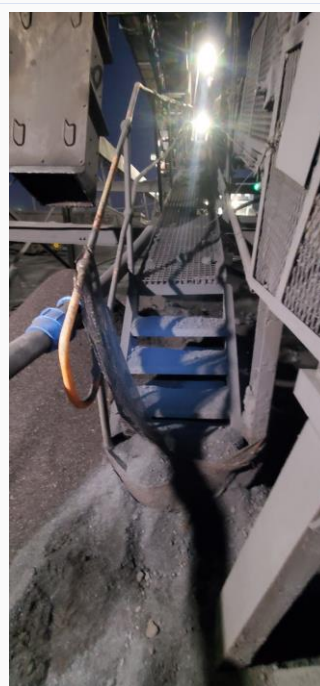
LoadoutStationSample1-REF-002 — substantial fines accumulation around the Sample Conveyor 1 tail/access area.

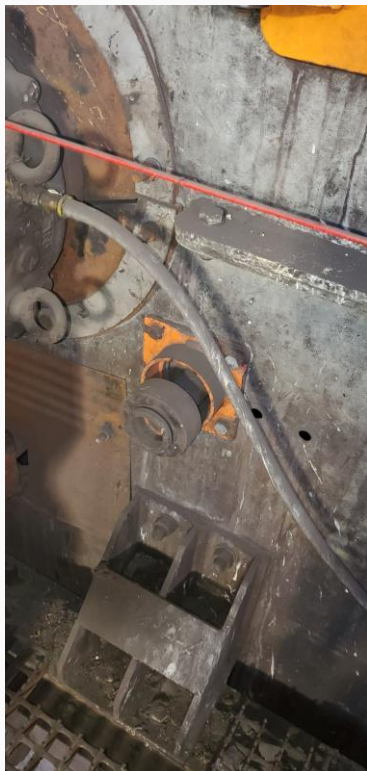
CV06-REF-004 — displaced cleaner support bush/insert.

| <b>ENGINEERING ASSESSMENT</b> | The missing scraper blades and displaced support component mean that the cleaner cannot provide the intended cleaning function in its inspected condition. Residual fines can therefore remain on the belt and continue onto the return run, contributing to carryback and subsequent fines spillage into the surrounding conveyor environment. Poor housing design was recorded as a possible contributor to the displaced bush/insert, but the available evidence does not establish the root cause or the history of the blade loss. |

| <b>RECOMMENDED NEXT ACTION</b> | Restore a complete functional cleaner arrangement; inspect and address the housing/support condition and retention, reinstate the required blade coverage, and verify cleaner contact, adjustment and maintainability. Incorporate the recommended support, adjustment and wear-compensation improvements where confirmed through the detailed maintenance/OEM review, and verify the completed arrangement under representative operation before close-out. |

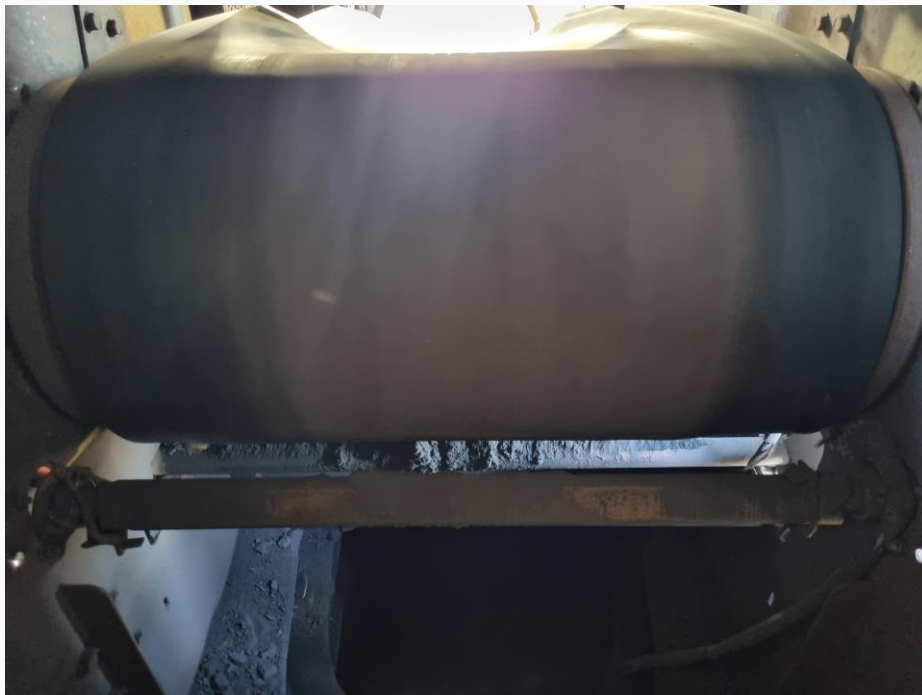
At CV06, the installed cleaner arrangement was not in a condition to provide the intended belt-cleaning function. The cleaner support structure remains in place, but the scraper blade elements are absent across the working belt width and a support bush/insert is visibly displaced. Poor housing design was recorded as a possible contributor to the bush displacement, with maintenance and replacement condition also relevant; however, the available photographs do not establish the root cause of the displacement or explain when and why the scraper blades were lost.

CV06-REF-005 — cleaner support structure present with scraper blades absent from the working belt width.

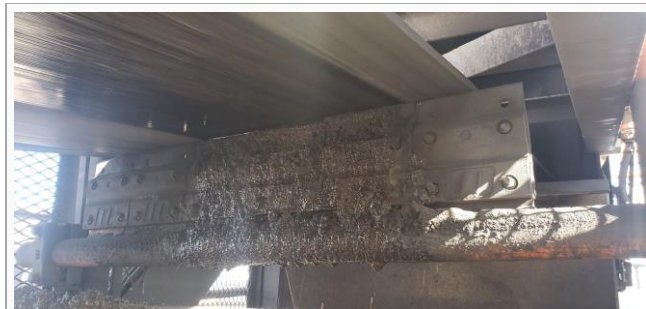
CV09-REF-003 — principal still showing the cleaner/open local arrangement.

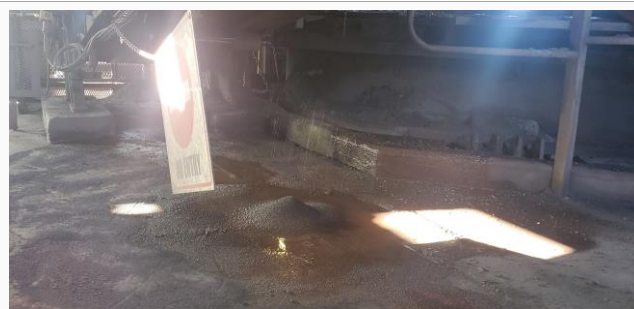
CV09-REF-002 — wet-fines/slurry consequence below the discharge/cleaner region.

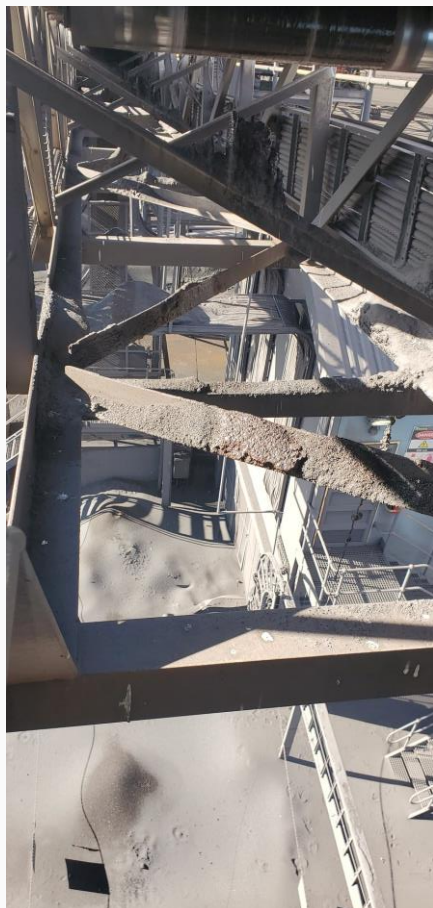
CV09-REF-005 — wider fines/material accumulation around the CV09 structure, supporting the broader consequence of material escaping and being redistributed outside the intended process path.

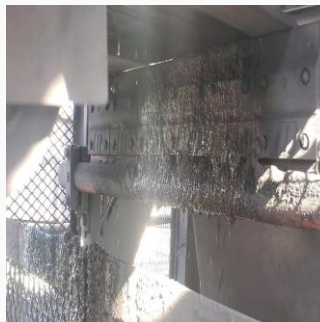
CV09-REF-008 — representative frame from inspection video showing contaminated cleaner/chute geometry relevant to the containment-boundary issue and pilot concept

| <b>RECOMMENDED NEXT ACTION</b> | Develop and trial the CV09 cleaner-and-containment concept from verified site geometry. The preferred arrangement is pulley-supported cleaning located inside the existing head/discharge chute, with two cleaning stages where practicable, effective wear compensation/self-tensioning, positive travel limitation and practical maintenance access. The completed pilot should be assessed under representative operating conditions to confirm that downstream carryback is materially reduced, cleaner-removed fines remain within the existing discharge flow and the arrangement remains maintainable without introducing unacceptable belt, cleaner, access or guarding problems. |

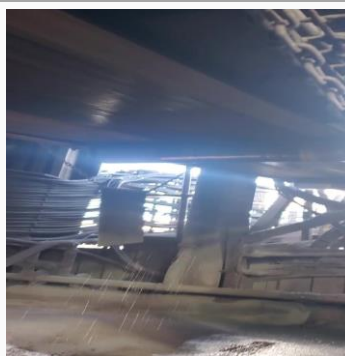
Active wet-material fallout was recorded during operation, while the surrounding deposits provide visible evidence of the consequence of material not being fully retained within the process. CV09 is therefore a particularly useful location for demonstrating the difference between simply cleaning the belt and controlling what happens to the material after it has been removed. Because both the cleaner arrangement and the resulting fines-loss condition are clearly represented at this location, CV09 also provides a potentially high-impact pilot location for proving an improved cleaner-and-containment approach before considering wider application elsewhere in the system.

CV09-REF-006 — representative frame from inspection video showing active wet-material fallout during operation.

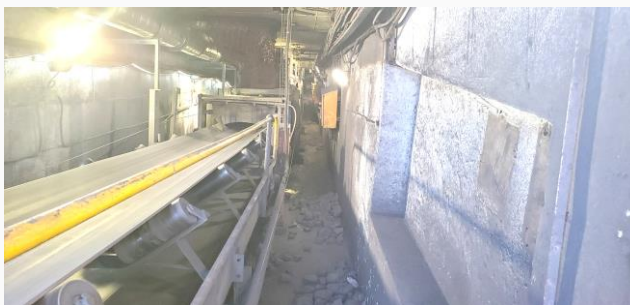
W10-REF-010 — long tunnel view establishing the confined topology and restricted access.

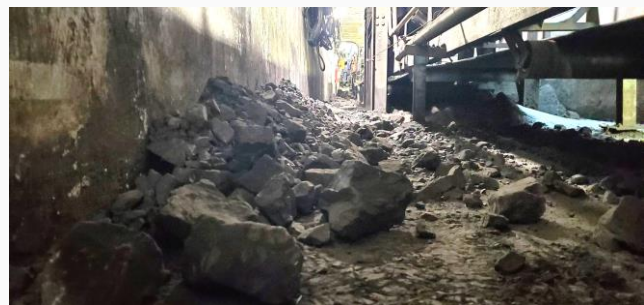
W10-REF-002 — principal coarse/mixed-product consequence in the access route.

W10 requires belt-edge side skirting/spill sealing as the preferred engineered containment addition for the demonstrated lateral coarse/mixed-product loss within the restricted tunnel environment. Representative loading, belt tracking and local conveyor geometry should still be verified and confirmed contributors corrected so that the final skirting arrangement is developed around the verified operating condition. The same side-skirt/spill-seal principle is proposed for Sample Conveyors 2 and 3 after their feed quantity/variation, product-size distribution, loading condition and belt-position/tracking or alignment have been quantified and corrected or adjusted where required. If the W10 principle performs successfully, it should also be considered and adapted at other underground or surface conveyor locations where a comparable lateral-containment requirement is identified and the local mechanism and geometry confirm suitability.

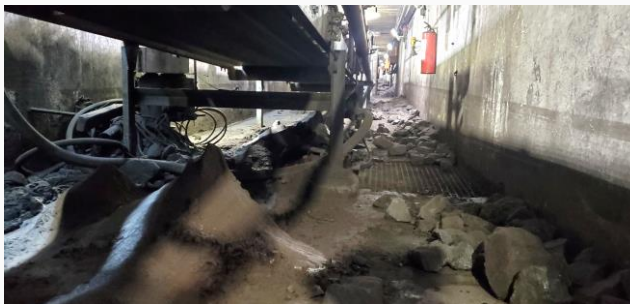
W10-REF-006 — product distributed below the conveyor around components, explaining local geometry.

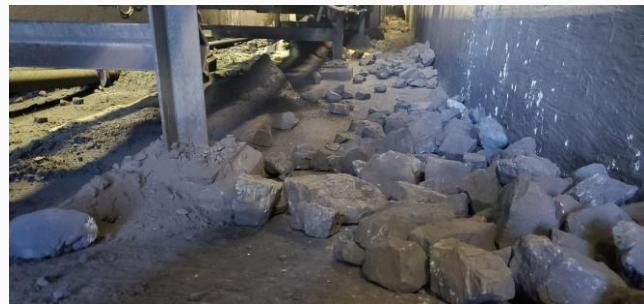
W10-REF-009 — product immediately beside support steel; useful context for local side-containment feasibility.

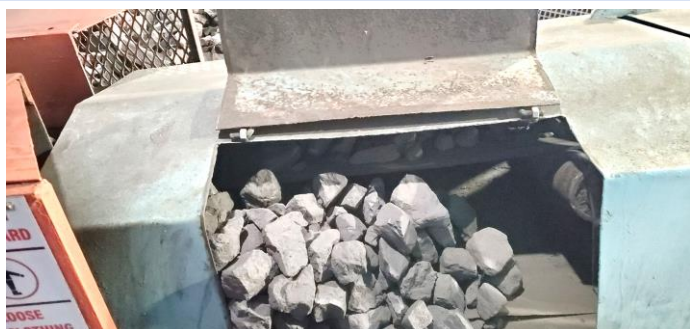
LoadoutStationSample2-REF-004 — Coarse/lump product occupying a substantial proportion of the available Sample Conveyor 2 carrying width. When read with REF-005, the belt/roller relationship also supports the captured lateral belt-position condition.

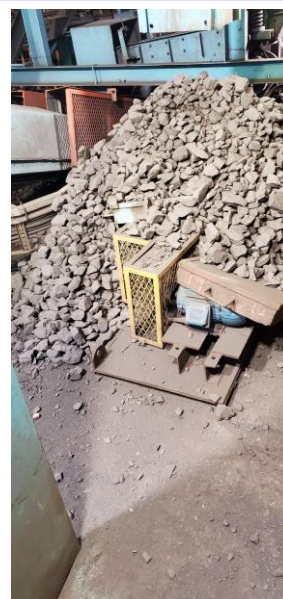
LoadoutStationSample2-REF-001 — Wider view of coarse/lump-product accumulation around Sample Conveyor 2, showing the surrounding consequence of local product loss.

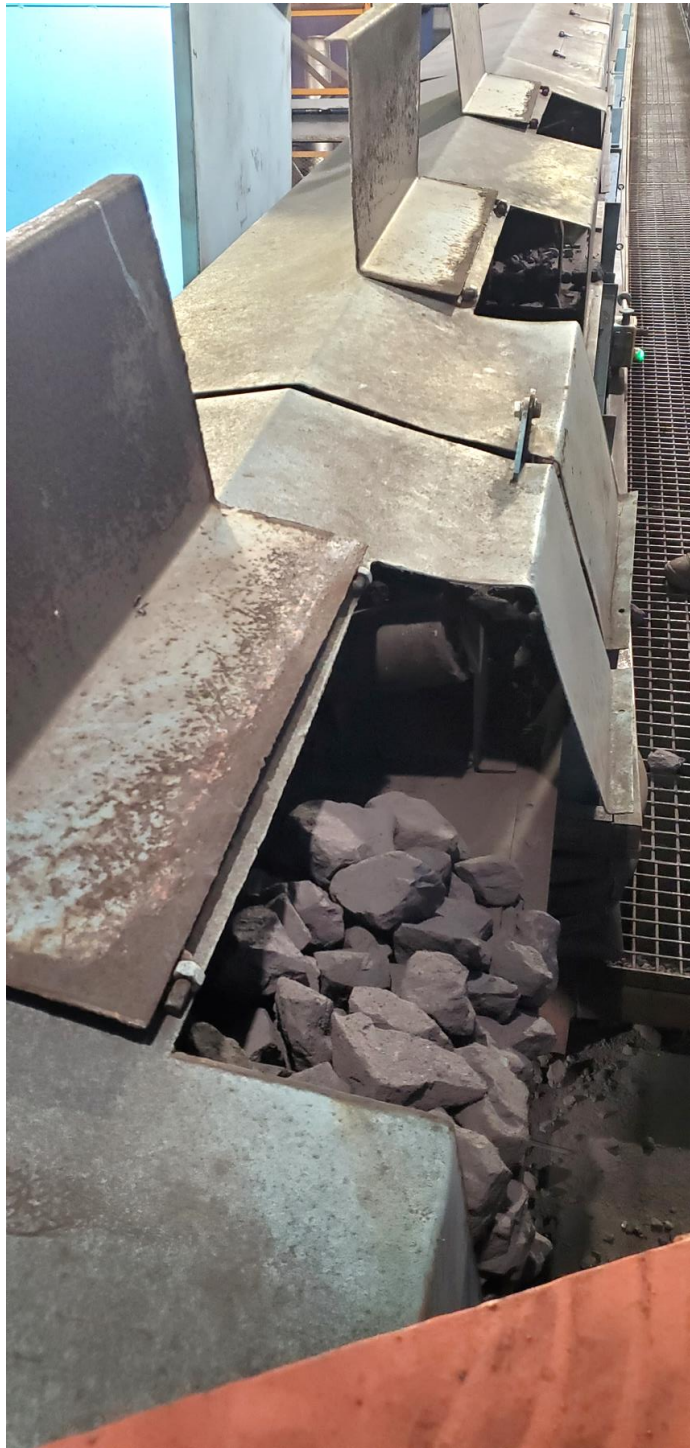
LoadoutStationSample2-REF-005 — Complementary view of the Sample Conveyor 2 belt/roller relationship, with a substantial portion of the roller exposed. Read with REF-004, this supports a captured lateral belt offset; the magnitude remains unmeasured.

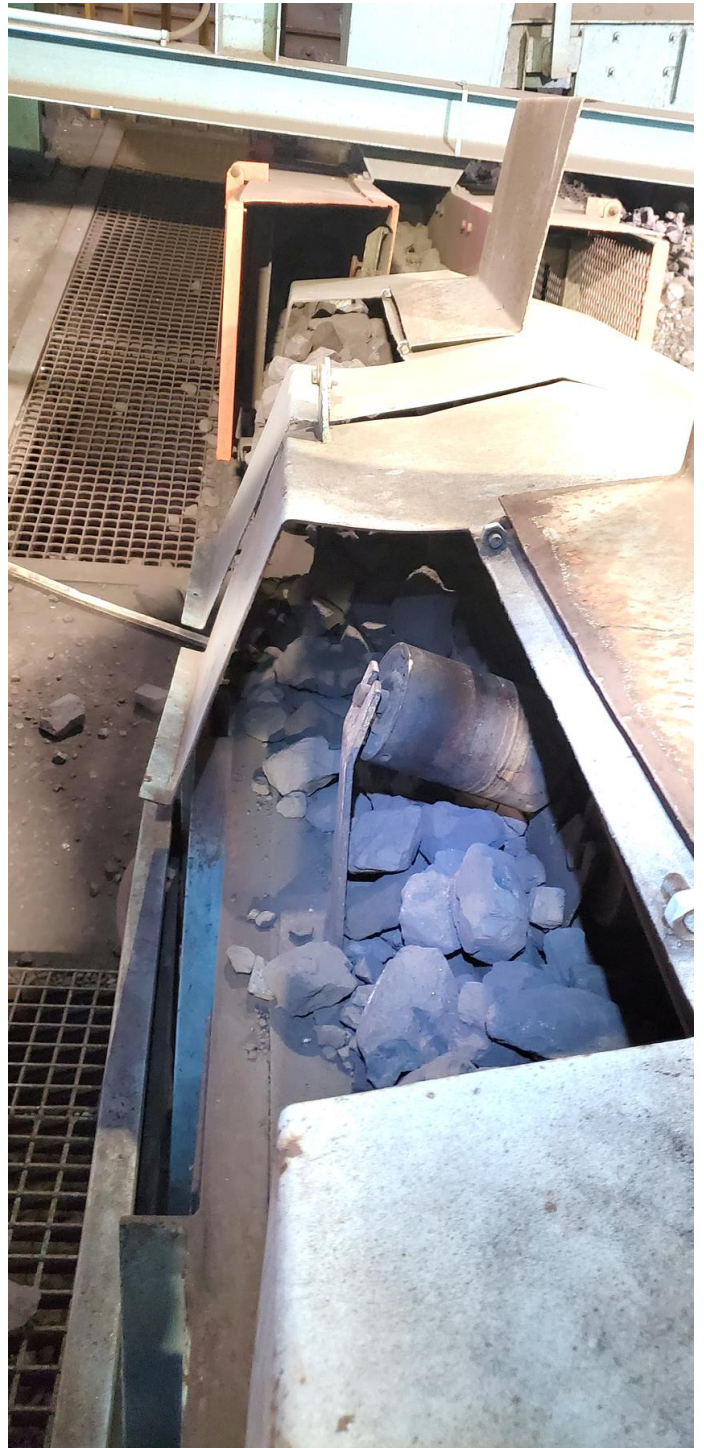
LoadoutStationSample2-REF-007 — Representative loading and product-size view showing coarse product relative to the limited Sample Conveyor 2 carrying width.

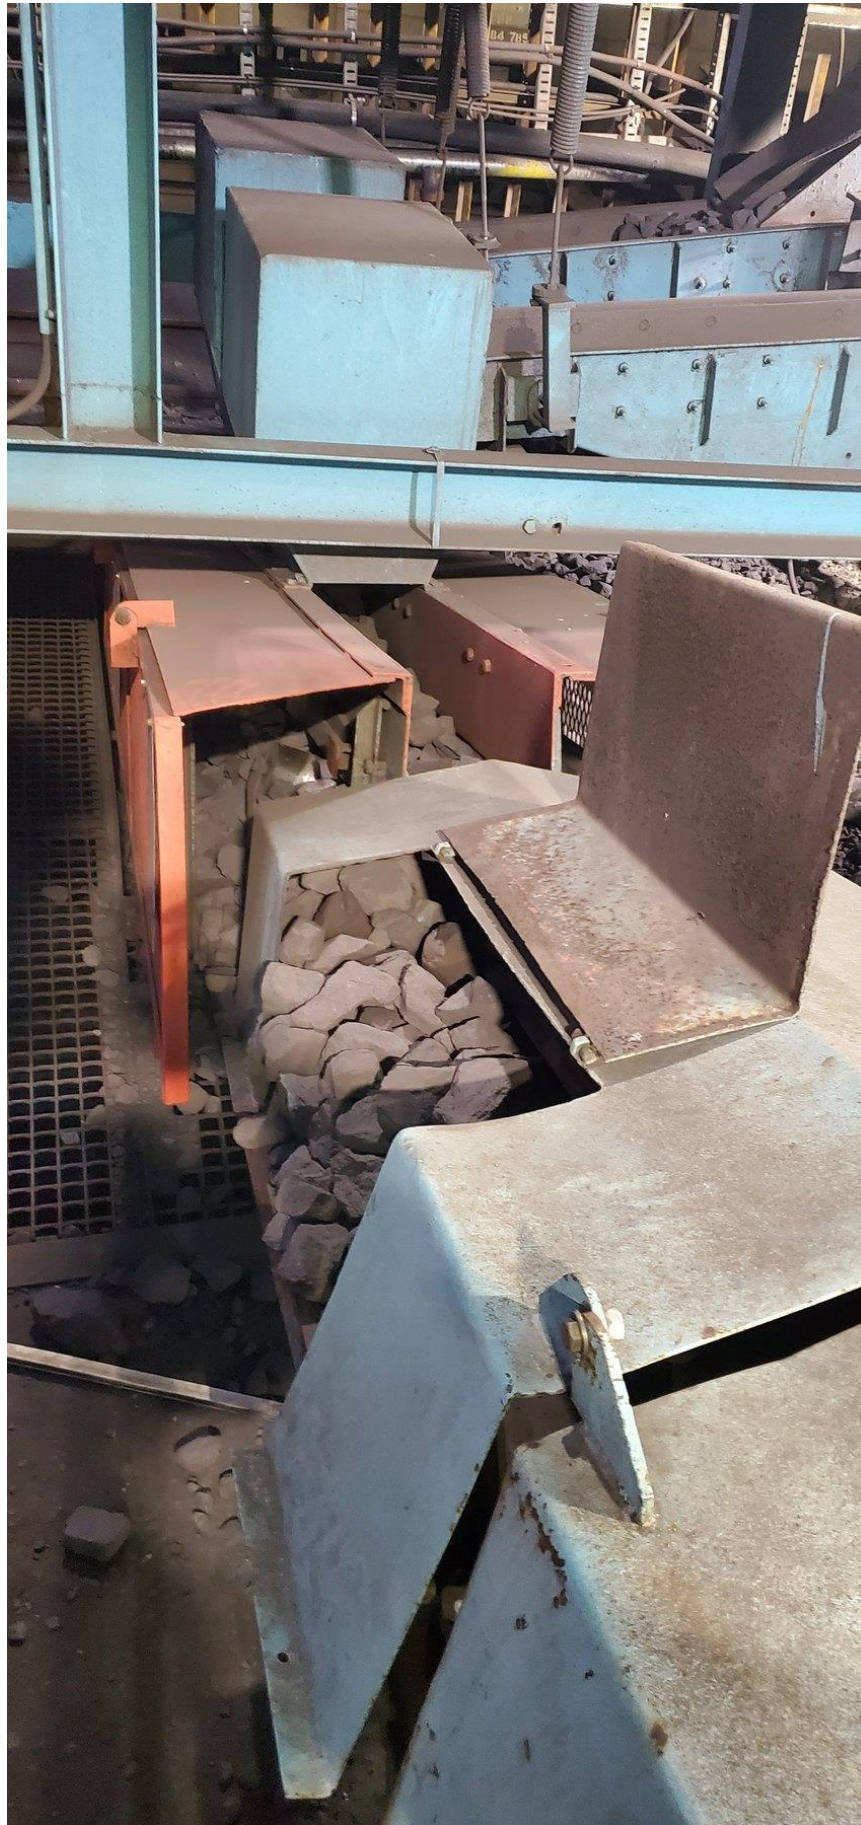
LoadoutStationSample2-REF-006 — Sample Conveyor 2 entry/guide area showing accumulated and displaced product around the local covers and outside the intended carrying path. The view provides context for the interacting feed, product-size, belt-position and containment conditions.

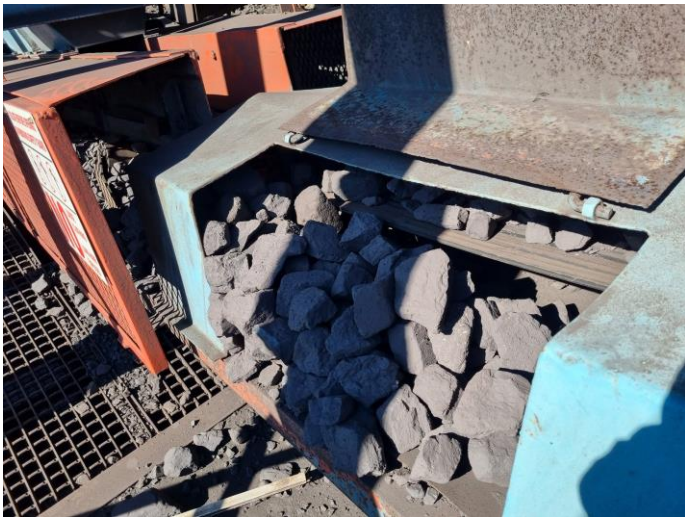
**LoadoutStationSample3-REF-002** — Feed/loading view showing coarse product relative to the limited Sample Conveyor 3 carrying width, with material also visible outside the intended carrying path.

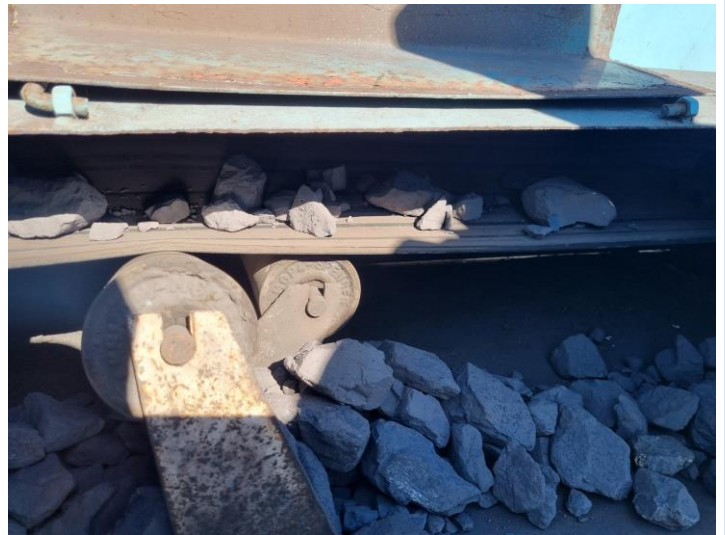
**LoadoutStationSample3-REF-003** — Supporting view showing smaller fragments retained on the belt while larger pieces are visible outside the intended carrying path.

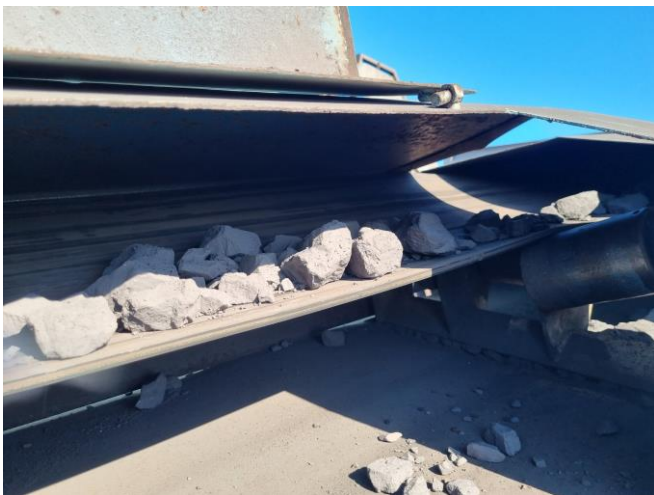
**LoadoutStationSample3-REF-004** — Wider relationship view showing product size, belt position, available carrying margin and material outside the intended carrying path within the same local area.

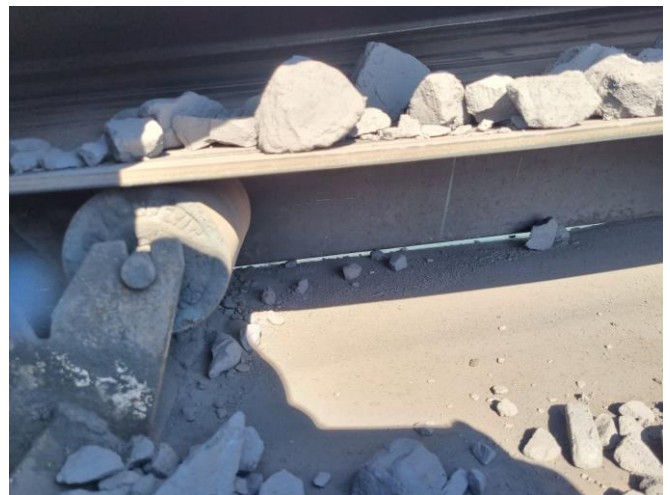
**LoadoutStationSample3-REF-005** — Additional view showing large coarse product occupying much of the available Sample Conveyor 3 carrying width.

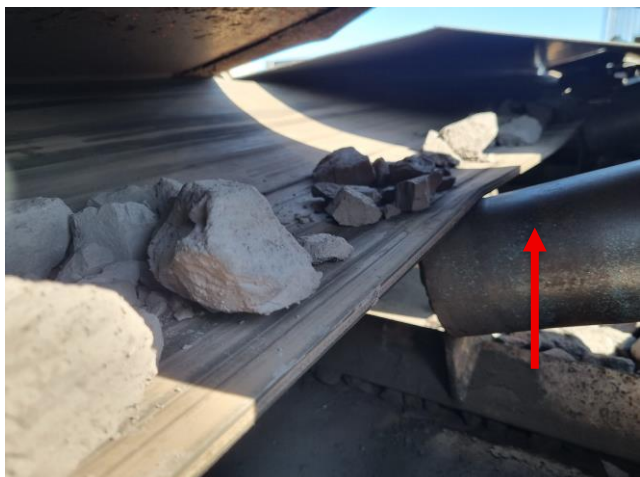
**LoadoutStationSample3-REF-006 — Sample Conveyor 3 belt/roller view showing a substantial portion of the roller exposed and supporting a visually substantial captured lateral belt offset.**

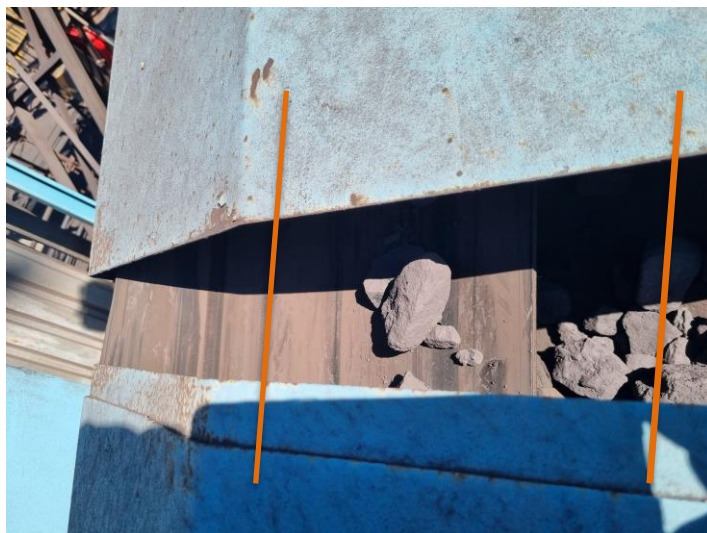
**LoadoutStationSample3-REF-007 — Complementary Sample Conveyor 3 view showing the captured lateral belt displacement. The magnitude of the offset remains unmeasured.**

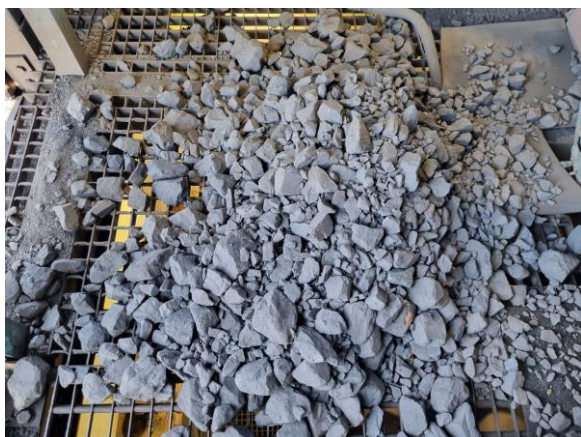
**LoadoutStationSample3-REF-012 — Wider view of mixed-size product accumulation on the surrounding grating/access area adjacent to Sample Conveyor 3.**

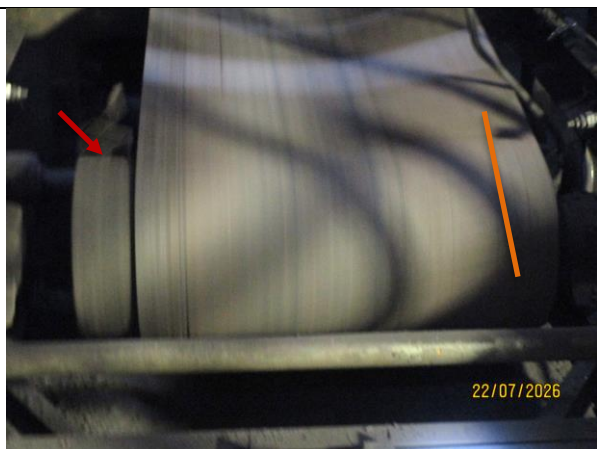
UGU4-REF-008 — Tail-end belt/pulley view supporting the alignment concern recorded during the inspection. The relationship is visually apparent but was not dimensionally measured.

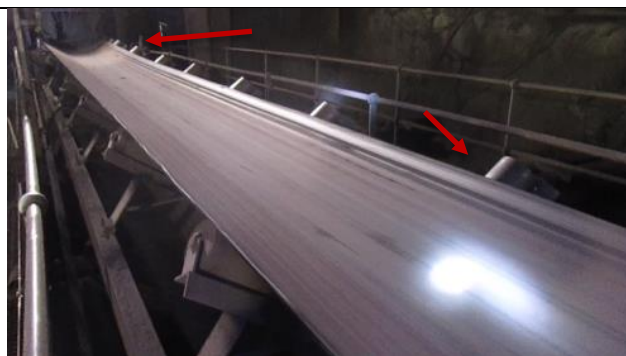
UGU4-REF-009 — Longitudinal view showing the belt displaced laterally relative to the carrying-idler/support geometry.

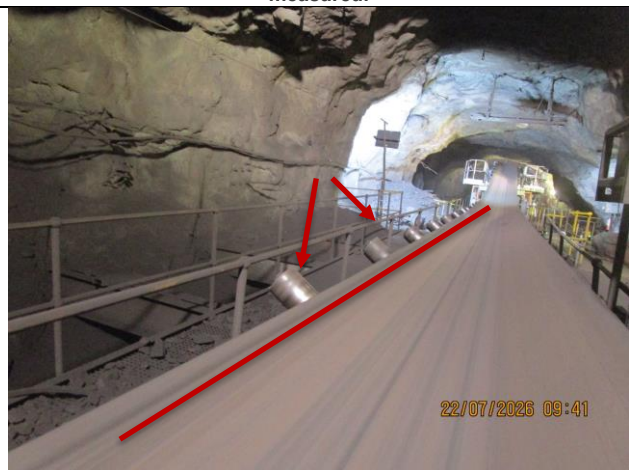
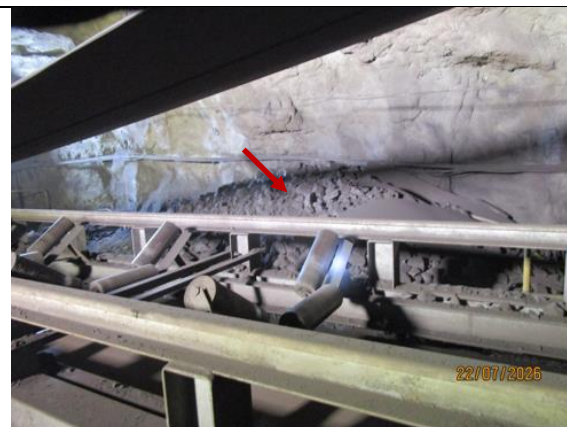
UGU4-REF-007 — Larger/coarse product accumulated predominantly along one side of the U4 Tripper Car conveyor

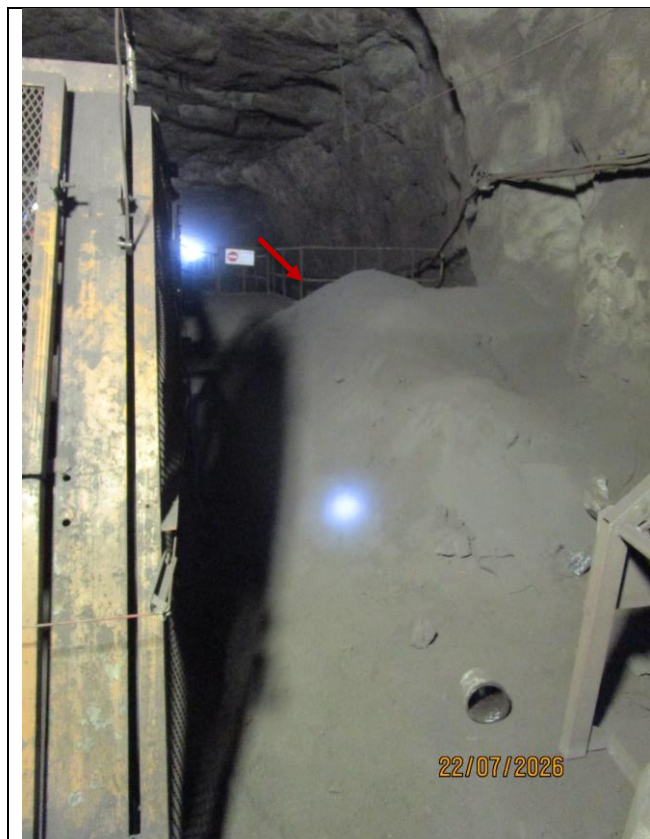
UGU4-REF-005 — Substantial fines/product accumulation beside the U4 Tripper Car, providing context for the separate fines/carryback condition.

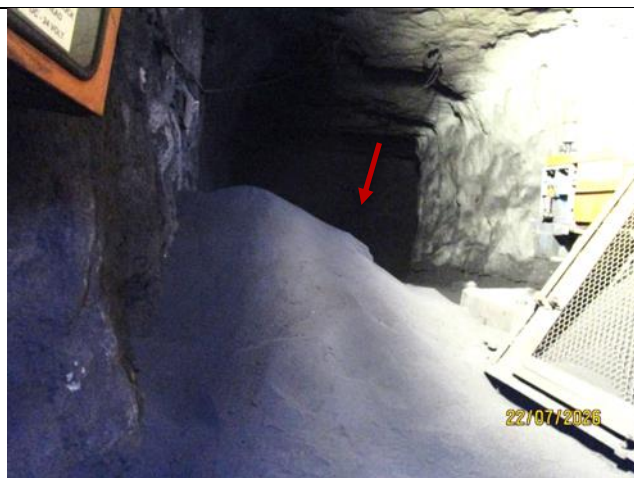
UGU4-REF-006 — Large fines accumulation in the head-pulley/tripper discharge area, showing the extent of the separate fines-related condition at U4.

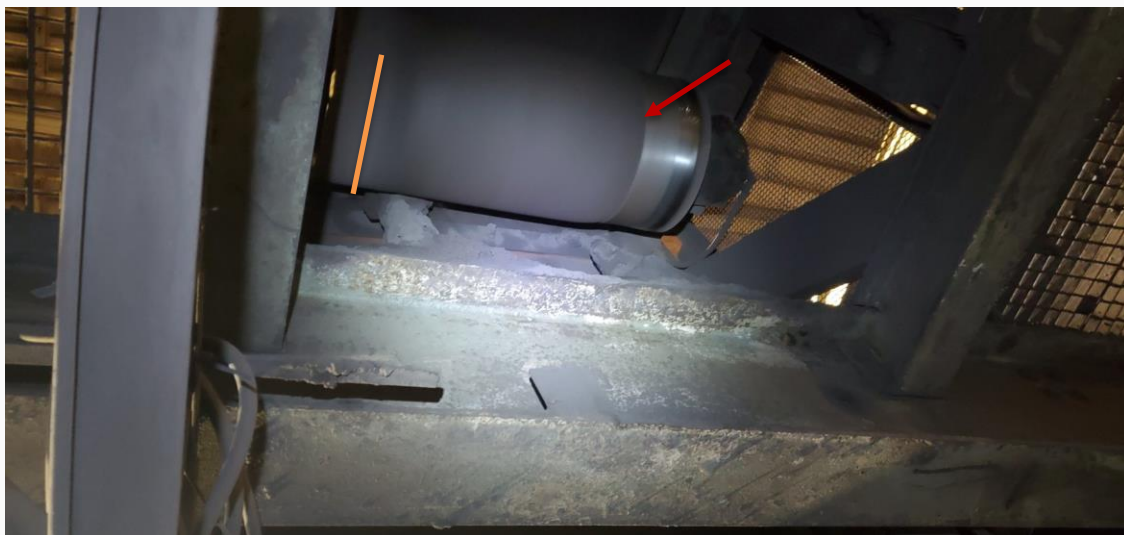
LoadoutStationL3-REF-001 — Tail-end view showing an asymmetric belt/pulley relationship consistent with an alignment or tracking concern. The magnitude of the condition remains unmeasured.

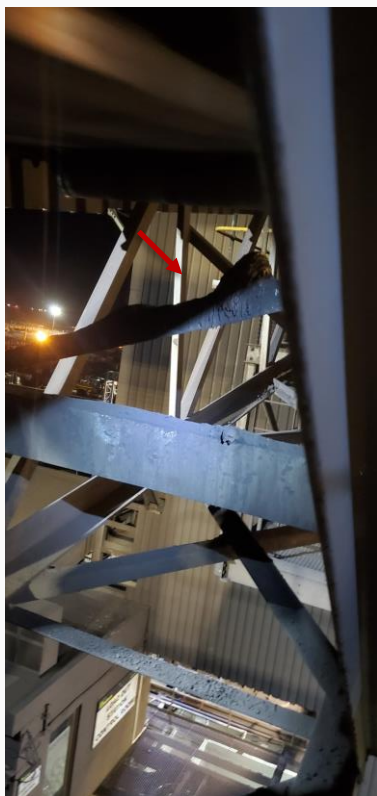
LoadoutStationL3-REF-004 — Additional view showing fines/material distributed around the local conveyor and support area. The photograph provides consequence context but does not establish the initiating source.

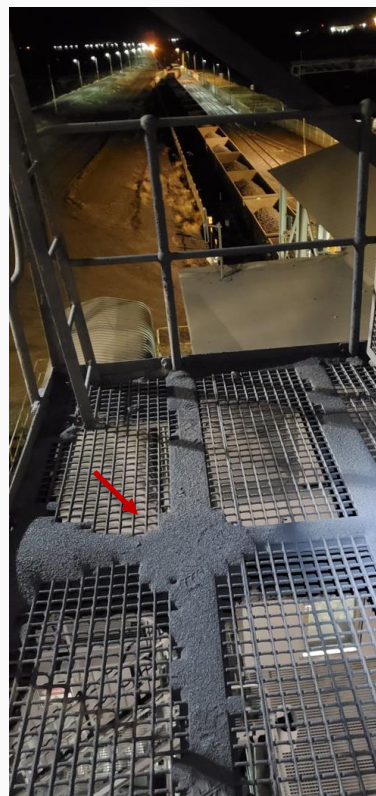
LoadoutStationL3-REF-007 — Close view showing substantial fine-material accumulation on the guarding and adjacent structure at L3.

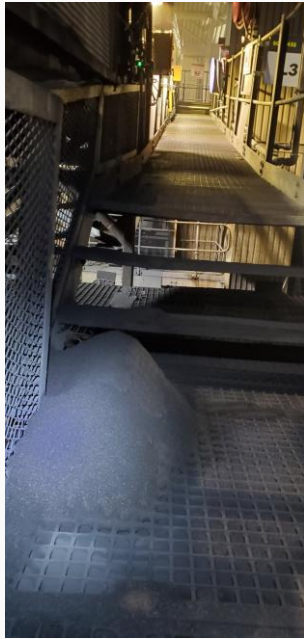
**LoadoutStationL3-REF-002 — Fines/material accumulation around the L3 conveyor and guarding area, illustrating the separate fines-spillage condition.**

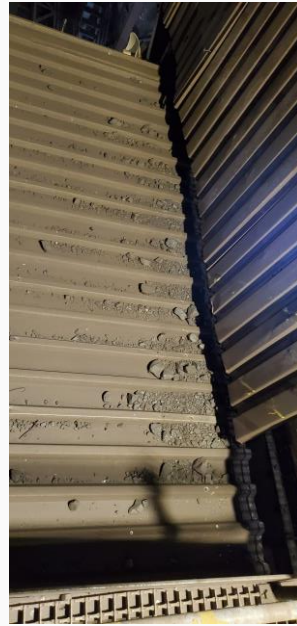
**LoadoutStationL3-REF-008 — Supporting lower-area view showing fines and small-fragment accumulation beneath the conveyor.**

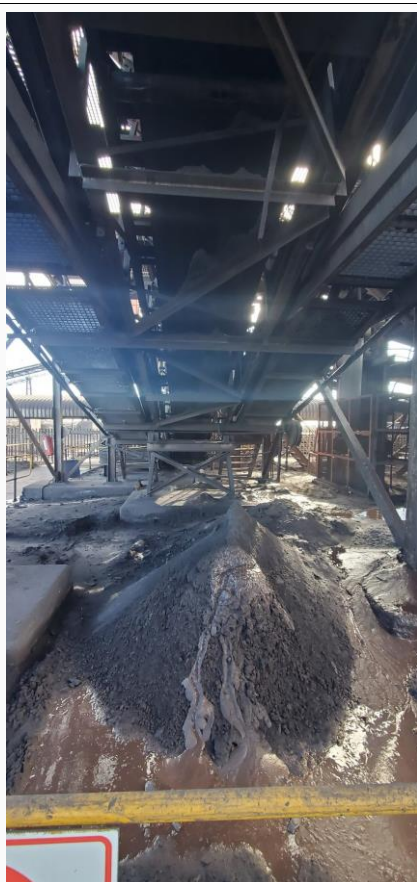
CV01-REF-003 — Wet-fines/slurry accumulation with pooled water beneath the conveyor area. The photograph shows the wet condition, while the initiating water source remains unresolved.

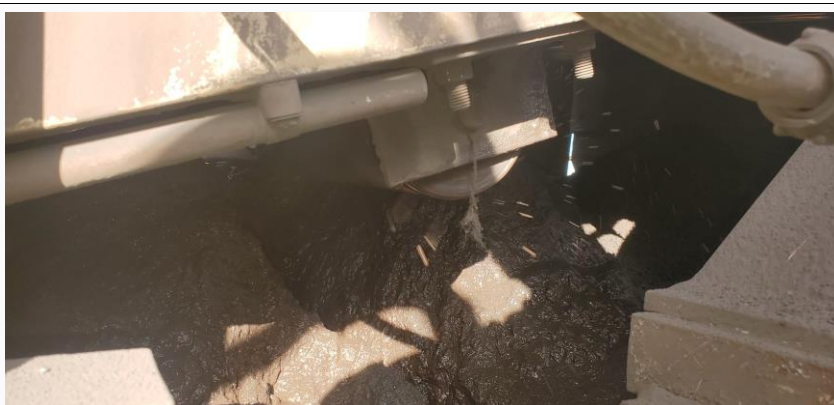
CV04-REF-002 — Saturated wet-fines/slurry accumulation beneath CV04, with visible wet fallout/droplet evidence in the local area.

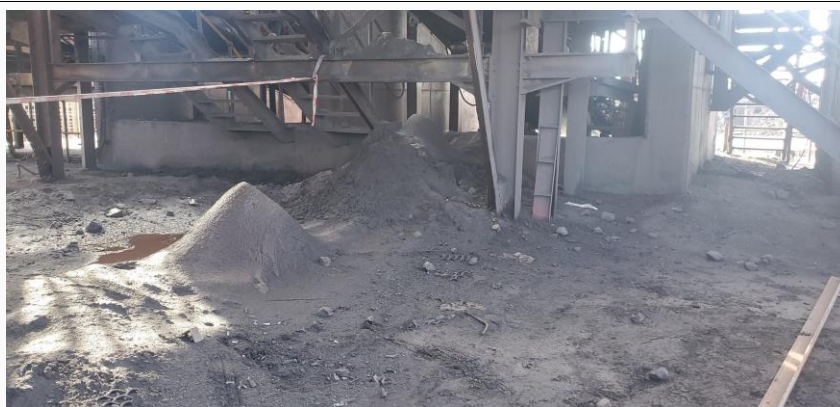
CV04-REF-005 — Wider view showing multiple fines accumulations beneath and around CV04, illustrating the broader distribution of material at this location.

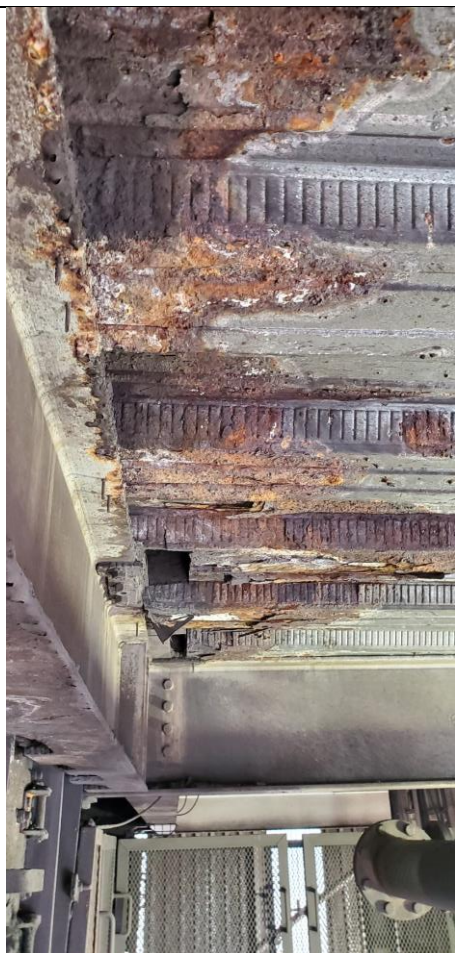
Screen-REF-008 — Wider deterioration view showing the broader extent of corrosion and section deterioration within the Screens structure.

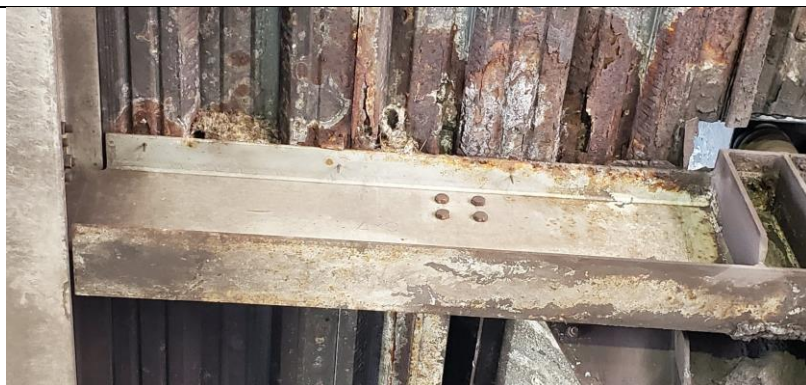
Screen-REF-002 — Close view showing substantial local corrosion and deterioration within the Screens structure. The photograph establishes the visible condition but does not determine remaining structural capacity or its complete cause.

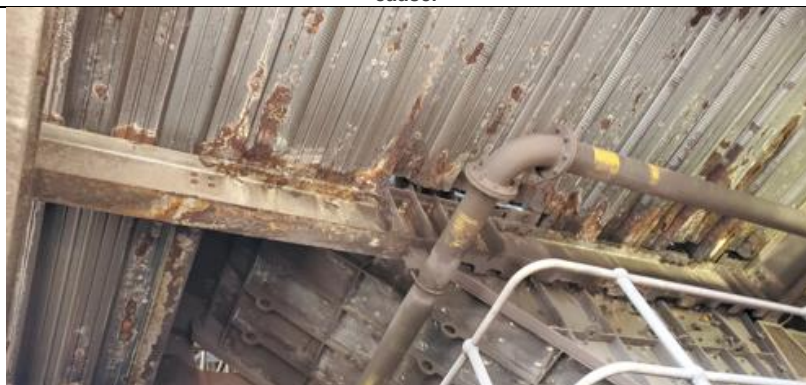
Screen-REF-003 — Wider view of the screen/chute structural area, providing context for the corrosion and deterioration shown more closely in REF-002.

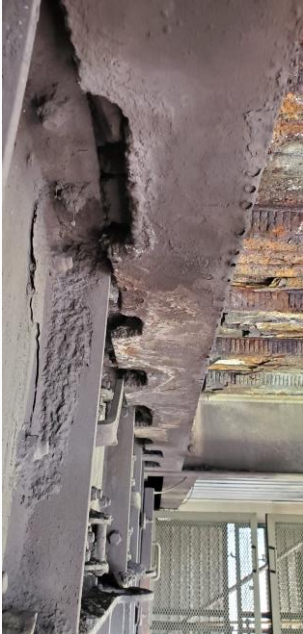
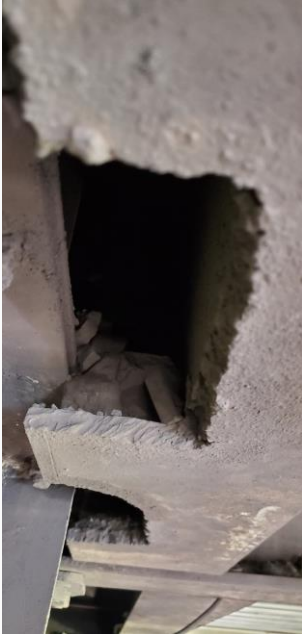
| <p>Screen-REF-009 — Wider view showing local cut-outs/notches in the affected support-member arrangement. The reason for the alterations and their effect on remaining structural capacity has not been established.</p> | <p>Screen-REF-010 — Close view showing a substantial cut-out in an affected support member. The physical alteration is clearly visible; structural adequacy requires assessment by the responsible structural authority.</p> |
| <b>OBSERVATION</b> | Active process-water escape is visible in the operating evidence. Substantial corrosion/deterioration and physical cut-outs/notches in support members are also visible within the Screens area. Although these conditions occur within the same operating environment, the available evidence does not establish that they arise from one common cause. |

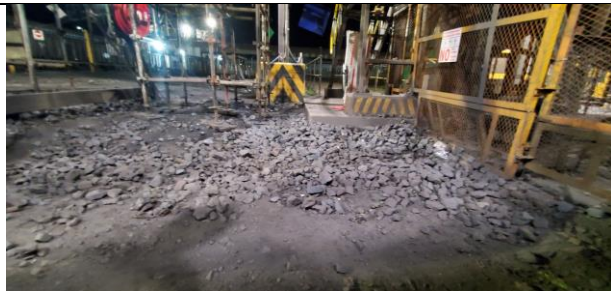
**LoadoutStationL1-REF-013** — Broad view showing extensive material and fines accumulation across the L1 conveyor/access area.

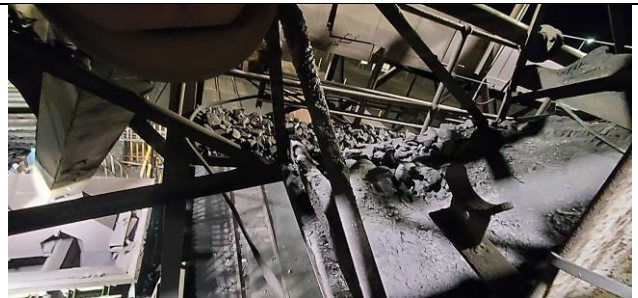
**LoadoutStationL1-REF-017** — Elevated view showing material accumulation retained on and around the L1 structural members, complementing the broader floor/access-area accumulation shown in REF-013.

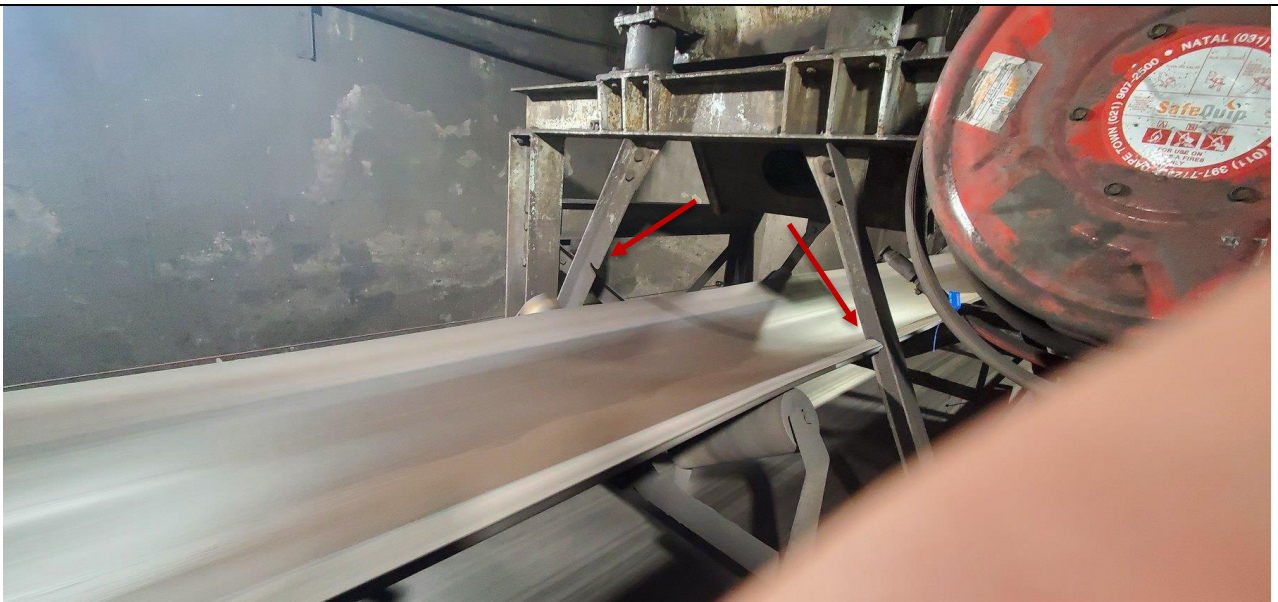
**LoadoutStationL1-REF-007** — Wear slots adjacent to a belt that was running clear at the inspected condition. The wear is consistent with previous or intermittent belt-to-structure contact, while continuous present contact is not established.
