# Combined-Product Spillage Inspection and Engineering Assessment Report

South32 Wessels Mine · Surface and Underground Conveyor / Process Areas

| Report number | S32WPPSR-01 |
| Revision | 0.6.1 - Integrated Controlled Draft |

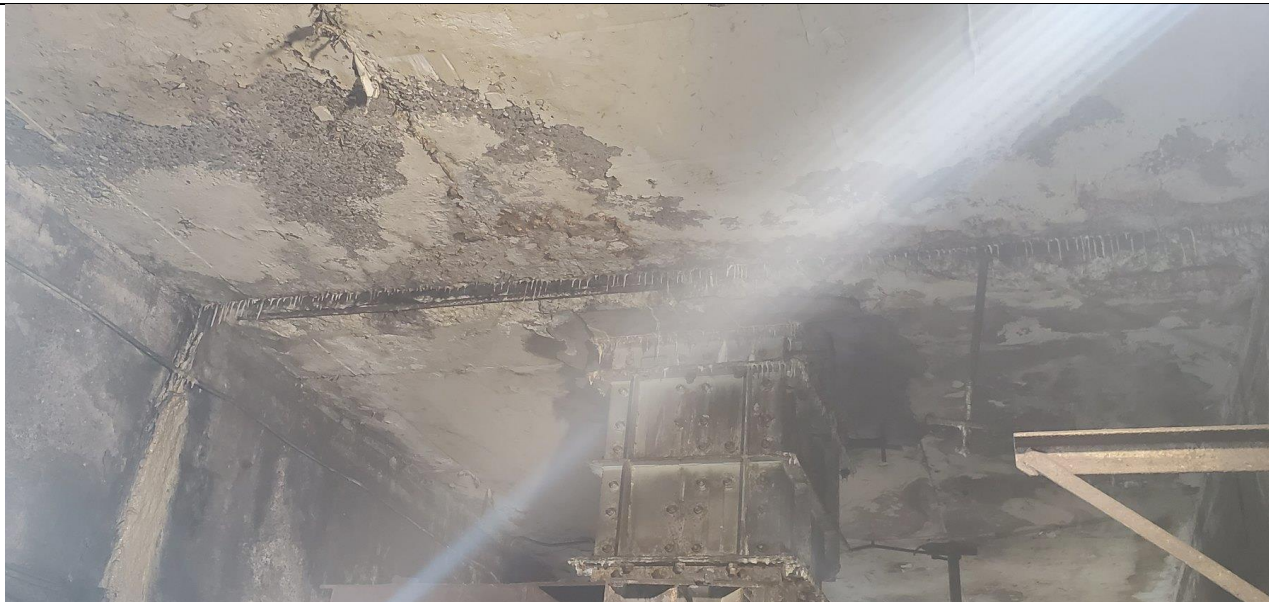
LoadoutStationL1-REF-004 — Wider view showing the location and surrounding context of concrete deterioration at L1.

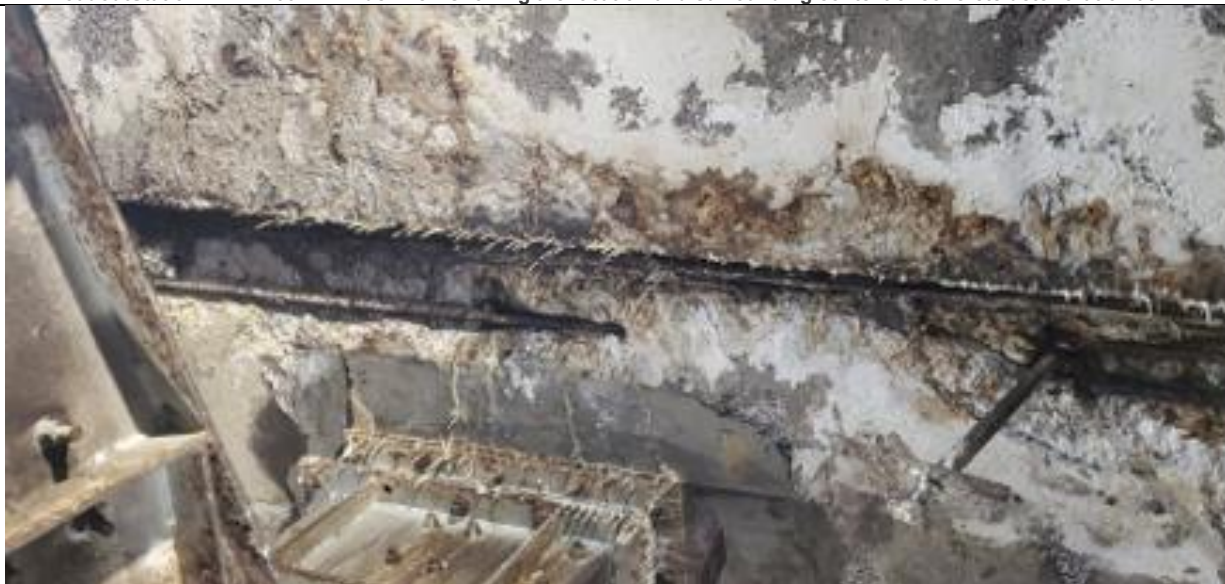
LoadoutStationL1-REF-005 — Close view showing substantial concrete material loss/spalling with exposed reinforcement. Remaining structural capacity cannot be determined from the photograph.

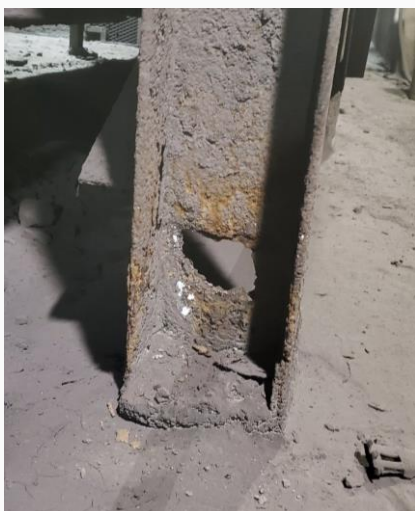
LoadoutStationL1-REF-008 — Local steel deterioration and section loss at one L1 conveyor support location.

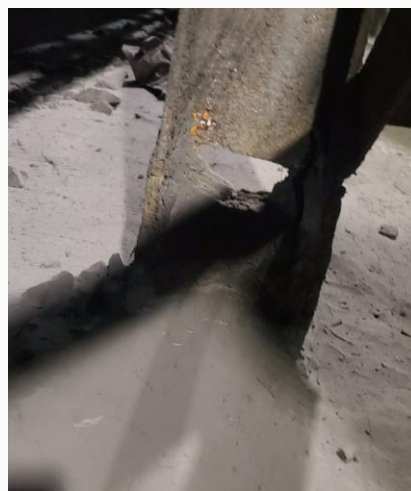
LoadoutStationL1-REF-009 — Steel deterioration and section loss at a separate L1 support location, showing that the condition is not limited to the support illustrated in REF-008.
