LABORATORIO DI LANDRO

TEST REPORT

Report No.: 53675

Test Requested: ADHESION TEST

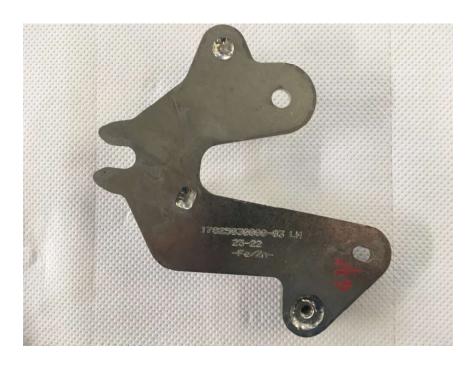
SAMPLE

No separation, for example by blistering, flaking or exfoliation of the coating
