TEST REPORT

Report No.: 53675

Test Requested: ADHESION TEST

Sample Descr. (#): UNALLOYED ZINC COATED PART CODE 17825030000 - BASE MAT. S420MC 4 mm THK-3 WELDING COMPONENTS

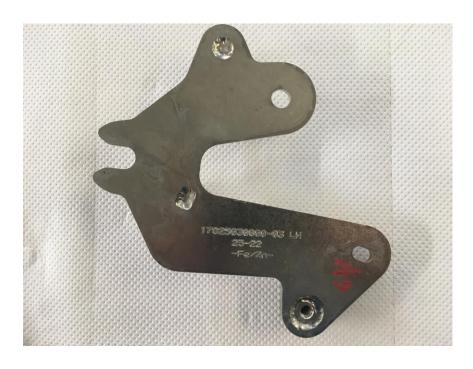
SAMPLE

No separation, for example by blistering, flaking or exfoliation of the coating
