Experimental and computational failure analysis of hydrogen embrittled steel cords in a reinforced thermoplastic composite pipe

<https://doi.org/10.1016/j.engfailanal.2024.107962>

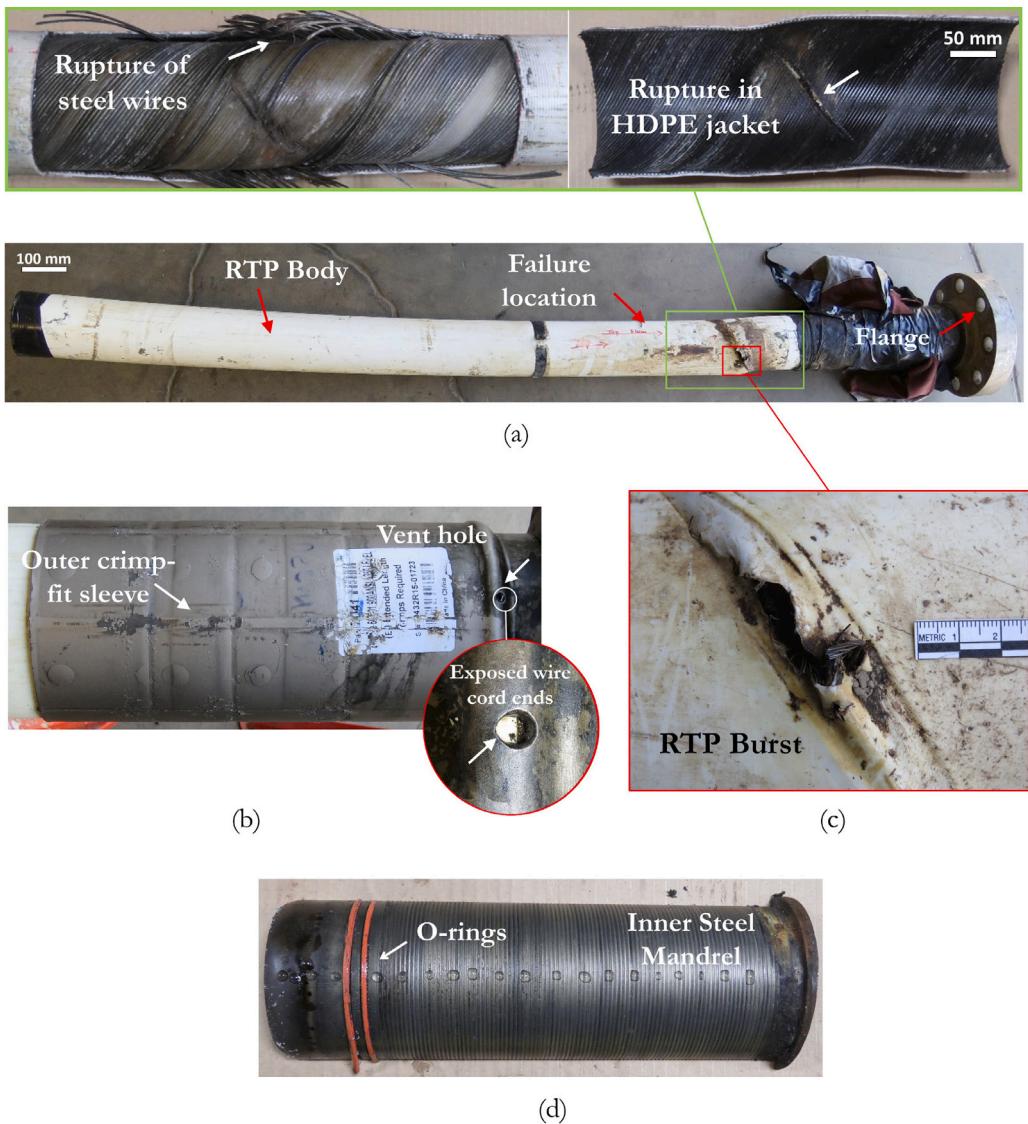
The failure event pertains to an occurrence of a burst in a RTP injection header handling produced water, as depicted in Fig. 2(a). The RTP system is responsible for transporting produced water originating from oil wells during crude oil extraction. This water often carries hydrocarbons and various chemical constituents from the reservoir. The leak was identified when the injection discharge pressure fell below the designated threshold. The failed segment measures 1311 m in total length. The pipeline has an outer diameter (OD) of 128 mm and an inner diameter (ID) of 99 mm. The daily production rate through the compromised section stands at approximately 650 cubic meters. The process stream maintains an average temperature of around 35 °C. During normal operation, the pipe operates within a range of 9.65 to 10.34 MPa for the affected segment, with a maximum pressure of 10.55 MPa recorded. The pipe's maximum operating pressure is rated at 13.79 MPa.

Fig. 2. (a) RTP section with failed steel reinforcement wires and HDPE jacket, (b) crimp-fit sleeve with vent hole and exposed reinforcement wire ends, and (c) burst location in RTP.

After removing the crimp-fit sleeve, a cut out of the HDPE jacket at the RTP burst location was visually examined, as shown in 2(a) and (c), revealing rupture in the HDPE jacket and rupture of reinforcement wires. Remnants of Denso paste, which is commonly used for moisture displacement and corrosion inhibition, and discolouration indicated the presence of water and prior corrosion as seen in Fig. 2(b). Exposed cords and wires at the pipe bend suggested incomplete sealing by the Denso paste during installation and operation. Signs of water ingress and corrosion degradation were observed at the vent hole area of the crimp-fit sleeve. The failure was found to occur within the outer jacket, rupturing in the winding direction of the steel cords in the outer reinforcement layer, as shown in Fig. 2(a). The twisted nature of the RTP at the failure location indicated a failure induced by internal pressure. Furthermore, the fracture surface of the outer jacket exhibited significant plastic deformation, characteristic of ductile fractures commonly observed in materials such as HDPE, as expected. The outer HDPE jacket contained steel wire cords, covered by a barrier layer with helical lines corresponding to the inner wire cords' winding direction. The barrier layer exhibited ductile fracture characteristics, and no mechanical damage was found except at the failure site. Both the barrier layer and outer jacket failed in the same location along the winding direction of the steel cords. The intact steel cords indicated separation rather than breakage. Overall, the findings align with failure due to internal pressure.
