## 2. The failure

There was a series of failure of bellows installed in a PSV of a hydrocracker unit leading to leakage of process fluid. The first failure of the bellows took place after 13 years of service. After the first failure, the bellows was replaced by a new one. However, the failure continued to occur and in total, there were three consecutive failures in a span of one week duration. On-site inspection showed several cracks on the outer surface of the bellows. The operating pressure and temperature of the PSV were  $1.6 \text{ kg/cm}^2$  and  $100^\circ\text{C}$  respectively. The construction of the PSV is illustrated schematically in Fig. 1.

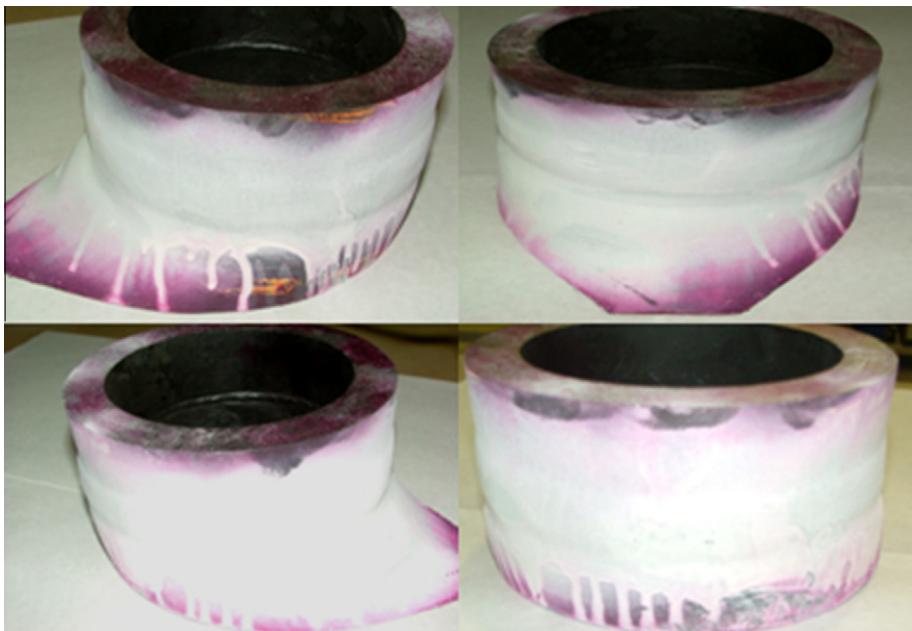
As can be seen in Fig. 1, there are no evidence of cracks on the surface.

**Fig. 1.** Reactor tube after dye penetrant test.
