Metallurgical Investigation of a fractured low-pressure turbine rotor (LPTR) cover plate of an aeroengine

K. Raghavendra, V. Venkatesh, M. Madan, M. Sujata*, S.K. Bhaumik

Materials Science Division, National Aerospace Laboratories, Council of Scientific and Industrial Research (CSIR), Bangalore, 560017, India

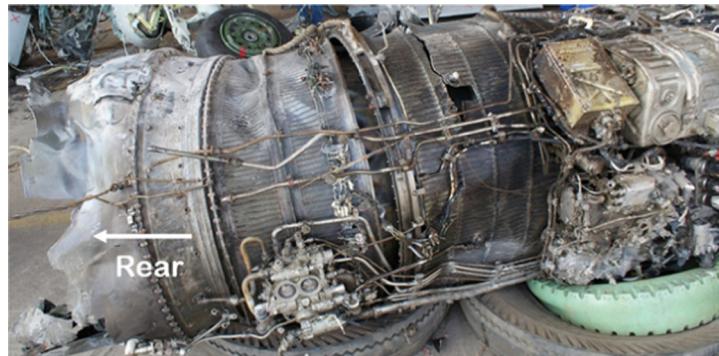
The wreckage of the aircraft was retrieved from the seabed. Examination revealed that while the LH engine suffered only minor impact damages, the RH engine was severely damaged and mangled (Fig. 1). On the left side of the RH engine, a puncture was noticed on the outer casing at 90° clock position looking from rear of the aircraft. The damages on the engine casing at the corresponding location are shown in Fig. 2. The damage pattern indicated that an object from the engine had ejected through the casing with high velocity. The impact of the ejected object was so high that it resulted in curling of the metal part at the punctured location of the casing. It was, therefore, evident that the ejected object was nothing but a part of a rotor component of the turbine and the ejection of the object occurred when the engine was in power.

Fig. 1. Damaged RH engine retrieved from the sea bed; looking from right side.

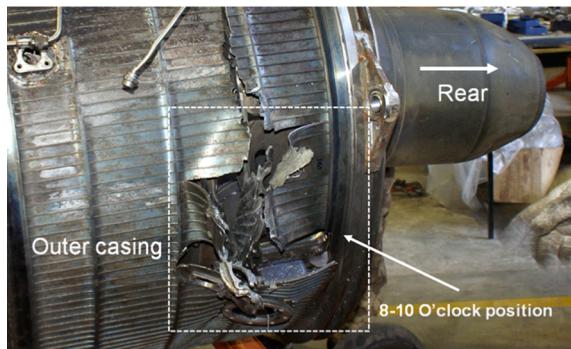
Fig. 2. Damage to the outer casing of the engine looking from left side; damage was caused due to ejection of a large object from inside the engine.
