In the present paper, a fractured railway rail which was used for cargo trains was analyzed to find out its failure cause. In the end, a conclusion was reached after performing macroscopic inspections, chemical analysis, SEM observations, and metallographic examinations.

## Materials Safety analysis report on brittle fracture failure of axle shaft of forklift

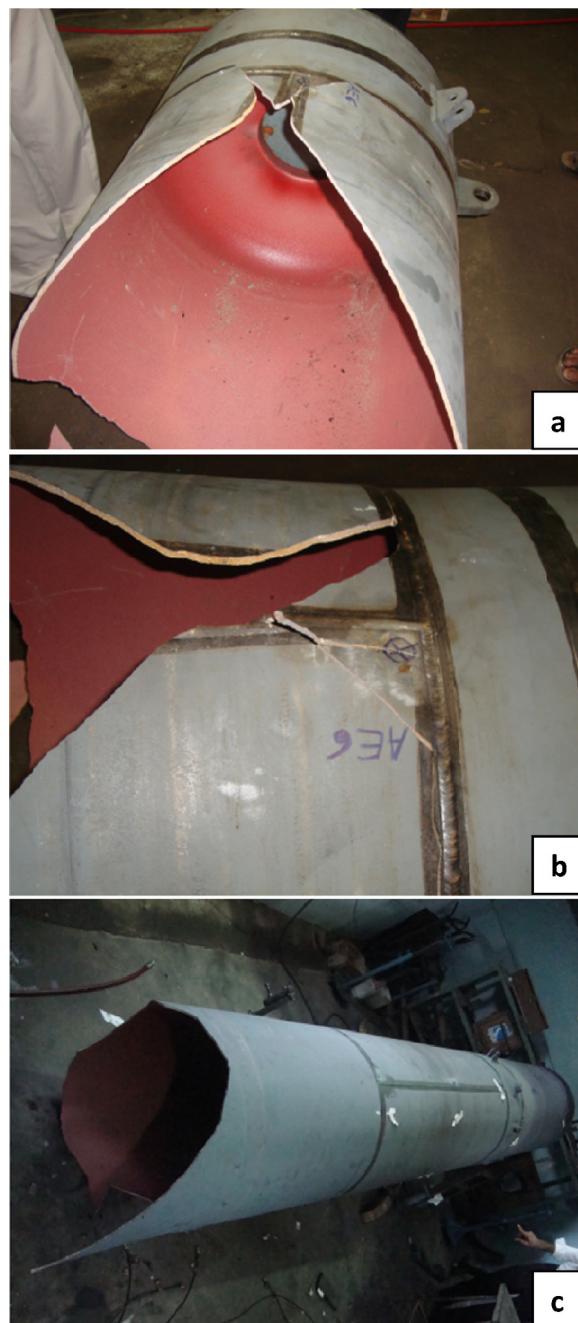
Failed tank was observed at the site of failure. Out of three shells of the tank, failure occurred in one shell, while remaining two were intact (Fig. 1). First hand observation indicated that failure initiated at long seam of the shell, near shell-ring

**Fig. 1.** Photographs showing failed tank, (a and b) failed shell and (c) failed shell with other two intact.

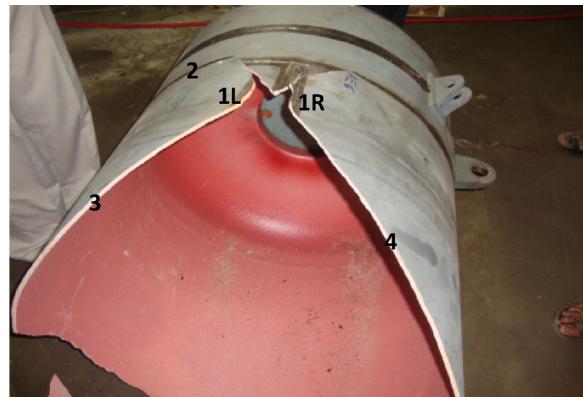
Fig. 4. Specimens taken out from locations 1L, 1R, 2, 3 and 4.

Fracture surface was studied using scanning electron microscope. Specimens were selected for fracture studies from location 1 (L and R) at region of long-seam weld, location 2 (at region of cir-seam weld; shell-ring weld) parting, location 3 and 4 (from region away from fracture initiation site), as shown in Fig. 4.
