Paper1_edit.pdf

This paper presents a case study of the failure analysis on M42 screws used in a power generator, including background information, visual examination, material properties determination, fractographic and metallographic examination and engineering analysis, pointing and describing the mechanisms involved in the failure cause and proposing solutions to mitigate this problem.

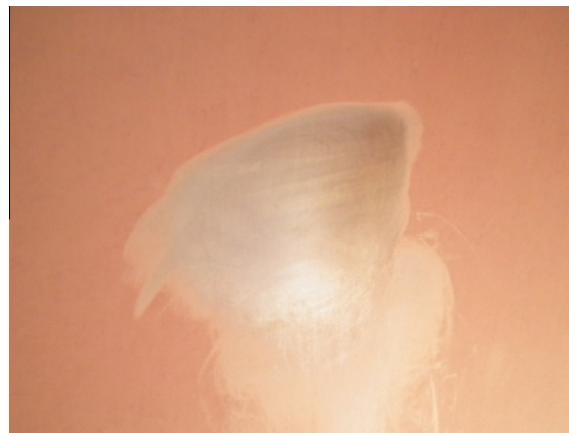
Fig. 1. View of the inner surface of the container with partially removed deposit.

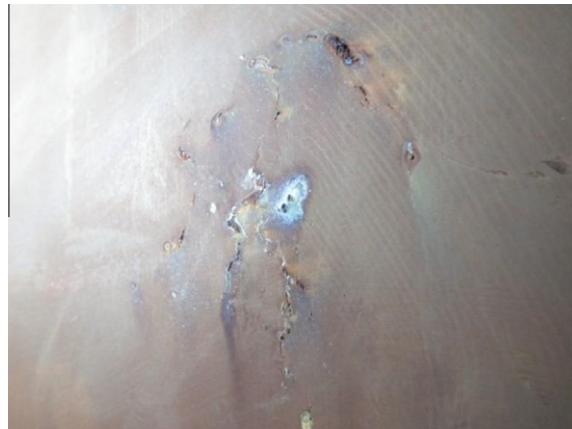
After the products of corrosion were removed, clear corrosive attacks could be seen as cracks, pits and etchings (the result of deposit corrosion) (Fig. 5).

Fig. 5. Corrosive attacks in a stainless steel tank.

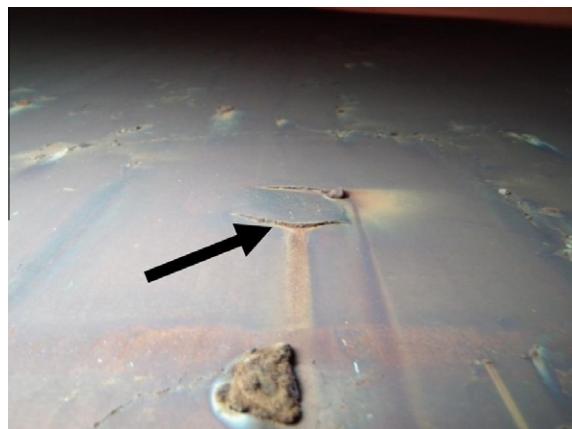
Fig. 6. Corrosion cracking of the mantle as the cause of perforation.

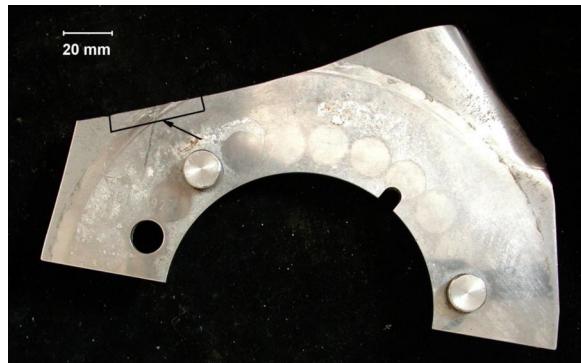
A general view of the broken blade is shown in [Fig. 1](#). Sample for testing was taken near to damage from the marked area ([Fig. 1](#)). The broken blade was made of high-speed tool steel typically used for cutting tools. The structure was made of

Fig. 1. General view of the broken blade. The arrow indicates the place where sample was taken for testing and indicates the place where the inscription (number "1") was made with engraving tool.

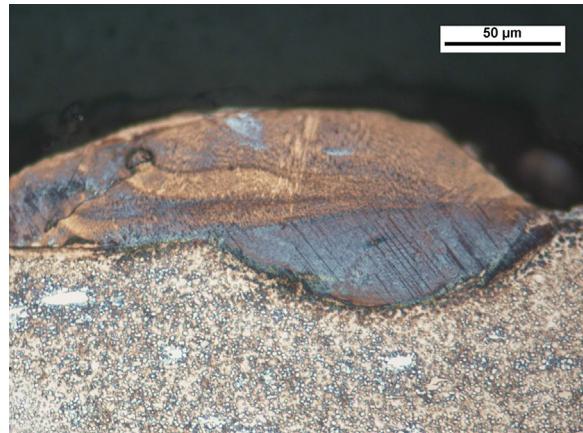
Fig. 12. The magnified part of area marked with no. 1 in Fig. 11. Changes in the structure caused by local melting of the specimen's surface where the inscription was made with engraving tool. Light microscopy, etched with Mi19Fe.

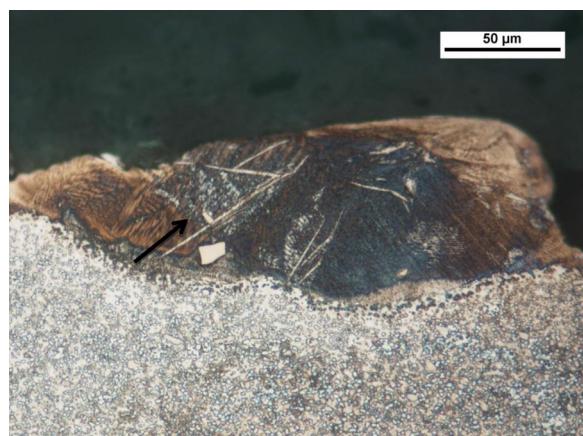
Fig. 13. The magnified part of area marked with no. 2 in Fig. 11. Changes in the structure caused by local melting of the specimen's surface where the inscription was made with engraving tool. The arrow indicates the micro dendrites formed during quick cooling process of melted material. Light microscopy, etched with Mi19Fe.
