# **Engineering Failure Analysis**

# Pitting corrosion and stress-corrosion cracking of buffer tanks in a brewery

# J. Orlikowski\*, S. Krakowiak

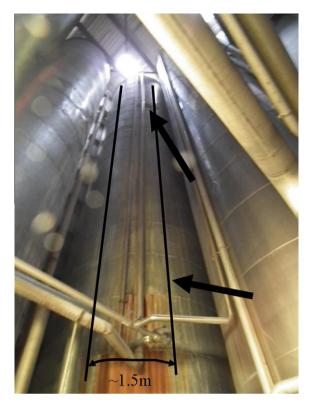
A corroded area was found in an approx. 1.5 m-wide cylindrical fragment of the tank (Fig. 2), located in the zone of mechanical impact of the pipeline outside the tank (See Fig. 3).

The locations of tank repairs correspond precisely to the zones of intense stress caused by the pipeline. This allows for associating the corrosion with the mechanical and corrosive impact. Corrosion attack visible in the form of branched lines and local centres is shown in Fig. 4.

Fig. 3. Outside view of the tank with the corroded zone inside the tank marked.

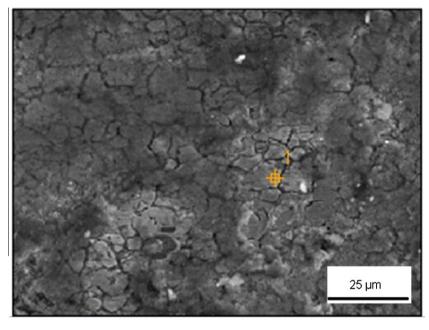
Additionally, SEM research of the examined steel surface was conducted. Steel specimens were taken from the places, where the corrosion products were detected on the tank. SEM images were obtained by using S-3400N Hitachi VP-SEM (with THERMO Scientific EDS unit attached). Results of this analysis are presented in Fig. 7.

Fig. 7. SEM and EDS images of the corroded surface of the tank.
