## **1. Introduction**

## **2. Propeller background**

### Materials Safety analysis report on the crankshaft fatigue failure

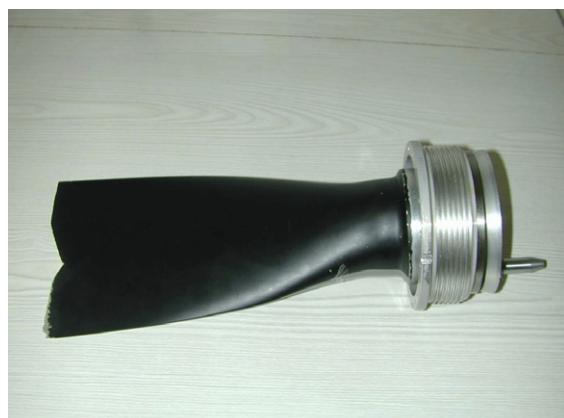
As shown in Fig. 2, One of the propeller blades of presently used mono-propeller U-17B airplanes was broken off during the flight. Propeller was a high strength 2024 aluminium alloy which is a commonly used material in aviation due to its advantages of resistant to crack growth, good repairability, perfect damage tolerance properties [4].

Fig. 2. General appearance of broken propeller blade.

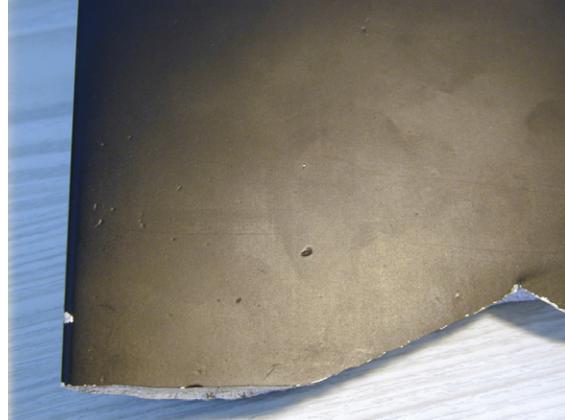
It was determined that one third of the total length of the blade was left on the lane whereas the rest was removed after breaking off. As shown in Fig. 3, on the surface of the blade it was determined that several deformed areas were formed as a result of impact effect. As shown in Fig. 4, crack surface investigations on the deformed surface did not show any intensive corrosion, dirt, lubricant layer, colour change or oxidation. Residual shape deformations (e.g. shrinkage, bending, etc.) were not determined on the remaining part of the blade.

Fig. 3. Surface of the failure blade.

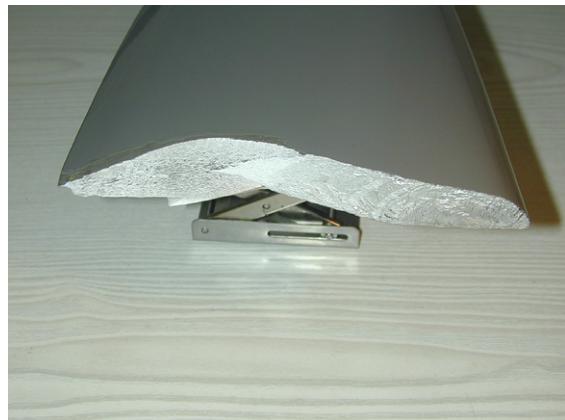
Fig. 4. Crack surface.

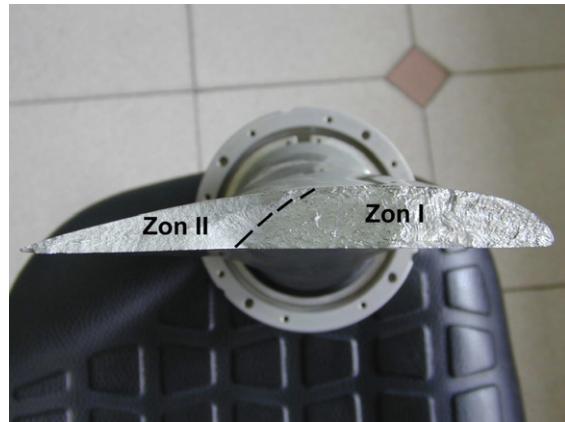
For the fundamental understanding of the crack mechanism on the blade, both the general condition of the removed piece and the crack surface is required to be investigated. For this purpose, crack surface was investigated in detail by stereo and scanning electron microscopes (SEM). General evaluation was confirmed by these microscopic investigations showing that corrosion was not occurred on the crack surface. Crack was occurred on two different surfaces in an area including the propeller leading edge during the axis normal to the propeller (zone I) and on the rest part including the propeller trailing edge during the axis having  $45^\circ$  angle with the propeller (zone II). It was observed that zone I contains straight smooth planes and has less roughness resulting in better light reflection ability whereas zone II has more roughness and has less light reflection. Hence zone I has a bright and zone II has a matte appearance (Fig. 5). When the surface areas of zone I and zone II are rated, the half portion of the fracture surface has been formed with fatigue.

Fig. 5. Zone I and zone II on crack surface.

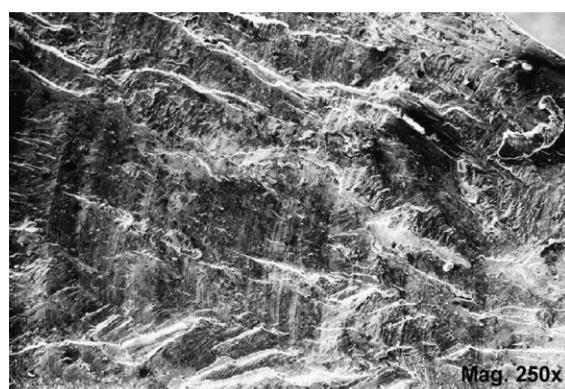
Zone I crack surface investigations showed that cyclic loads caused fatigue striations and stop lines. As can be shown in Fig. 6, the fatigue striations have characteristic semi elliptic circles that formed and propagated under cyclic loads. In this examination it was revealed that the fracture surfaces did not display evidence of corrosion products.

Fig. 6. Zone I "semi elliptic" fatigue striations (Mag. 250 $\times$ ).

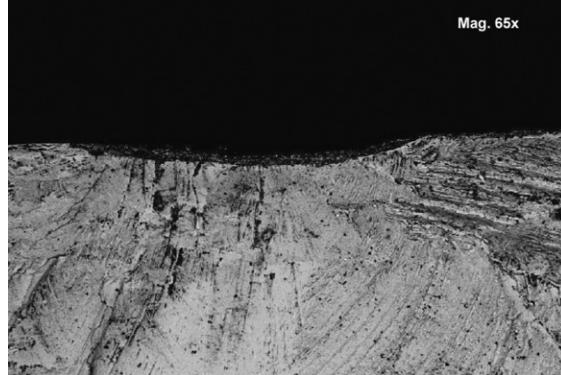
Fig. 8. Appearance of backscattered SEM image of crack initiation site (Mag. 65 $\times$ ).

crack starting point revealed that the surface is covered by the paint. These observations can be seen stereoscopic and backscattered SEM images in Figs. 7 and 8, respectively.

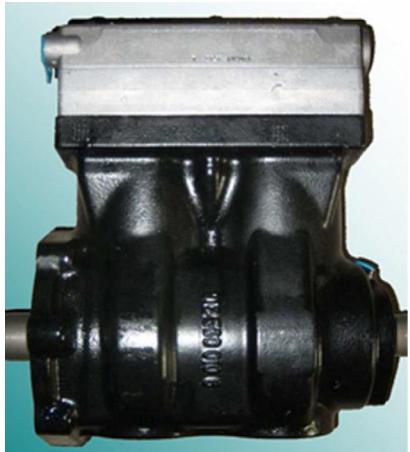
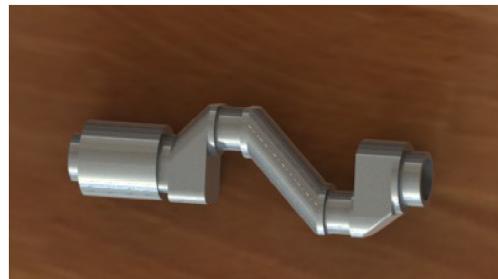
**Fig. 1.** Picture of the air compressor.

(a) the air compressor

(b) the crankshaft

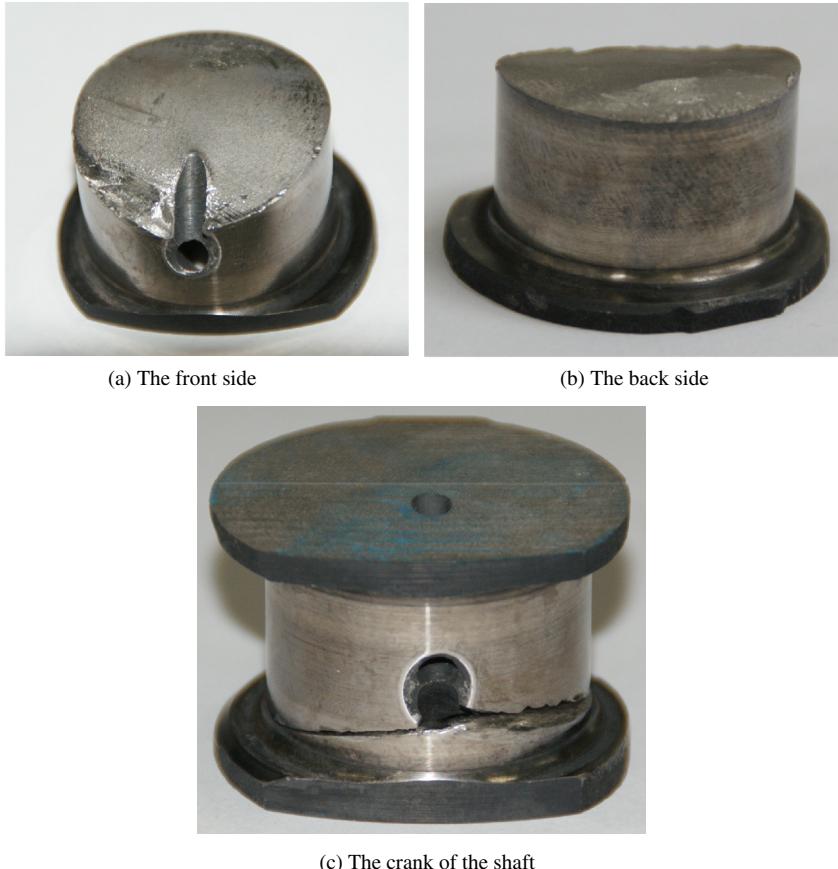
In this paper, the crankshaft is made of 42CrMo steel with forging, heat treatment and nitridation. The crankshaft occurred fracture failure after using a period of time. The fracture position and surface of the crankshaft is shown in Figs. 2 and 3. The region around the lubrication hole is rough by observing Fig. 3.

**Fig. 3.** The fracture surface of the crankshaft.
