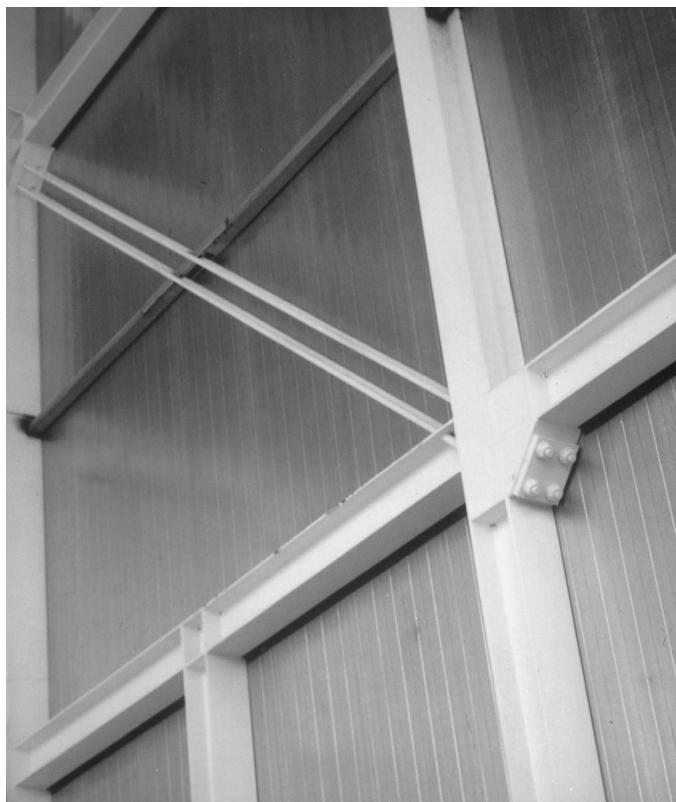
The reported failures occurred in a prestressed steel structure. To improve the transversal stiffness in some steel frames, post-tensioning with a couple of bars was applied diagonally, as shown in Fig.

Fig. 1. Prestressed steel frame using two bars.

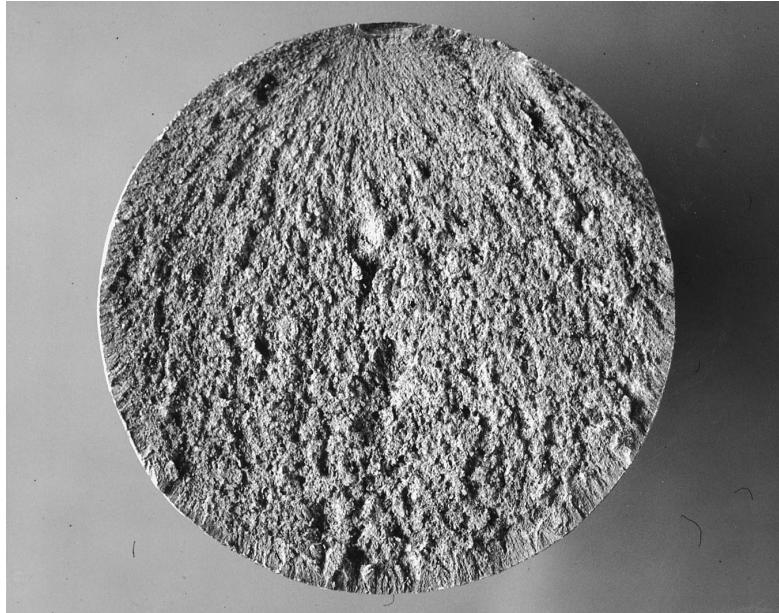
Examination of the fracture surfaces revealed that in both cases the fracture was triggered by a small surface crack. The morphology of the fracture surfaces was very similar in the two bars; a representative picture is shown in Fig. 2. Observation by scanning electron microscopy revealed a quasi-cleavage morphology.

Fig. 2. Fracture surface of a broken bar.

Using the scanning electron microscopy, a fracture surface of the broken bar was obtained in figure 2. Unfortunately, this is the only fractography provided in the analysis and it shows the surface in low magnification. By using the ASTM standards for test specimens, fracture toughness K_{IC} was obtained which are presented in table 3 of the analysis. The results from the test samples used in the fracture toughness measurements show that the fracture toughness is around 35 MPa in the short bar and around 33 MPa in the beam. The conclusion the analysis has is that the fracture toughness is low enough to be considered to have brittle behavior and it follows the same propagation plane as in the failed bars. In addition to fracture toughness tests, load vs COD test results were also provided in the paper. And iso-K curve was drawn based on the stress intensity factor K_I . The analysis mentions that the iso-K curve fits very well on the load vs COD results drawn in figure 4a. Which would further support their theory of using linear elastic fracture mechanics. Lastly, the analysis obtained rupture load graphs of the cracked bars as a function of crack depth. These graphs show at which point the crack length becomes critical as in the material will have failure. The analysis also concludes based on their information that the damage happened likely due to cracks because pits or notches would not be able to increase the local stress enough to produce a failure under the load, they were in.

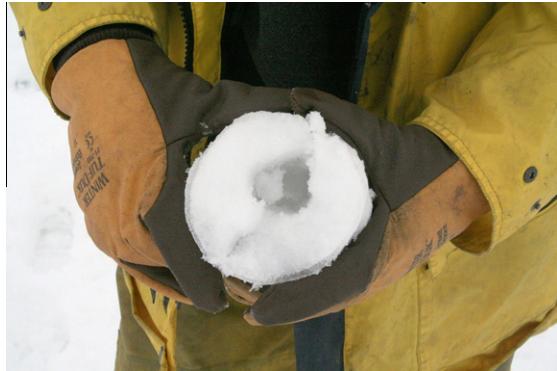
On November 25th/26th, 2005 strong south-west wind with storm force (8 Bft. \approx 18 m/s) and heavy snowfall at a temperature of approx. 0 °C were predominant in the region Münsterland, Germany. Due to these weather conditions wet snow rolls formed around the conductors of several overhead transmission lines. This led to excessive line loads of approx. 5 kg/m, [Fig. 1](#). Some of the covered conductors were sagging to the ground. Eighty-two tension and suspension towers of five different, 110 kV overhead electrical lines collapsed mostly by buckling, e.g. failed catastrophically, [Fig. 2](#). As a consequence nearly

Fig. 1. Wet snow roll with clear ice cover, diameter approx. 13 cm, line load approx. 5 kg/m. Source RWE.

Weather conditions (snowfall, strong southwest wind) led to preferred deposition of snow on conductors of overhead electrical lines (northwest-southeast) perpendicular to dominant wind direction (southwest). Wet snow rolls with 13 cm and more in diameter formed, Fig. 1, that exceeded the line loads given in former [18] and current [19] design codes. At direction changes of overhead electrical lines specially designed deviation tension towers are used which are able to carry higher horizontal loads. During the severe weather conditions a change in line direction led to a deposition of snow rolls on the conductors, Fig. 1, perpendicular to the wind direction while in the direction parallel to the wind there were nearly no snow rolls. This applies for nearly all aerial lines that were pulled down during that night. Starting from the lines affected, it was investigated why the towers failed. Extensive photographic documentation provided by the operator (references in [20]) showed that snow rolls of the critical size were only existant at one field of deviation towers but not on the other field more parallel to wind direction. Moreover, photographs showed fields of this line BL1503 where conductors on the right side were covered with ice while they were not on the left side. This could be explained by different electrical currents of left and right electric system during snow/ice accretion. This meant for the further investigated deviation tension tower M65 that only the conductors on the right side (viewing direction towards increasing tower numbers) were covered with snow rolls while the conductors on the left side were not. This led to an asymmetric load distribution. The incoming conductors had only little snow coverage. This onesided and field-dependent (unequal) loading with lineloads of approx. 5 kg/m was identified as load case before failure of tower M65 and will be referred to as "failure load case", Fig. 13.

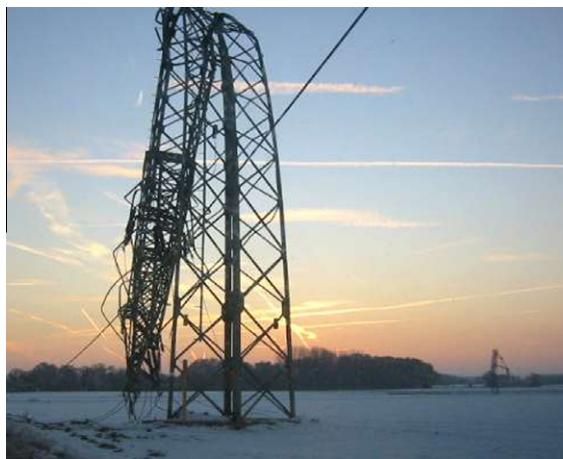
Fig. 2. Collapsed deviation tension tower M65 and suspension tower M66 (appearing small in background, right). Source RWE.

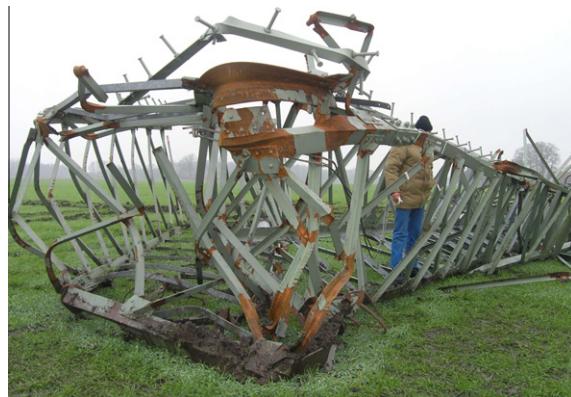
During a visit of the failure site in the western region of Münsterland eleven of the failed electricity towers were inspected on December 20th in 2005, Fig. 3. Signs of surface corrosion were not found. A corrosion induced weakening of the structures could be excluded. Fifteen samples were taken from four of the failed transmission towers: broken diagonal members, corner rod connections and more components. The collapsed transmission tower named M65, Fig. 4, was in focus of the failure investigation based on its function as deviation tension tower, the brittle fracture of a component found there, its condition and accessibility. It was assumed, that the collapse of M65 as deviation tension tower is responsible for the failure of the supporting towers M66..M73. Moreover, an extensive photographic documentation shortly after failure has been available

Fig. 3. Failure site inspection, transmission tower M65 layed down for inspection. Searching for ruptures with brittle fracture surface.

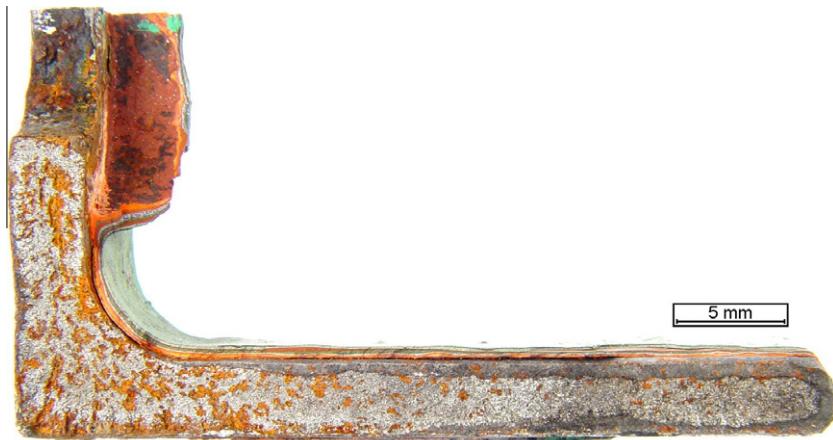
Fig. 7. Original fracture surface M65-04 after cleaning. Most of the rust was removed.

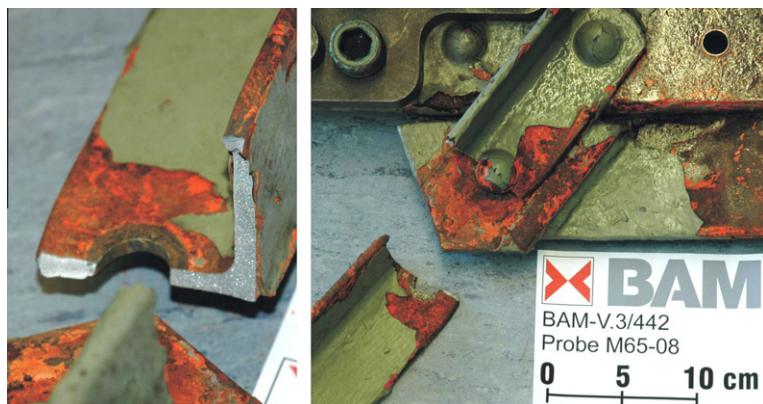
Fig. 11. Tensile testing of structural parts (corner rod/diagonal member connection). Brittle fracture of netto cross-section.
