## CASE STUDY

OISD/CS/2023-24/P&E/15

Title: Fatal Incident due to fire in wet slop oil pump house.  
Location: Refinery  
Loss/ Outcome: Property Damage and One fatality

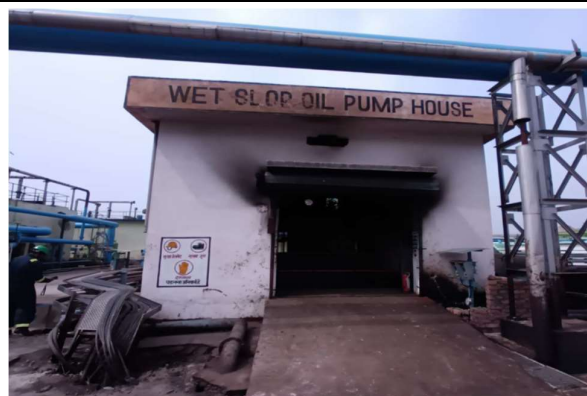
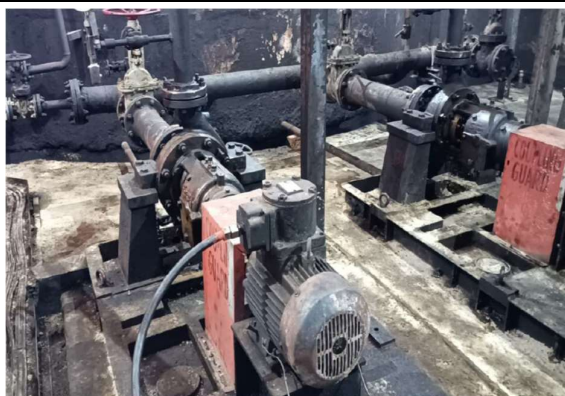
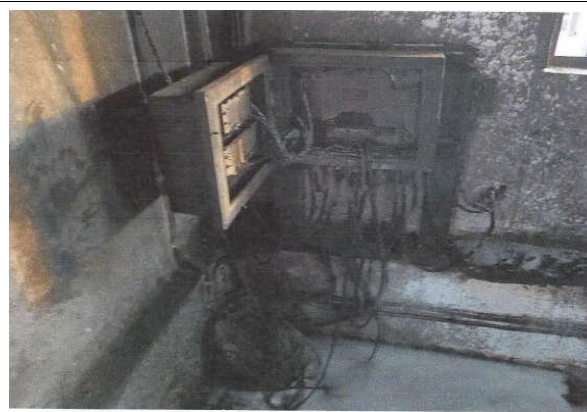
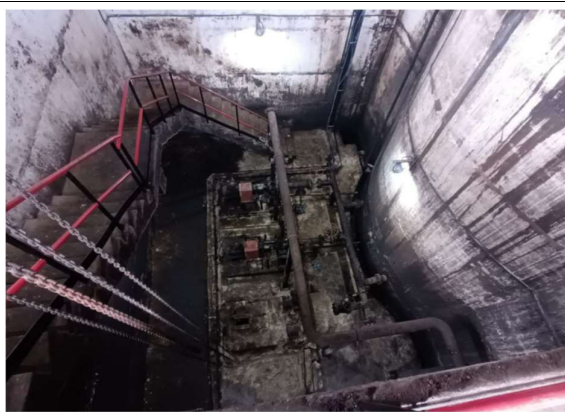
#### *Site Photographs*

Fire occurred in the wet slop pump house due to accumulation of hydrocarbon vapor. Electrical cables in the wet slop pump building were damaged and a contract employee suffered burn injuries in the fire. He was admitted in a Burn Hospital and succumbed to his injury after seven days.

12. Electrical technician had provided temporary electrical connection for portable exhaust fan in pump building. Temporary connection was taken from Flame proof distribution board located at the ground floor inside the building from where permanent exhaust fans were already connected. However, the distribution board cover was not closed after providing the connection, as evident from the site photographs taken just after the incident, compromising the flame proof integrity.

**Source of Hydrocarbon:** The pump and pipeline holdup material, being emptied on the pump floor for strainer cleaning job, may have created a pool of slop on the floor (aggravated by the suspected pump suction valve passing). The liquid pool on the pump floor must have created a vapour cloud well above the LEL level (corroborated by the smell that IP felt and for which he had requisitioned an exhaust fan).

**Source of Ignition:** Flameproof electrical distribution board was provided in wet slop oil pump building according to hazardous zone classification, but the integrity of electrical system was compromised when it was left open while providing the temporary electrical connection for the temporary exhaust-fan, which was also non-flameproof. Source of ignition was likely the electrical plugin for the temporary exhaust fan that may have generated spark while switching on, leading to ignition of the hydrocarbon/ air mixture.

2. **Electrical Integrity:** Electrical equipment integrity shall be ensured as per hazardous area classification drawing approved by PESO. All electrical equipment and instruments shall conform to the hazardous area classification requirements and shall have appropriate PESO approval.
