## CASE STUDY

OISD/CS/2023-24/P&E/07

Title: Fatal Incident due to explosion of sample bomb.  
Location: Refinery  
Loss/ Outcome: One fatality

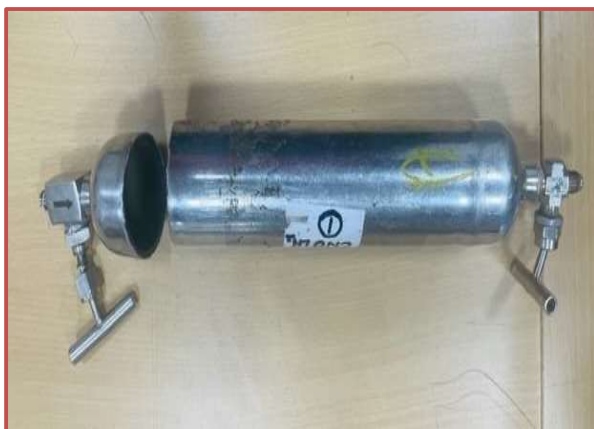
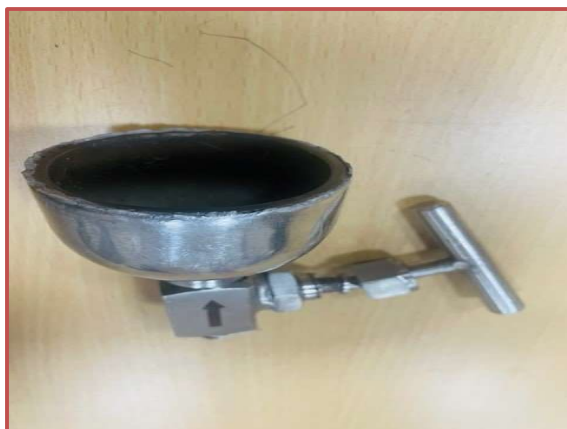
Prior to unloading the liquid nitrogen tanker, purity of nitrogen was to be checked. Accordingly, a sample had been collected. Subsequently, the sample bomb exploded during leak checking of the bomb valve and split into 02 pieces. One of the pieces (dome along with valve) penetrated in the upper part of left thigh of the truck cleaner/ helper. Truck helper succumbed to the injury a day later.

Sample collection bomb after the incident

4. Sample bomb exploded into two pieces. The dome portion of the bomb along with needle valve penetrated the upper left thigh of helper, who was standing beside the driver.

- On the day of incident, the liquid flow into the sample bomb must have been higher than that happening in earlier occasions (more by few millilitres). The sample bomb collected with liquid nitrogen was isolated/ sealed with the needle valves firmly on both ends. By virtue of contact with ambient air & atmospheric conditions, the liquid nitrogen in the sample bomb must have vaporised vigorously resulting in build-up of pressure in the sample bomb. Consequently, the bomb failed from the weld joint. Considering that the bomb had already been tested at 70.4 kg/cm<sup>2</sup>g, the pressure must have increased more than the test pressure.

- It is also likely/ probable, that dipping the bomb in water might have increased the heat transfer to the small quantity of liquid nitrogen in the sample bomb, as water is not as good insulator as air. Further the heat content in water is much higher than in air. So, these factors might have quickened the pressure build up.

Nitrogen Gas sample shall be taken instead of nitrogen liquid sample in line with the operating manual and standard practice. If liquid nitrogen sample is required, then appropriate collection device, suited for cryogenic services, is to be used.

- a) Use of the sample bombs whose OEM documentations/ engineering design details are not available, shall be suspended.
- b) OEM documentations/ engineering design details of equipment should be available as and when required.
- c) Hydrotest records shall be maintained in standard format.
