## CASE STUDY

OISD/CS/2023-24/P&E/08

Title: **Fatal accident during construction activity**

Location: **Refinery**

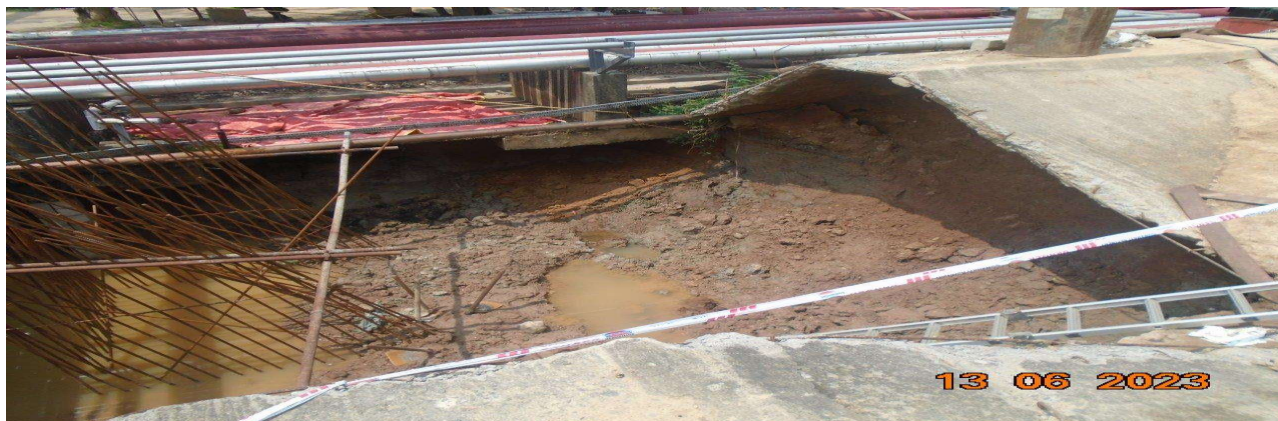
- It was observed that shoring was not there in the excavated pit, where accident took place. Shoring was absent even in the adjacent excavated pit. There was no proper approach to the excavated site and lot of iron rods and clamps were lying there.

Non-provision of sloping/shoring/strutting was the cause of soil collapse of one wall of the pit. The pit depth from ground level was 4 m. The mud dyke wall height was approximately 2 m. Accordingly, the effective depth of the pit bottom from top of the mud dyke was 6 m. Angle of repose was not maintained for excavation and steep vertical excavation was done. The unavailability of safeguard resulted in soil collapse of 6 m of the steep vertical mud wall instigated by the activities of the contract workers.

- All excavation should be done as per clause no 6.1 of OISD-GDN-192 by providing shoring and strutting and maintaining angle of repose for ensuring the structural stability of the pit. Other requirements as per clause 6.1 of OISD-GDN-192 and OISD-GDN-207 should be followed during excavation work.
- Compliance of work permit system as per OISD-STD-105 to be ensured. Actual situation in field is to be verified before mentioning the conformity of stipulated conditions in the permit. The recommendations and safeguards of JSA are to be followed. Recommendations of soil test report should be followed or appropriate/alternate mitigatory measures should be ensured.
