## CASE STUDY

OISD/CS/2025-26/P&E/02

Title: 220 KV cable fire incident in a RCC cable trench.  
Location: Refinery  
Loss/ Outcome: Complete damage of 4 nos. of 220 KV feeders (total 12 nos cables) in a span of 175 m

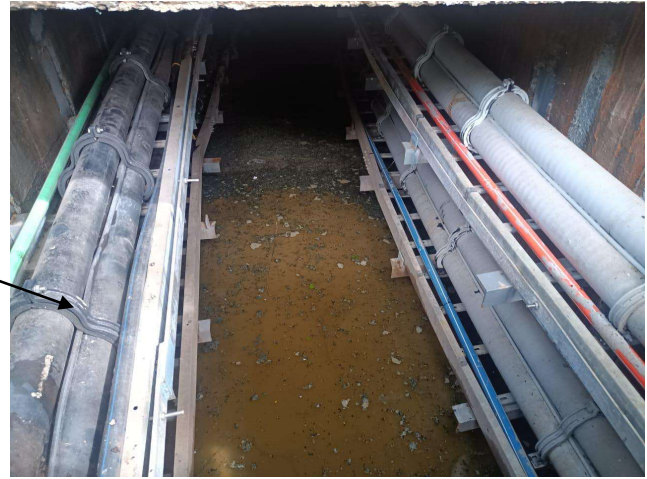
Configuration of cables in the trench – healthy portion

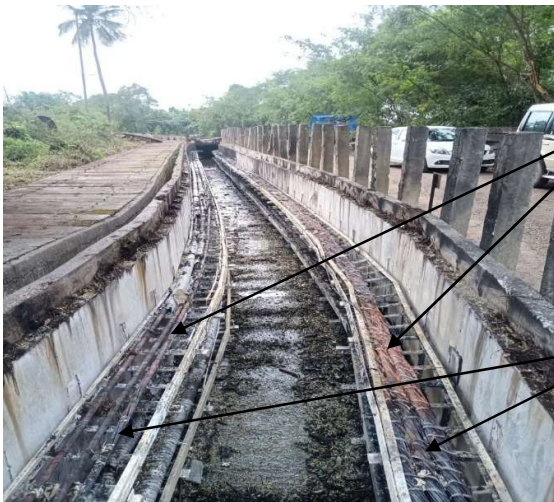
Extensive damage to all 12 power cables in a stretch of 175 m

Bare copper conductor with all outer covering viz XLPE insulation etc. melted away

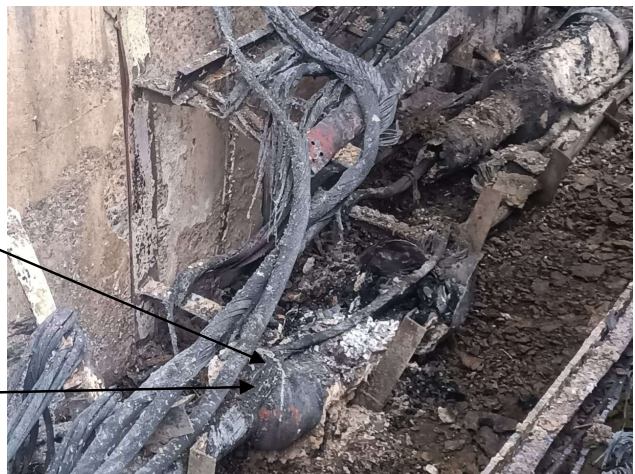
Cable joint after explosion

Initiation point of the damage with extensive damage to cable trays, supports, adjacent concrete structure & melting away of copper conductor

The cable joint might have deteriorated due to poor workmanship during cable jointing or manufacturing issues and the charging of the cable resulted in the cable joint failure triggered by the switching surge. The cable joint explosion heat-initiated smouldering of insulations of other three feeders and resulted in failure of the other cables also.

3. EHV Cable joints inside a cable trench should be protected against fire/explosions by suitable means like fire- and explosion-proof partitions, joint protection boxes, fire- and explosion-proof blankets, covering with sand etc.

6. Industry to carry out the root cause analysis for cable joint failure along with the cable OEM's. Any recommendations thereof shall be implemented in a time bound manner.
