## CASE STUDY

OISD/CS/2026-27/P&E/08

**Title:** Fire Incident in Crude and Vacuum Distillation Unit (CDU/VDU)  
**Location:** Refinery  
**Loss/ Outcome:** Property Damage

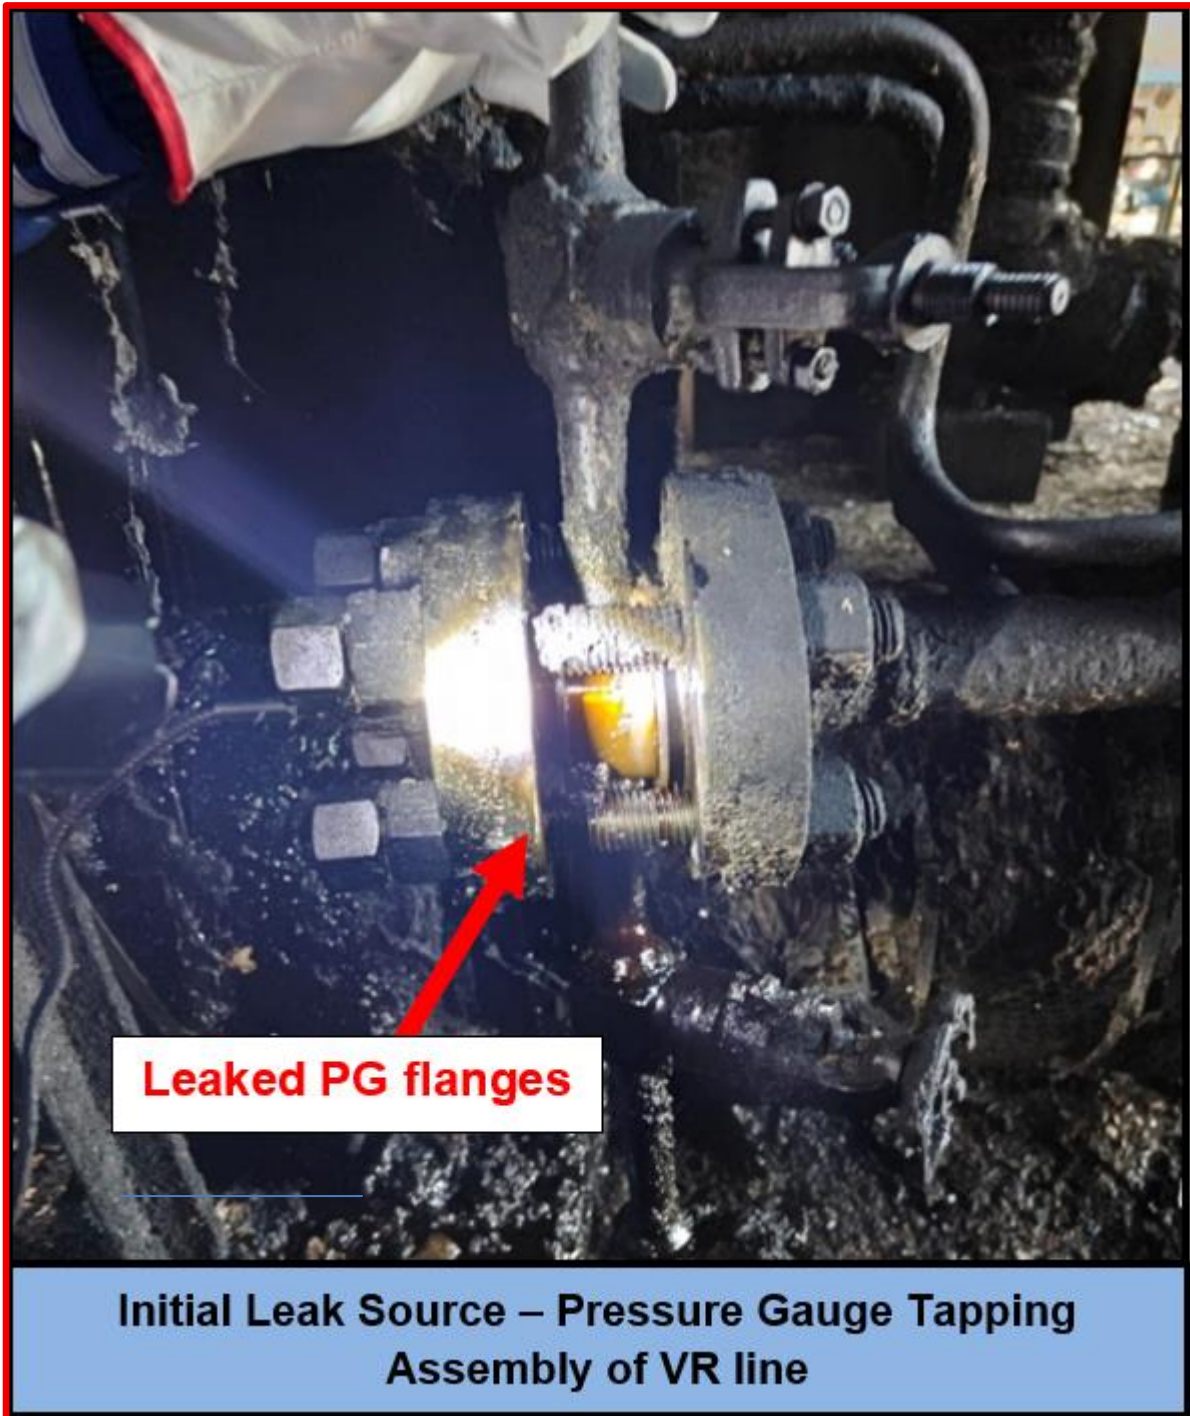
1. Dripping of VR (predominantly reduced crude oil - RCO) stream was observed from the flanges of the diaphragm-type pressure gauge installed on the vacuum residue (VR) shell-side inlet line of the crude versus vacuum residue exchanger (located on ground level). The flushing ring assembly of the pressure gauge was also found loose.

2. The spiral wound gasket of the assembly was damaged and positioned off-center, indicating improper box-up and misalignment. Accordingly, the sealing integrity of the assembly seemed to be compromised. The compromised pressure gauge assembly was concluded as the source of the initial leakage of hot vacuum residue (predominantly reduced crude oil - RCO) at auto-ignition temperature.

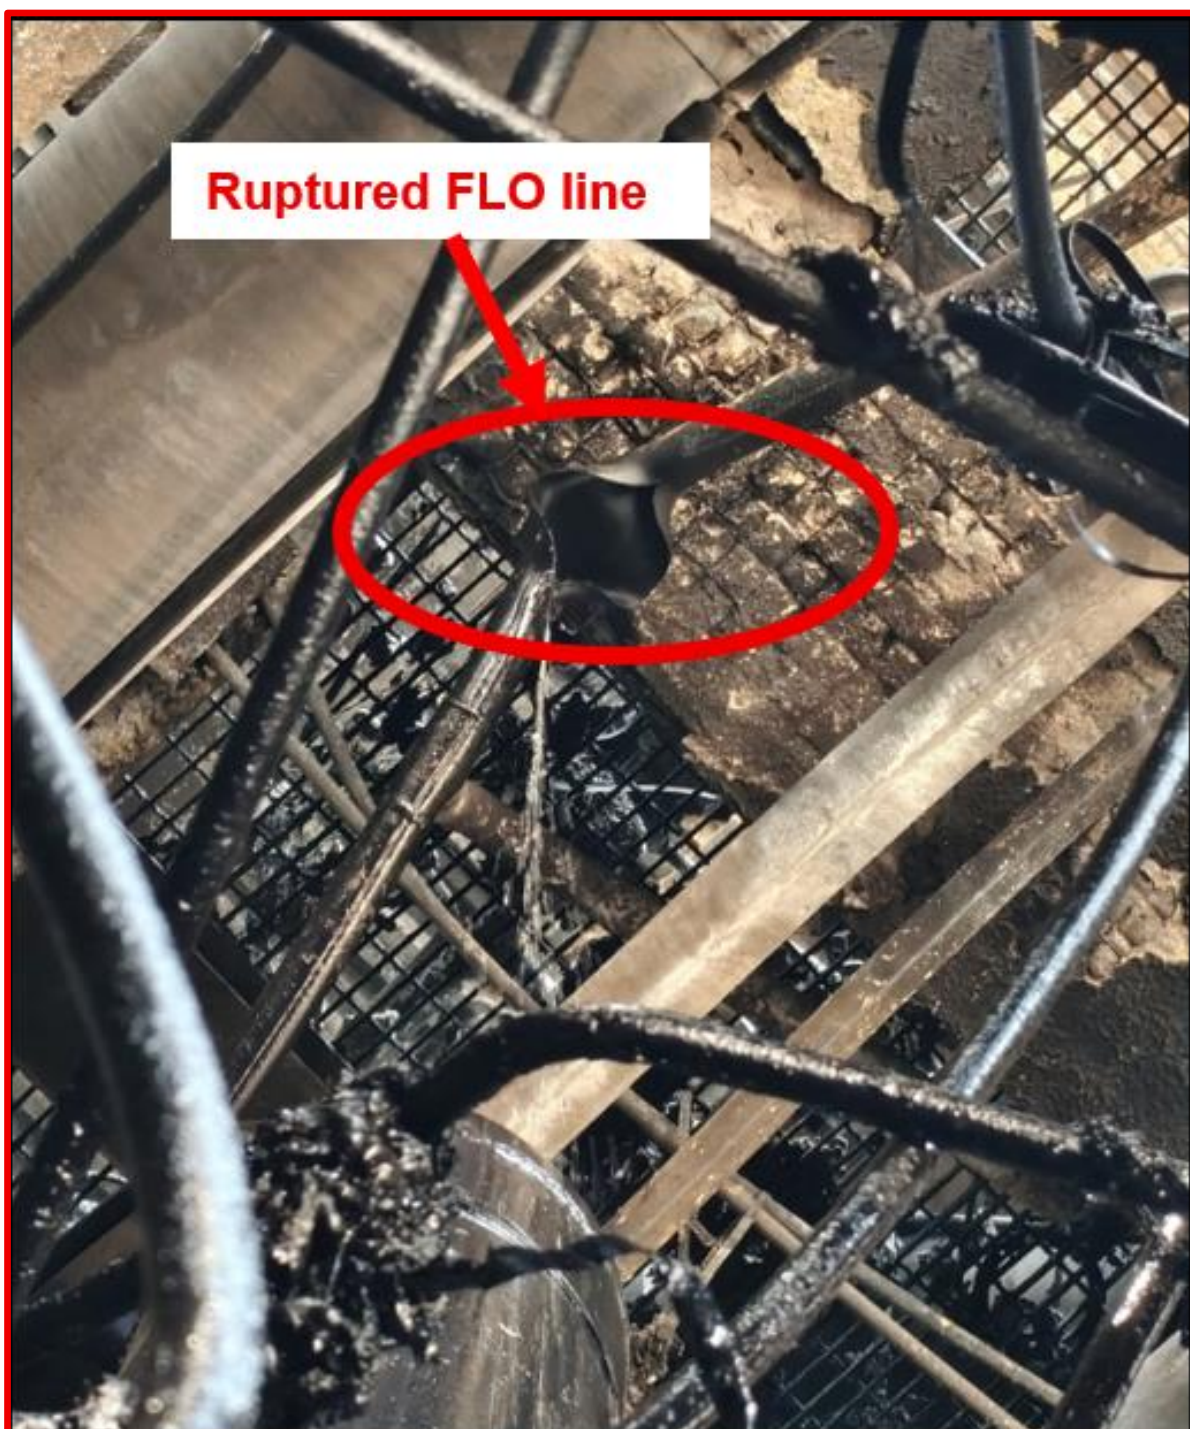
3. A fish-mouth rupture (around 6") was observed in the 2-inch flushing oil (FLO) line located just below the first platform of the technical structure (TS), approximately 5–6 meters above the fire initiation area. The line was provided for flushing the tube side of the CRUDE/HVGO CR EXCHANGER located on the first platform of the TS.

4. The pressure indicator of the FLO line showed a rise from 23.4 kg/cm<sup>2</sup> to 68 kg/cm<sup>2</sup> between the citing of smoke and sudden intensification of fire, approximately 4 minutes after the initial outbreak, as per the CCTV footage. Then the FLO pressure dropped down to 2.3 kg/cm<sup>2</sup>. This implied that the FLO line got pressurized due to heating up in a blocked condition in the flame emanating from the ground floor. It then ruptured, adding FLO into the fire.

**Ruptured FLO line**

**Ruptured FLO Line – Secondary Hydrocarbon  
Source Escalating the Fire**

- b. Hydrocarbon lines susceptible to blocked-in thermal overpressure conditions, including fire case, should be reviewed and the feasibility of providing suitable overpressure protection devices such as Pressure Safety Valves (PSV) / Thermal Safety Valves (TSV), with safe relief routing arrangements, should be considered.

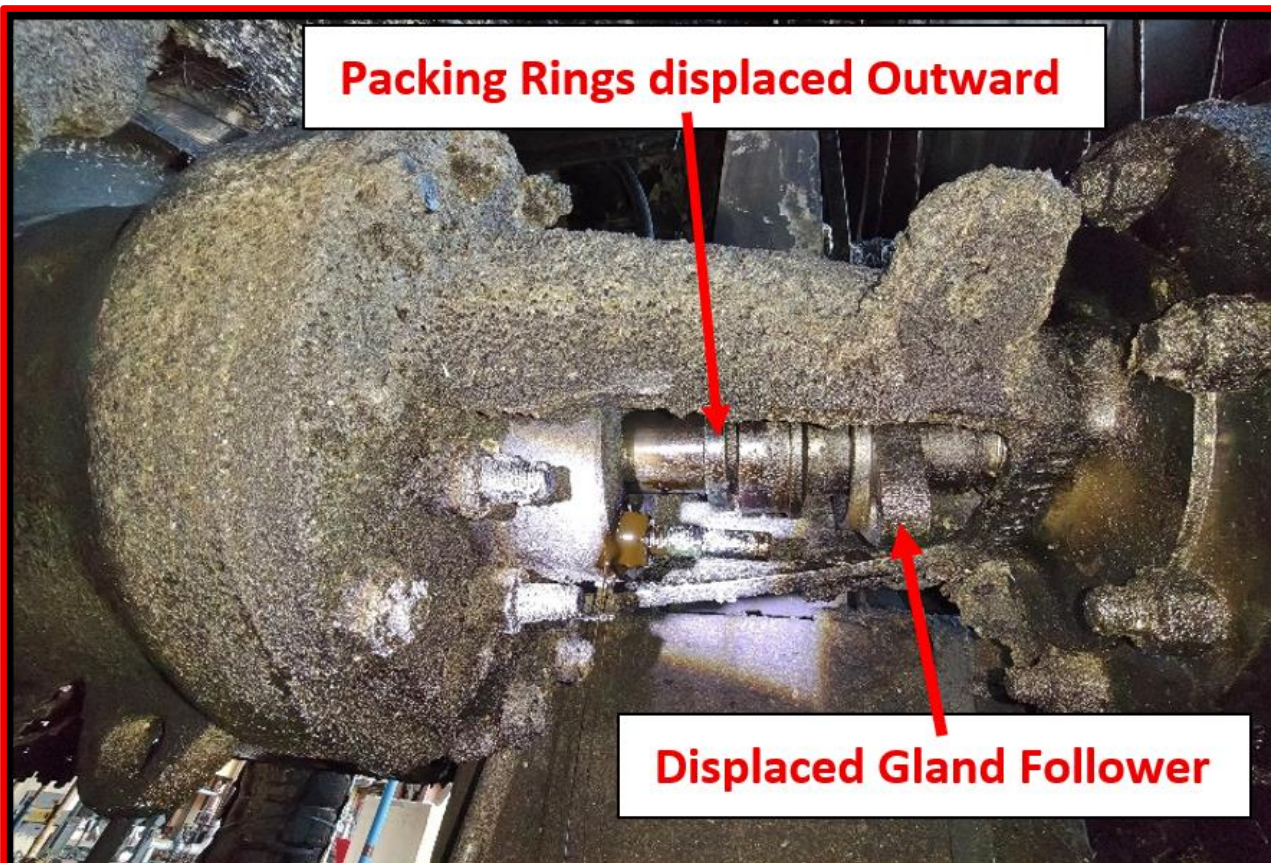
7. Dripping and minor leakage of VR stream (predominantly RCO) was also noticed from the gland area of the vacuum residue (VR) inlet gate valve of the same crude versus vacuum residue exchanger. Displacement of the gland packing and gland follower assembly of the valve was identified. The eye-bolt nuts were found disengaged and outward thread deformation was noticed on the gland flange studs, indicating additional leakage through the gland opening during the incident.

8. The vacuum residue (VR) inlet isolation gate valve was found maintained in a partially open condition without backseat engagement, resulting in continuous process pressure acting on the gland packing arrangement and making the gland more susceptible to leakage.

**Failed Valve Gland Assembly – Additional VR Leak Source Sustaining the Fire**

- a. Integrity of gland packing assemblies, pressure gauge (PG) connections and temperature tapping (TT) connections should be ensured through proper inspection, assembly verification, maintenance and certification practices under the Gasket Stud Functional Committee (GSFC) system prior to startup.
