## केस स्टडी / CASE STUDY

OISD/CS/2024-25/MOLPG/10

**Title:** Major accident during activity of putting soap solution to the chain conveyer soap tray.

**Location:** LPG Bottling Plant

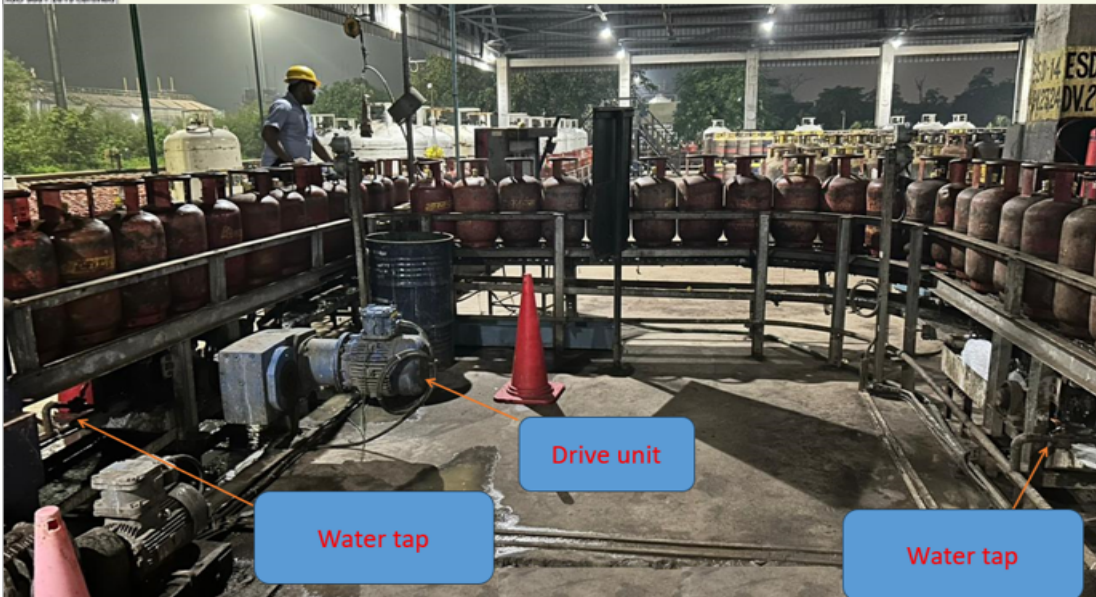
## Accident Spot Photographs

1. IP (Injured person) operated the water tap from the incorrect side of the conveyor belt indicating casual approach by him violating standard practice.
2. The water tap near the soap trays is positioned too close to the running sprockets.
3. The loading area lacks a safe passage for movement between the Hot Air Sealing unit and the conveyor belts. Crossover is not available for the conveyor loop.
4. There is no protection around the sprockets.
5. Rubber hand glove being used by the personnel on soap duty is having loose open ends extended up to the elbow, making it prone for easily getting trapped in the moving parts.
6. It appears that similar shortcuts are being taken during topping up of soap solution tray however the same gone unidentified because the culture of identifying unsafe act & condition was missing.

- 2 Relocation of Water Tap: - Possibilities may be explored to position the water tap suitably. Additionally, water taps may be installed on both sides of the tray for easier access and safer operation.

- 3 Sprocket Guard Installation: - Possibility to be explored to Install suitable safety guards on both sides of the sprockets to prevent accidental contact and ensure additional safety.

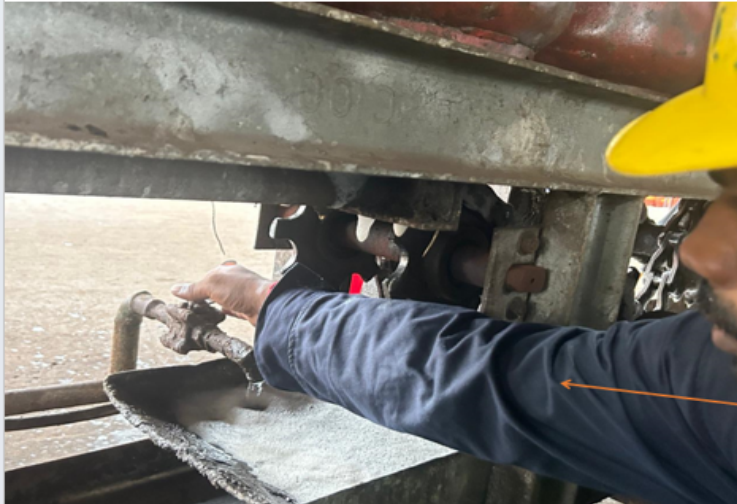
## Simulation of accident

The root cause of the subject incident is negligent act by contract workman by extending hand below the running conveyor without stopping it and operating valve from the wrong side.

During opening of water tap from opposite side accident happened

- 1 Standard operating Procedure: - SOP for soap solution pouring work to be prepared, approved and displayed at work. Proper training and adherence to established procedures to be ensured.

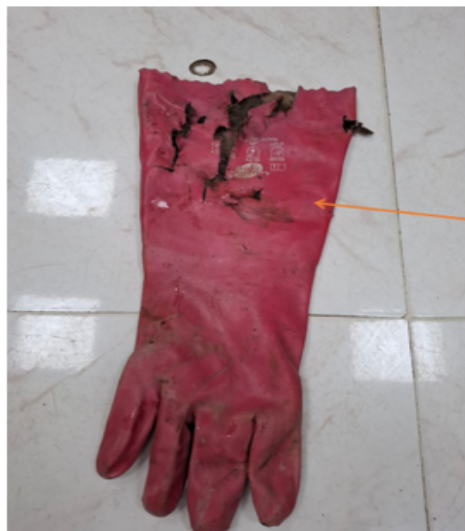
## Hand Gloves Used

This hand gloves used

- 4 Behaviour based safety culture to be implemented.
7. Suitable hand gloves should be used so that loose open ends can be avoided.
8. Normalization of deviation if any to be noticed and reported as unsafe act and unsafe condition.
