## CASE STUDY

OISD/CS/2023-24/P&E/09

Title: Major Fire Incident at HCU.  
Location: Refinery  
Loss/ Outcome: Production Loss & Property Damage

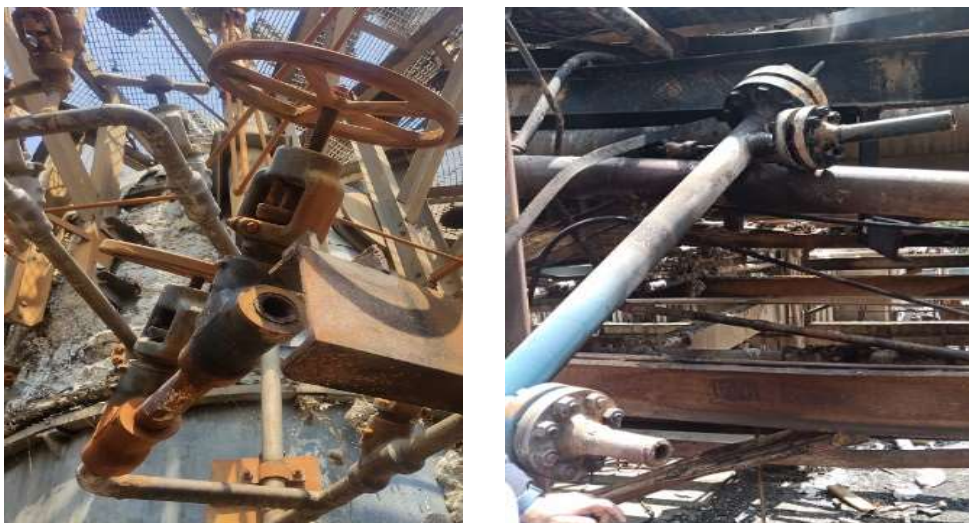
*Incident Site Photos*

5. Pipe racks including pipes and supports, cable trays, within 15-20 meters from the leakage point were found damaged. Electrical and Instruments cable duct in the pipe rack were also found damaged.

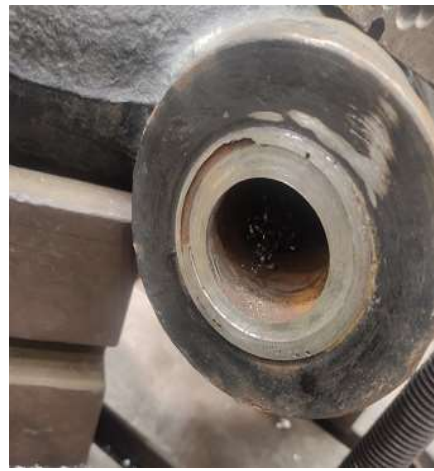
18. Bevel end orientation was not in line with the original valve. Sharp ends were observed which might lead to stress concentration. Refinery did not notice this deviation during acceptance of valve and prior to installation.
19. Bevelled end of the failed new valve was machined off in a boring machine in refinery workshop and the observations are as follows:

- ✓ Mark of the welding was observed at the end of valve body.
- ✓ An elongated circular discontinuity observed at its vertical to bevel end interface. The fillet welding also has discontinuity and other defects.

1. The newly installed valves had manufacturing defects. Brittle fracture might have happened due to hydrogen embrittlement at the bevel end of the "Y" type globe valve which resulted in release of hydrogen, hydrogen sulphide and hydrocarbon followed by explosion and fire.
2. Apparent possibility of submission of false or fabricated third party inspection certificates for the lot of failed valves supplied by the vendor. Probably the valve lot might not have been tested at 392 kg/cm<sup>2</sup> in the vendor premise as required for ensuring its integrity. Though refinery has tested the valves at 208 kg/cm<sup>2</sup> after installation in the HCU plant, the test pressure of 208 kg/cm<sup>2</sup> might not have been sufficient to detect the manufacturing defect.

1. Following should be ensured to prevent manufacturing defects.
  - a. Proper scrutiny of TPI witness test certificates during material receipt.
  - b. Suitable mechanism or confirmation & verifications of inspection certificates directly from TPI. The material supply tender may include provision for direct submission of copy of witness test certificates from TPI to user. TPI to submit the inspection release note and stage inspection progress directly to the entity with copy to equipment manufacturer.

2. Standard Maintenance Procedure (SMP) should be developed, including joint inspection by Mechanical & Inspection personnel, for thorough checking during valve replacement in critical service before installation.
