## CASE STUDY

OISD/CS/2026-27/E&P/02

**Title:** Fall of travelling block.  
**Location:** Onshore workover rig.  
**Loss/ Outcome:** Financial loss.

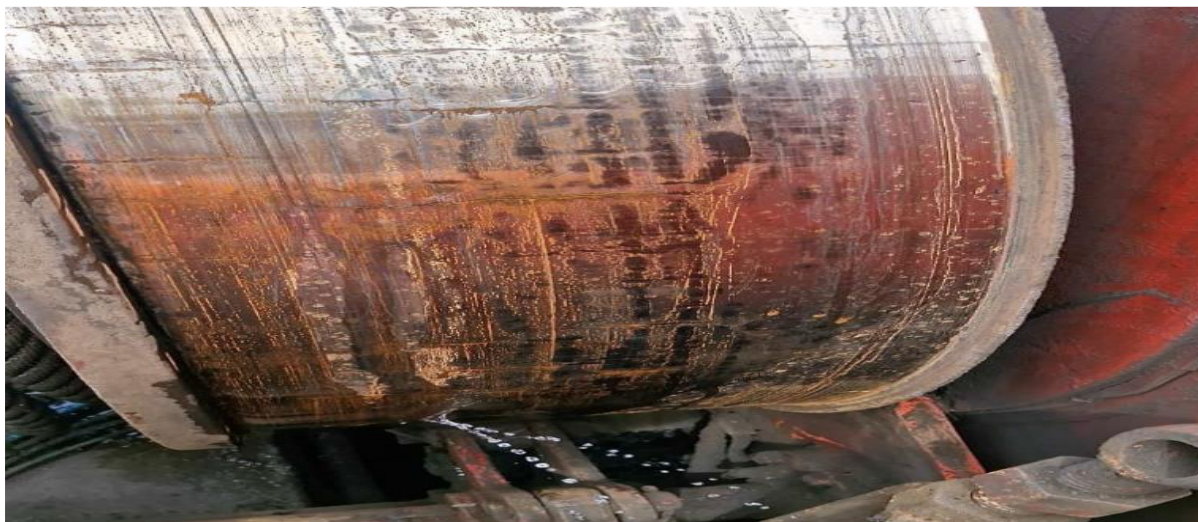
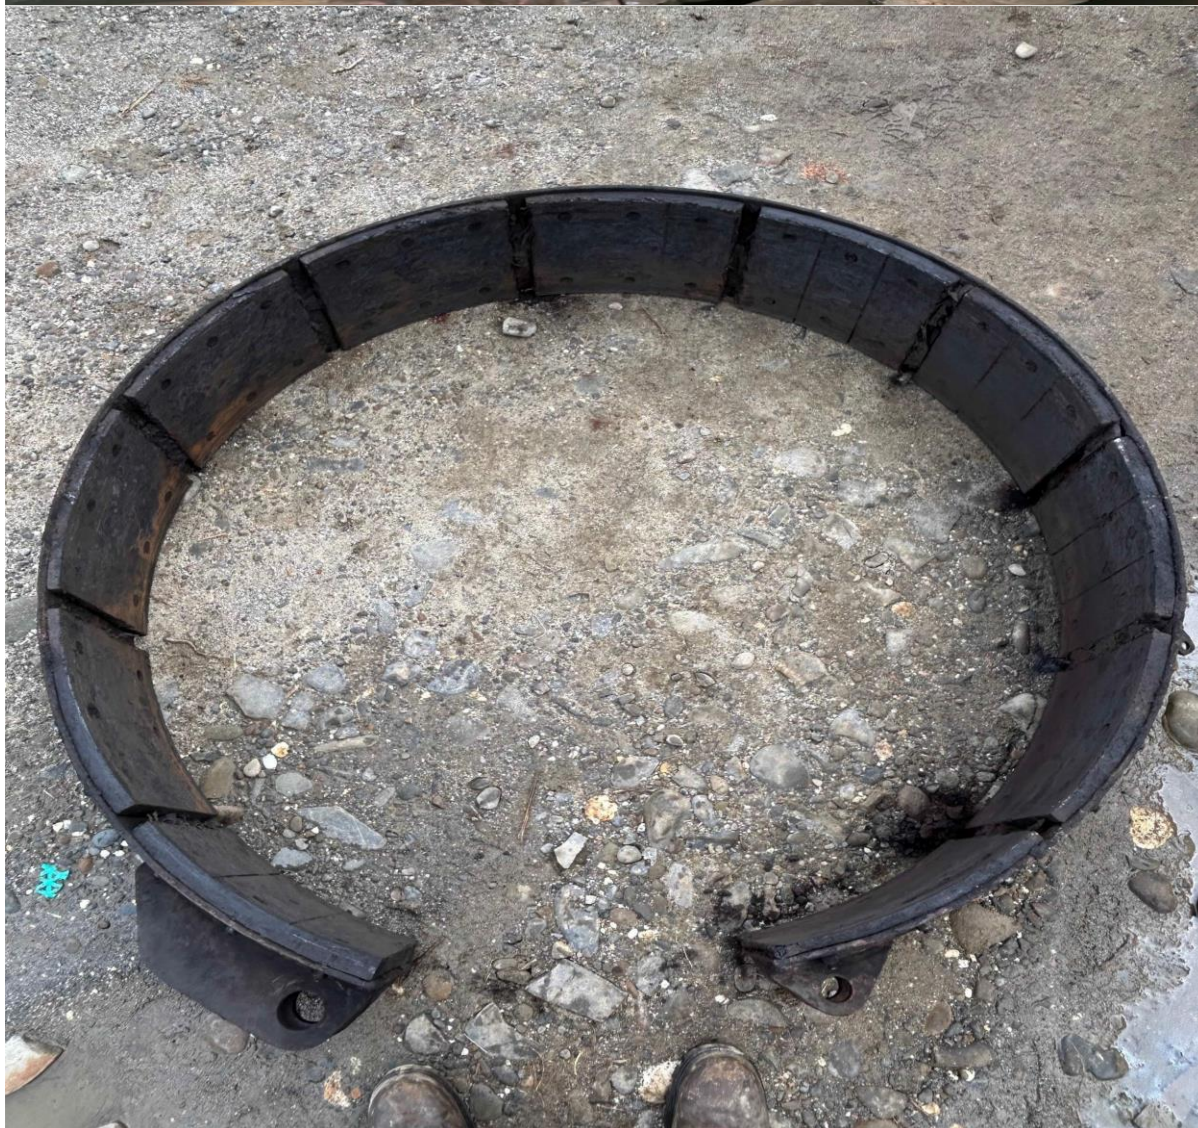
**Pictures of Brake drum and shoe after the incident**

- Multiple horizontal cracks were observed at several locations on the left-hand brake drum. These cracks are likely to have developed due to leakage of cooling water, which came in contact with the braking surface, thereby significantly reducing braking efficiency.

- The brake shoes were observed to be unevenly worn out and burnt. As per the draw-works logbook entry, all brake shoes were replaced recently. The reason for replacement of brake shoes was not mentioned in the logbook. The details of the manufacturer of the replaced brake shoes could not be verified from the available documentation, indicating a possibility that non-OEM / non-standard brake shoes may

have been used. The presence of cracks on the draw-works brake drum was not reported or recorded during this maintenance activity.

- Poor and ineffective maintenance of rig equipment.
- Uneven worn-out brake shoes and horizontal cracks in the left-hand brake drum might have resulted in cooling water of brake drum coming in contact with braking surface and resulting poor braking action. This resulted in loss of desired mechanical property required for brake to function properly.

- The gap in competence level of rig personnel should be identified and addressed as per OISD-STD-176.
- The preventive maintenance schedule should be strictly adhered to. Logbooks should be maintained inclusive of major repairs and replacement of equipment parts. Traceability for the replacement of spares consumed should be maintained with quality considerations.
- Root cause analysis of failures of critical components shall be carried out, and the resulting recommendations shall be effectively implemented.
- The rig crew should be trained and encouraged to identify and report unsafe acts and unsafe conditions. Appropriate corrective action should be ensured as per OISD-GDN-206.
