## CASE STUDY

OISD/CS/2024-25/P&E/09

Title: Fire incident during maintenance activity.  
Location: Refinery  
Loss/ Outcome: INR 85 lacs

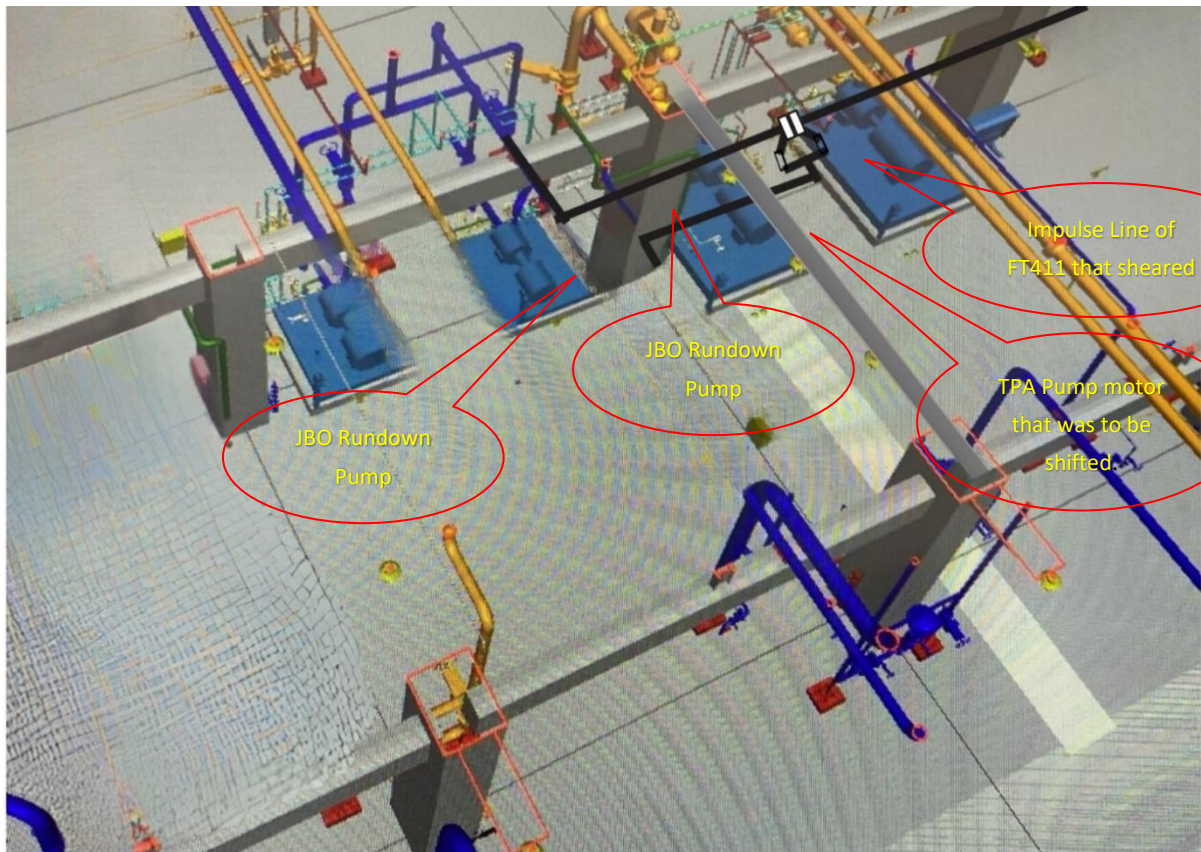
1. One of the impulse line HP tapping of flow transmitter of JBO rundown pumps' common discharge line, was found sheared from the orifice flange (upstream of root valve).

2. The flow transmitter connection piping upto root valve was found bent implying being hit and dragged.
3. The impulse line was just above the TPA pump whose motor was attempted to be lifted.

4. The height of the tapping was 3350mm. The forklift mast height was 2250mm. On lifting the forklift, the height can reach upto 3500mm.
5. There was a scaffolding immediately in front of motor of TPA pump that was hindering free movement of both man and vehicle. This was built in two month ago for completing the post turn around insulation jobs in pipe alley.

3D Schematic of incident area

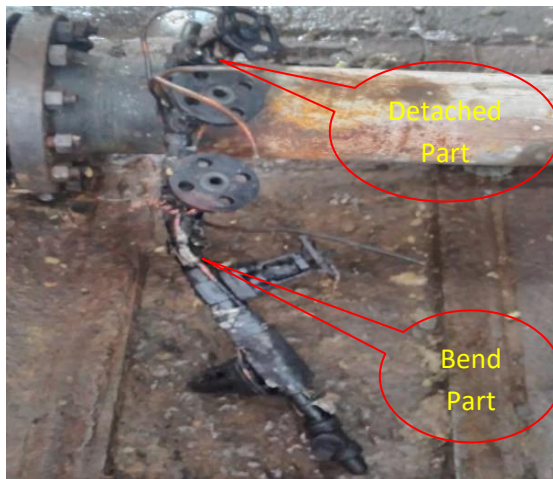
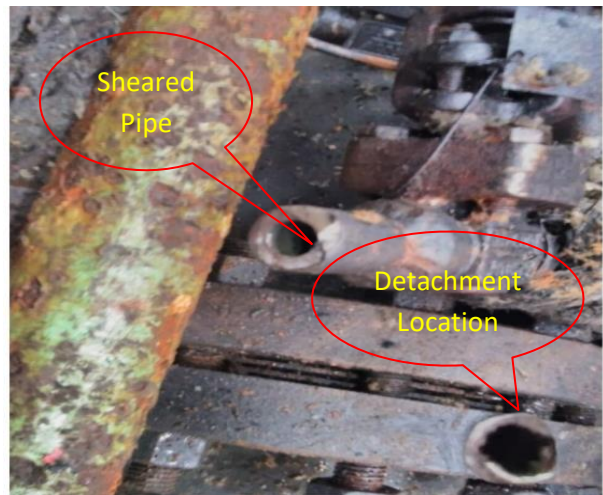
Pictures of damaged equipment taken after the incident

15. No CCTV was installed in the unit.
16. Major damage occurred to electrical/instrument cables, cable tray, light fittings, pipes, flanges, etc. All the six tiers of pipe rack were found affected by fire. Total 22 lines were affected. Six number utility lines (2" and below) were observed sagged and bowed. No sagging was observed in any structure. Total damage (Static + Electrical + Instrumentation) was evaluated around INR85 lacs as per the detailed submitted by the entity.

Based on the site conditions, statements and incident scene recreation, it was concluded that forklift hit the flow transmitter impulse piping during the backing of the forklift after abandoning the lift operation (without fully lowering the fork) resulting in shearing of the impulse line piping from the root.

The JBO in the pipeline, which was above auto ignition temperature (i.e. 310°C), gushed out and self-ignited, resulting in the fire.

1. Operators of mobile lifting equipment (inclusive of crane/forklift/Farhana) shall have minimum training in line with procedure given in IS13583. A robust mechanism should be developed for competency assessment before deploying the person. As per High Level Committee recommendations (Ref. recommendation 14 of HLC on Baghjan incident)- Competency criteria of key operating personnel shall be explicitly included in tender and to be ensured.

4. Entity shall review the delayed shutdown initiation.
5. Accessibility to the job site and working space should be assessed and ensured before executing/ conducting the job.

6. Minimum height at lowest point of the bottom most pipe-rack should be stencilled in units for information to all concerned.
