## CASE STUDY

OISD/CS/2020-21/P&E/02...

Title: **Fire incident on Maintenance Vessel used for SPM maintenance.**

Location: **During MBC replacement job carried out on the Maintenance Vessel.**

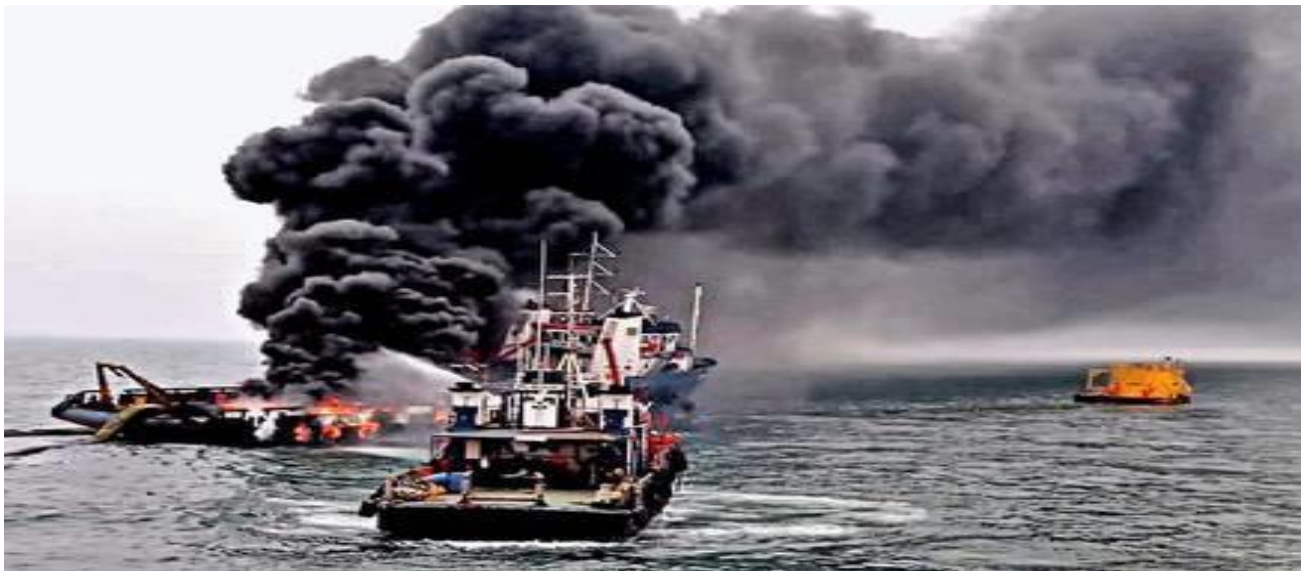
- Later on, the main Maintenance Vessel - A was physically inspected. It was ascertained that the entire engine room seemed to have been engulfed in fire. Main area of the flame appeared to be the starboard side near the emergency exit of the engine room. The electrical panels of the main engine and one of the MSB on the starboard side near the emergency exit were fully burnt and deformed. Some amount of fire melt areas were also seen on the starboard side including some parts of the starboard Main Engine.

- The fire appeared to have started from an ignition point in the engine room near the MSB panel or from generator which was in operation at that time. The most probable reason for explosion appears to be presence of highly flammable gases in the engine room due to which fire spread quickly to the entire oil spill (including vapor) on the main deck.

- Main Maintenance Vessel - A was taken to SPM without having valid certificate/ clearances for sailing. As per Port Trust report, hot work was pending and vessel had gaps on the deck. Through these gaps, crude oil seeped into the engine room and caught fire. Although, O&M contractor has taken the vessel in the larger interest of mitigating environmental disaster but had not anticipated the rough weather resulting in overspill of crude oil from floating hoses onto deck of main Maintenance Vessel - A.

Maintenance Vessel on fire
