## CASE STUDY

OISD/CS/2023-24/E&P/11

Title: Major fire incident at cluster location.

Location: On-land Workover Location.

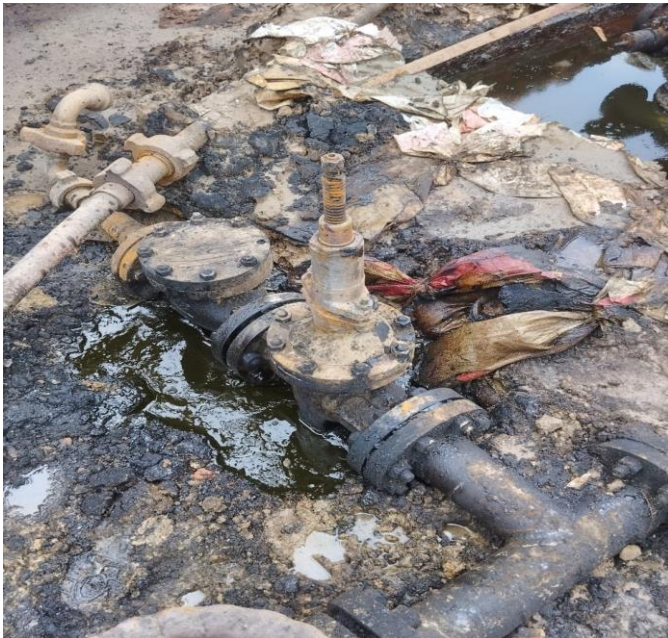
Workover operation was being carried out at a well, by a rig, situated within a cluster including three more wells. One well was producing; the remaining wells were temporarily closed. Unexpected release of hydrocarbon was detected near one of the temporarily closed well. Release of hydrocarbon was from the flange joint between gate valve and NRV in flow line of one of the well. The situation escalated, resulting in an uncontrolled eruption of oil and gas which caught fire within few minutes.

***Flange between NRV & Gate valve that leaked***

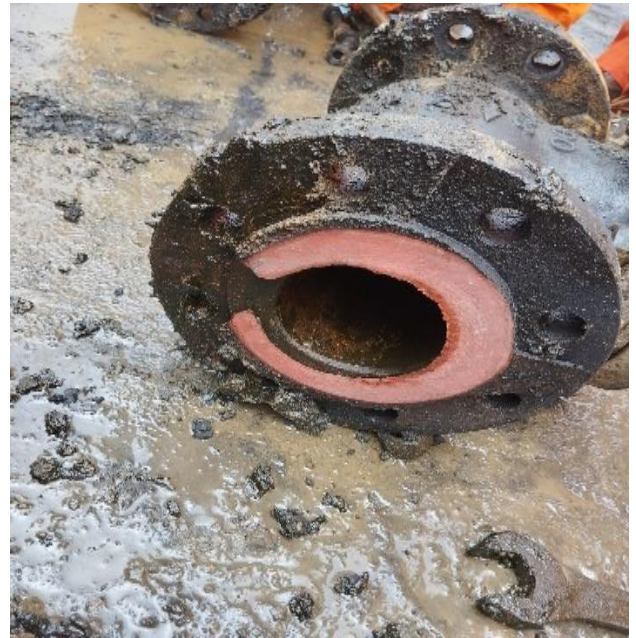
- The control wheels of valves on the X-mas tree of temporarily closed wells were not removed.
- Non-metallic compressed asbestos sheet was used as the gasket for flange of gate valve 4"X400#RF type instead of spiral bound metallic gasket.

- Selection of non-metallic gasket for 4"X400#RF class gate valves instead of spiral wound metal gasket was not as per best industrial practice.
- There was absence of recorded pressure monitoring for the flow line of producing well at cluster location, following the flushing activities conducted at other well which was connected to the flow line of producing well. Due to this, constant building up of pressure in the flow line of producing well went unnoticed.

***Questioned gasket which gave way.***

- All rig crew members shall undergo comprehensive training on SIMOPS.
- The flange joint should be provided with either spiral wound metallic gaskets or metallic ring type gaskets, depending upon the piping class. Metallic gasket should be used for Raised Face flanges (RF) as per best industrial practice.
