## CASE STUDY

OISD/CS/2023-24/P&E/10

Title: **Accident during maintenance activity**

Location: **Refinery**

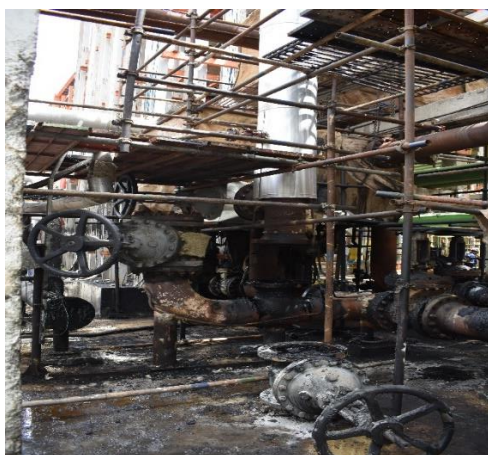
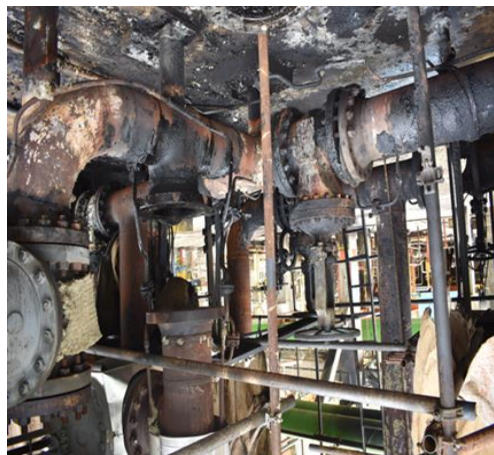
- Site was congested due to project job scaffolding all around the accident location. Reportedly, one of the injured had fallen while running away from the site and had maximum burns.

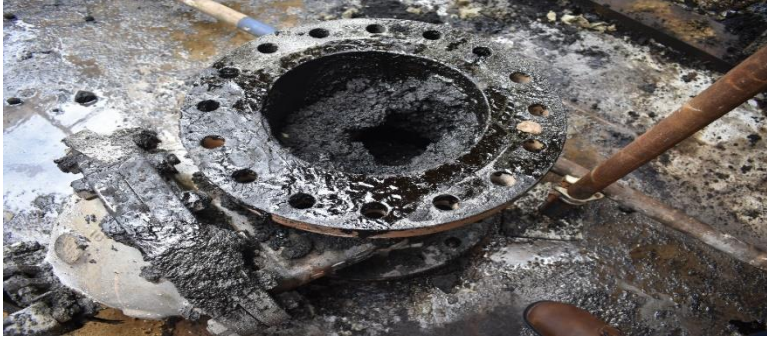
- Dropped 12" common outlet valve of VR exchanger was found chocked with tarry material/coke.

- The vertical loop of line was in tension and after removal of the valve, the line had shifted slightly towards battery limit.
- Provision for draining of steam condensate and fouling material had been made from the 2" horizontal stub of vertical header. The stub had a high possibility of being choked.
