## CASE STUDY

OISD/CS/2023-24/PL/12

Title: Pipeline failure incident in River crossing.

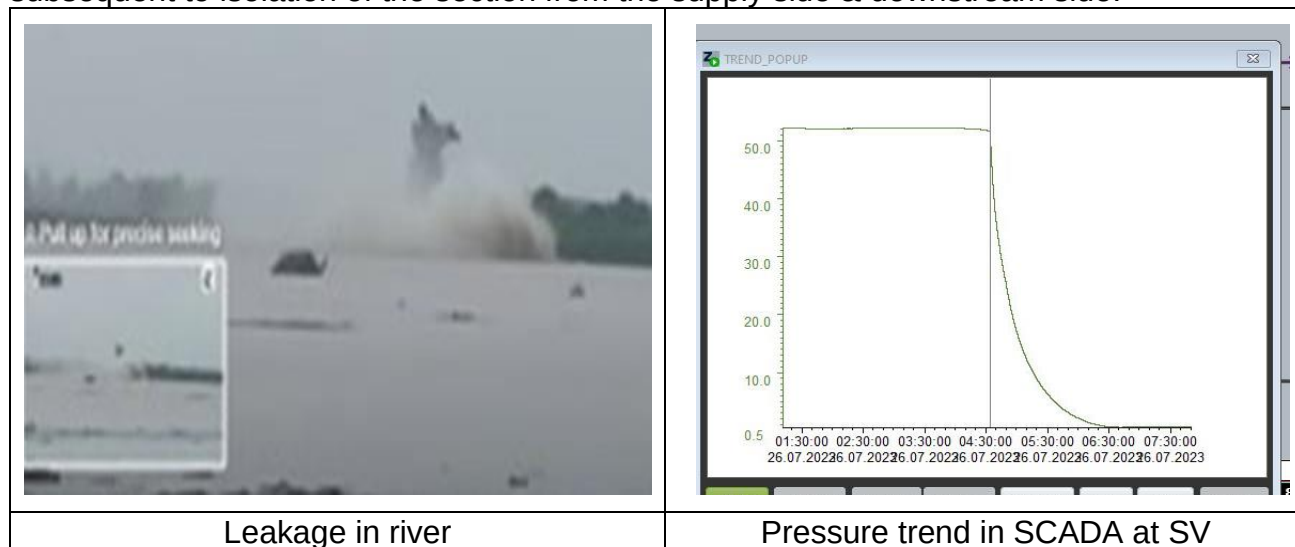
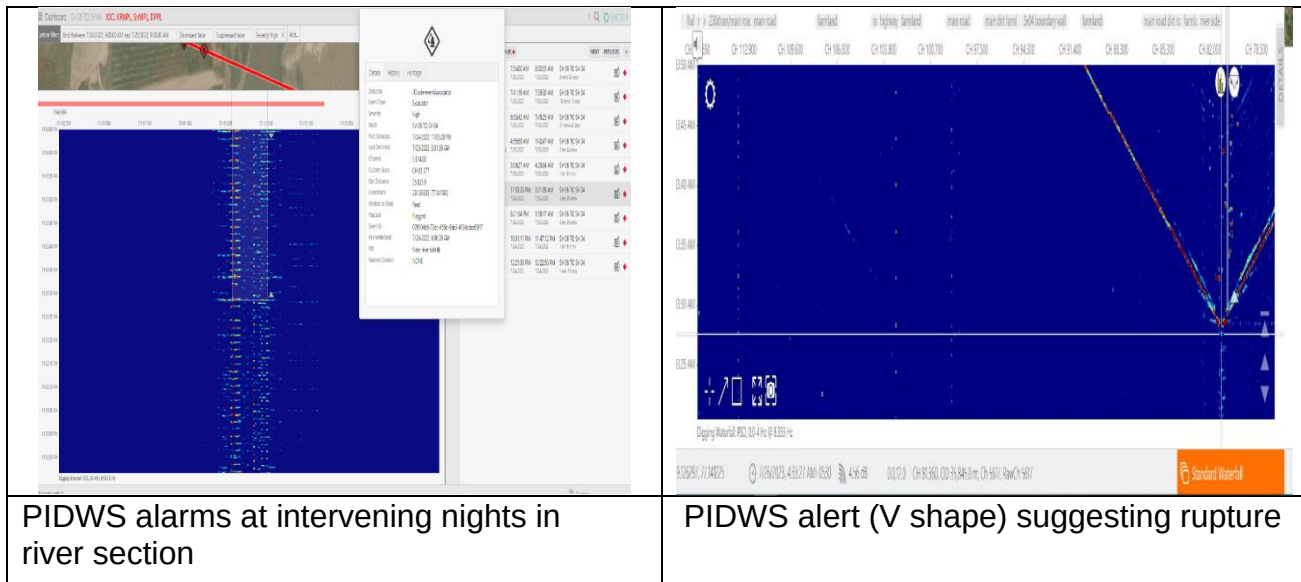
Later, information regarding gas leakage in river crossing was received through villagers approximately 35-40 mins after the fluctuations in monitoring parameters. The sectionalizing valves were closed for isolation of leak section and monitoring of the mainline pressure. The maintenance team reached the location and observed leakage from mainline in river crossing.

The information regarding the incident was shared with District Administration and Police Authorities and affected area was cordon off. The situation was brought under control. No fire incident/ casualties/ injuries were reported from the site. Gas leakage from the affected section was stopped after gas got released into atmosphere subsequent to isolation of the section from the supply side & downstream side.

1. During construction, design of the HDD crossing was modified based on site conditions. Initial design was having single HDD section, which was modified to two HDD sections with tie-in at the midpoint. The pipeline tie-in section was constructed by excavating pit in the middle of the river during dry season. At tie-in portion, in-situ concreting was done on pipeline at 5-meter intervals for providing anti-buoyancy measure.

7. The river crossing inspection being followed was based on visual inspection of washout as per internal format and not covering the profile study of the river course. As per the profile data of the river, it was observed that river course had shifted towards downstream side by about 500 m laterally. The tie-in point, which was located at a dry zone within the

river channel at the time of construction, was currently submerged in river. Learnings from OISD issued Safety alert OISD/SA/2022-23/PL/07 dated 6<sup>th</sup> September, 2022 was not considered in river inspection procedure.

Based on data and evidence collected, it can be concluded that lapses relating to the design and monitoring of river course, caused the pipe portion exposed to high stresses in tie-in portion, which led to its failure.

2. To the extent feasible, HDD should be done in single shot avoiding any tie in section within river channel. In case of constraint, the design of tie-in section shall be considering washout and mechanical protection in flood situation.

11. The presence of a high quantity of debris shall be investigated and necessary mitigation to be carried out.
12. Monitoring of features like major river crossings which are prone to changes in profile/ course should include main flow channel profile and its shifting using google images/ drone survey, soil cover data, use of Geotechnical surveys like SONAR etc. inorder to check course of river crossing

15. All pipeline operators shall consider tie-in section as the vulnerable portion of the HDD crossing and frequent watch to be kept to check any erosion on account of heavy floods during monsoon.
