## CASE STUDY

OISD/CS/2021-22/E&P/01

Title: Fall of the Hatch on a Roustabout.

Location: Offshore Drilling Location

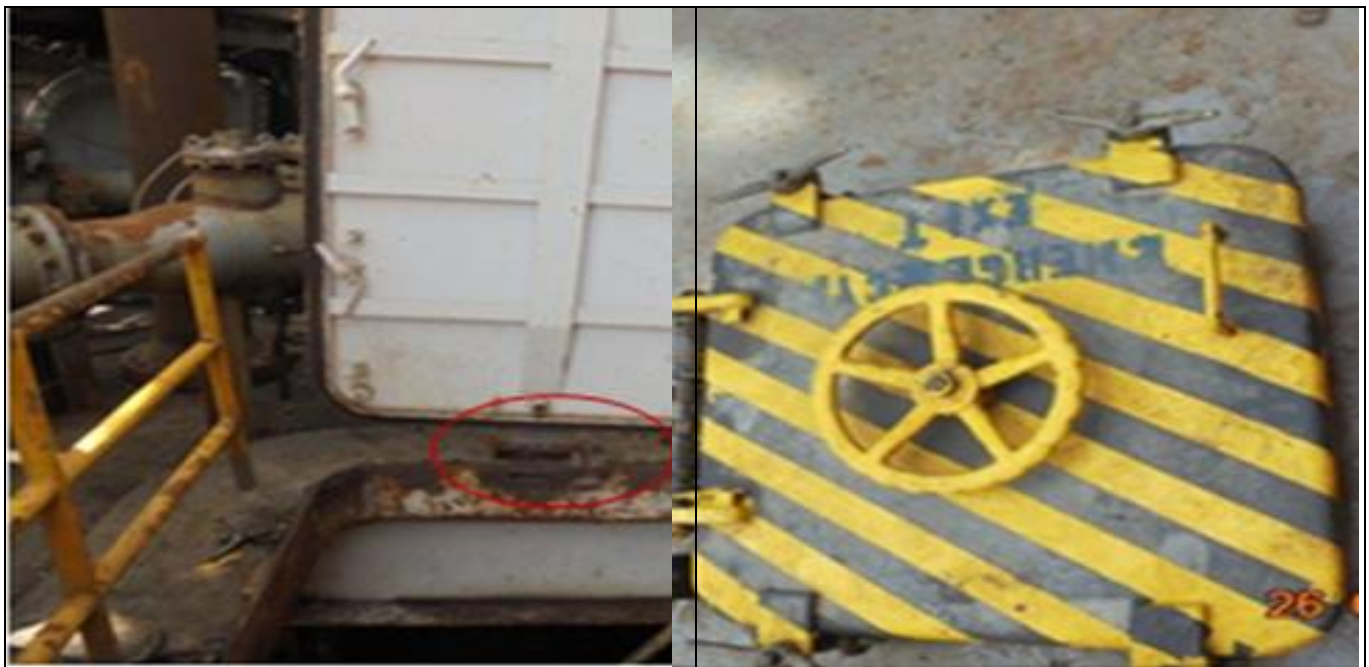
**Hatch**

- During investigation it was observed that surrounding area of pole where hatch cover is meant to be secured is not easily accessible because of storage of stabilizers and other items. The person who secured the hatch cover cannot physically see that whether the bolt had passed through both the holes (eye pad on hatch as well as pole). This is in Violation of Rule-162 (sub rule (2) of P&NG rules-2008.

- There is no provision of negative angle in hatch securing provision so that force of gravity prohibits hatch cover from accidental closing on its own.

- Hatches are primarily meant for cargo transfer and for alternate exit route in emergency conditions. Hatches should not be used for regular entry and exit.

- Hazard identification and risk assessment system should be reviewed holistically.
- Housekeeping near the hatch area should be improved by relocating stabilizers to some other place.

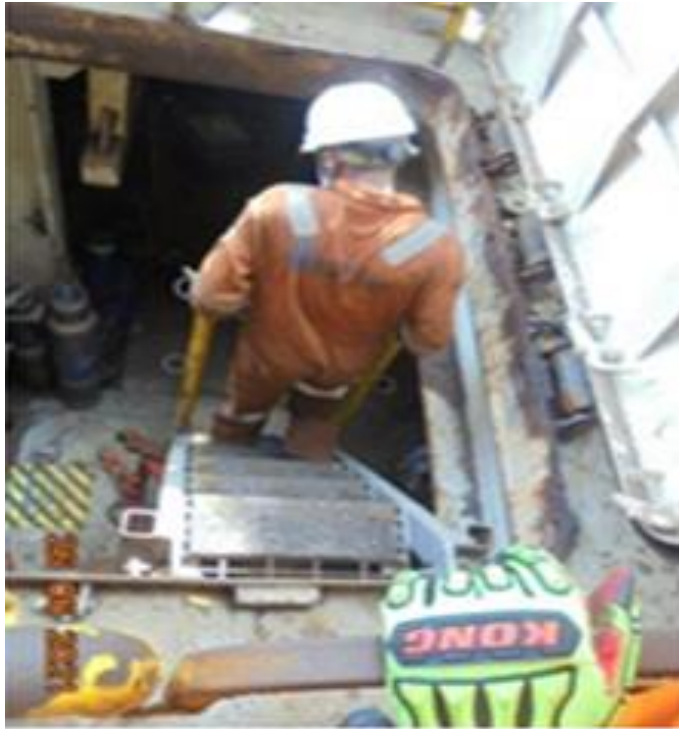
**Entry into Drilling Store via Hatch**

- There was poor housekeeping around the hatch area.
- Heavy tool store is made in a confined space, which has a single exit. Permit to work system for entry into confined spaces was not followed, which violates Rule-131 of P&NG rules-2008.

- Top most railing of stair case in heavy tool store needs to be removed for closing of hatch door and this railing needs to be put again prior to crew movement. However, there is no means to ensure this.

- Rig crew entry through hatches should be stopped and use of this heavy tool store should be discontinued till the time normal entry route is made available for crew using management of change.
