## CASE STUDY

OISD/CS/2021-22/E&P/02

Title: Fall of The Telescopic Mast  
Location: On-land Drilling Location  
Loss/ Outcome: Major Loss of Asset

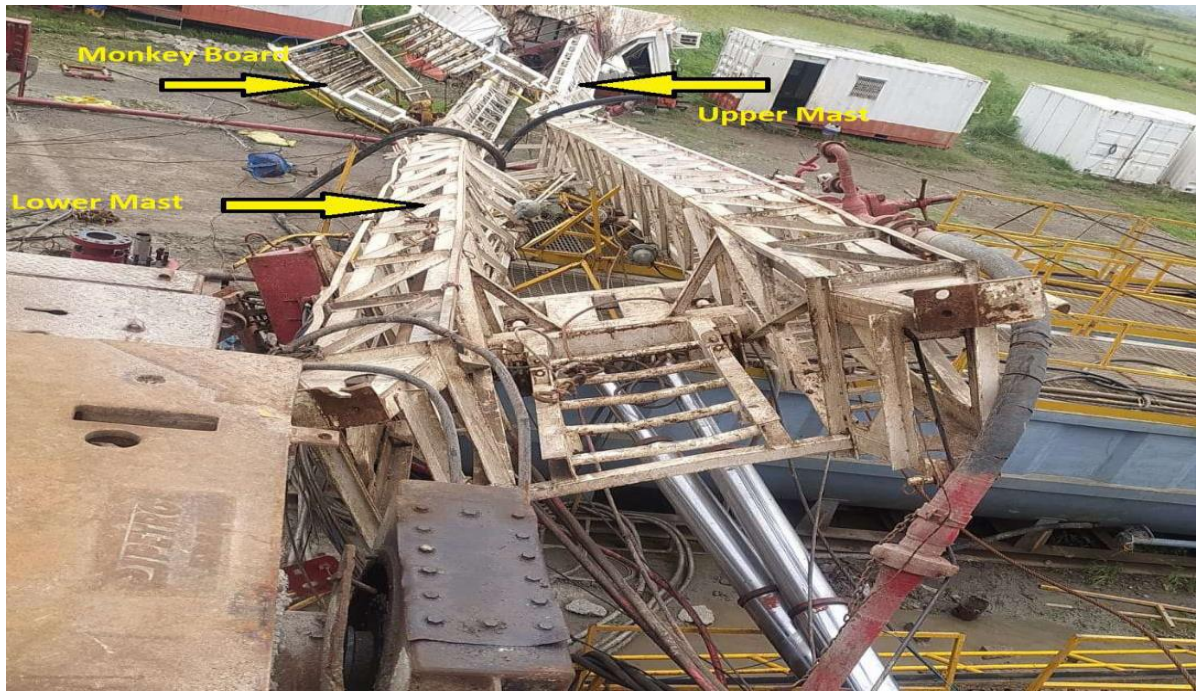
**After the incident**

After conducting Pre Job Safety Meeting, shift crew started rig mast down process. Mechanical l/c operated lever meant for raising telescopic mast 3 to 4" up, so that mechanical lock can be removed and telescopic mast may slide down. Subsequently, driller on derrick floor observed some vibrations in the mast and after few seconds a loud metallic sound was heard by everyone. All crew escaped and no injury occurred; complete mast fell down towards left of the rig damaging the Shift in charge/ Store bunk house completely.

As the telescopic ram (right side) couldn't move up, stress generated in the right side of the structure got transferred to the weakest joint (in this case, it was the joint between lower part of the mast and 'Y' frame). This resulted in snapping of bolt and hinge I-pad fitted at the top of 'Y' frame (right side); subsequently damaged left side of the 'Y' frame joint too and rig mast toppled to left side of the carrier.

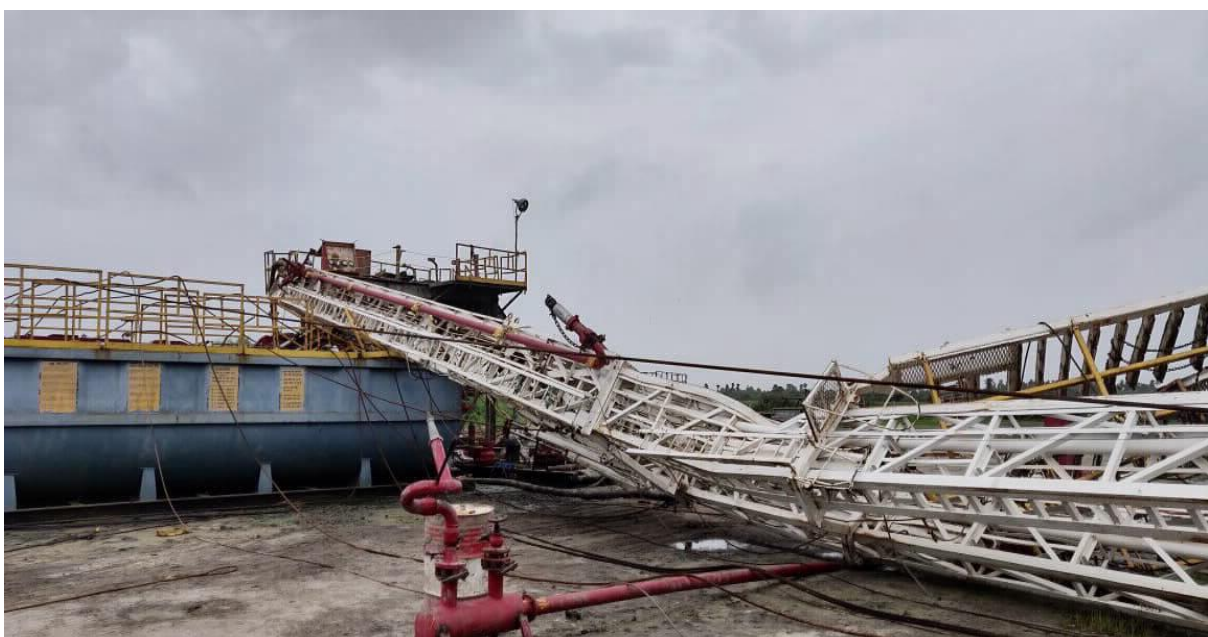
**View of fallen mast from bunk house side**
