## CASE STUDY

OISD/CS/2024-25/E&P/08

Dt.:04.09.2024

Title: Fire in a Battery Room

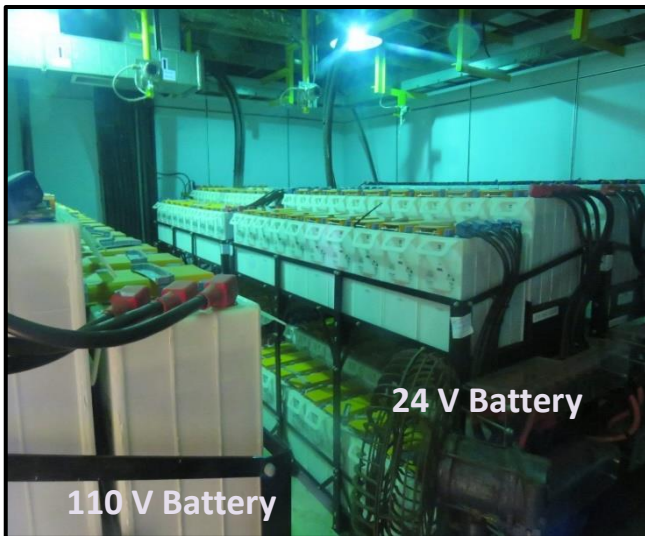
Photograph of battery room of a similar well head platform

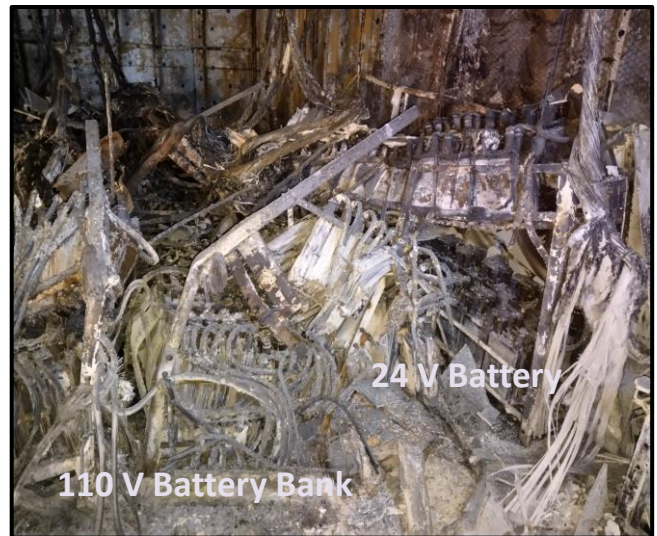
1. The fire incident was due to the continuous overheating and overcharging of the Ni-Cadmium battery banks supplied by OEM which led to a thermal runaway condition within the battery banks.
2. Organization's over-reliance on OEM for resolving battery issues without seeking alternative solutions or taking independent actions led to significant delays in addressing critical battery problems.
3. The absence of continuous battery room monitoring when batteries were heating allowed critical parameters like voltage and temperature to escalate without detection. SCADA system for well-head platforms was not monitored at night, and alarms were in an inhibited state. There was no action for about 11 hours.

Photograph of burned battery room at the well platform post fire incident

1. **Preventing Runaway reaction in Nickel-Cadmium batteries:**
  - a) Battery temperatures should be maintained within optimal ranges as specified by the OEM. [Refer clause 6.2.1.3 of IEEE Std 1635-2012/ASHRAE Guideline 21-2012].

- b) Battery management system (BMS) should be used to control the amount of charge and output of battery systems. BMS are meant to shut down or control the battery before thermal run-away may occur. [Refer to clause 52.3.2 of NFPA-1].

- c) A system to disconnect batteries in case of ventilation failure should be ensured. [Refer to clause 10.3.4.3.7.2 of API 7F-2018]
2. **Competency building:**

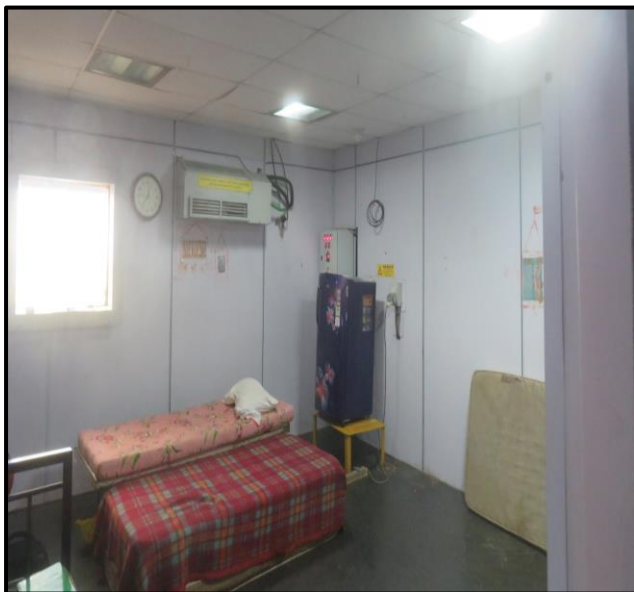
Photograph of shelter room of a similar well head platform

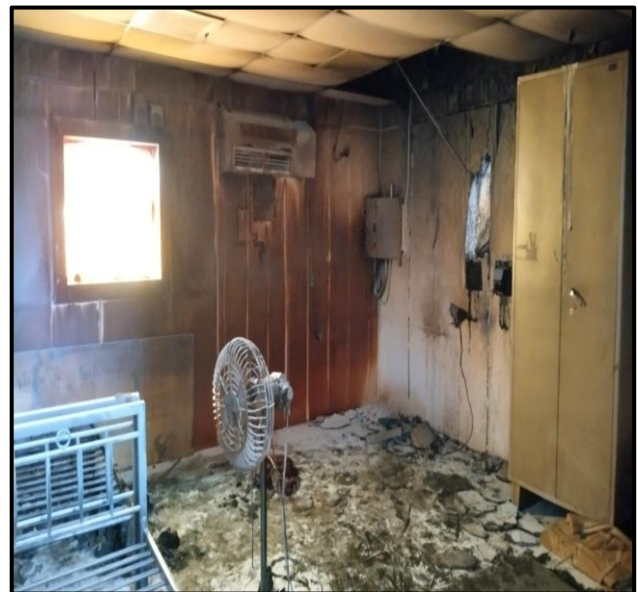
Photograph of shelter room at the well platform post fire incident
