## CASE STUDY

OISD/CS/2024-25/MOPOL/06

Title : **Explosion of the Ethanol Above Ground Horizontal Tanks – 2 nos.**

Location: **POL TERMINAL**

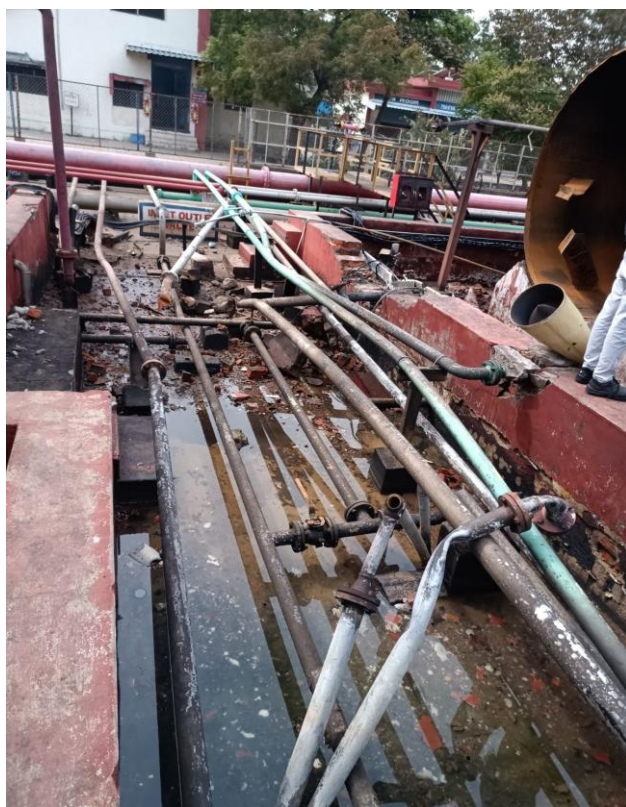
Pipe Alley outside the dyke of Ethanol tanks
