## केस स्टडी / CASE STUDY

OISD/CS/2021-22/LPG/05

Title: Fatal incident during degassing process of 150 MT capacity above ground LPG storage bullet

Location: LPG Bottling Plant

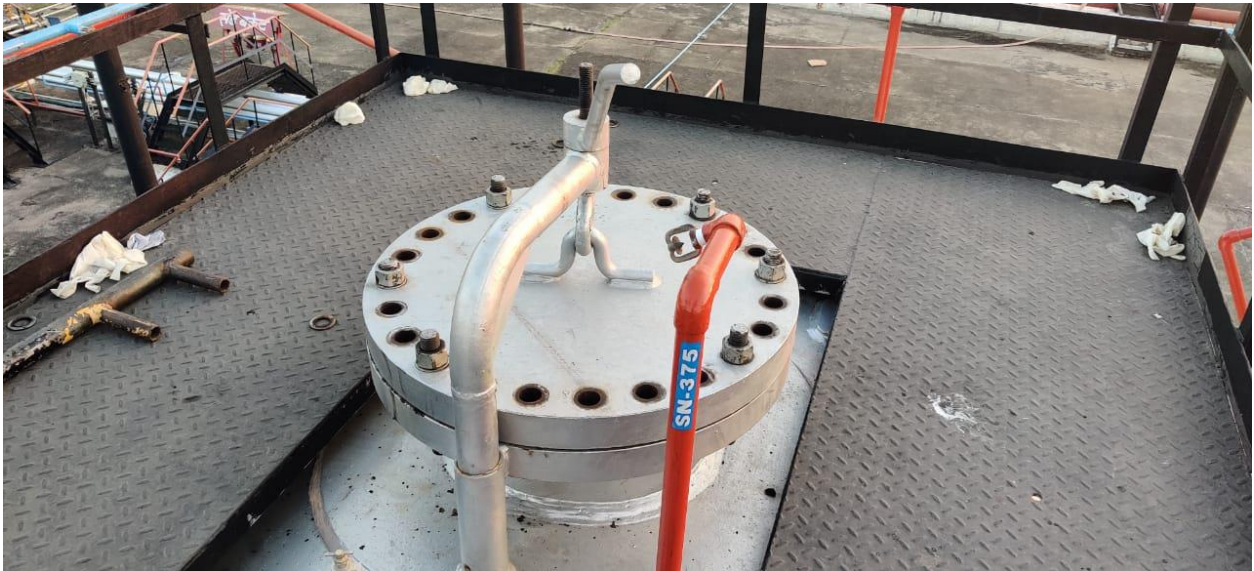
Plant personnel tried to rescue these two persons but due to lack of oxygen inside the bullet, small size of manhole (460 mm internal dia) and non-availability of appropriate equipment for rescue in such condition, no one could enter inside the bullet.

**MANHOLE OF BULLET (460 MM INTERNAL DIA)**

Rescue operation could not be done in time due to non-availability of equipment for safe vessel entry (having LPG vapour/ lack of oxygen) through manhole (460 mm internal dia). To provide suitable equipment such as hose mask with hand operated blower/ Supplied Airline Respirator system and full body safety harness with double lanyard, for safe vessel entry. Same to be used at the time of vessel entry even after degassing of vessels during periodic testing/ any other maintenance work.

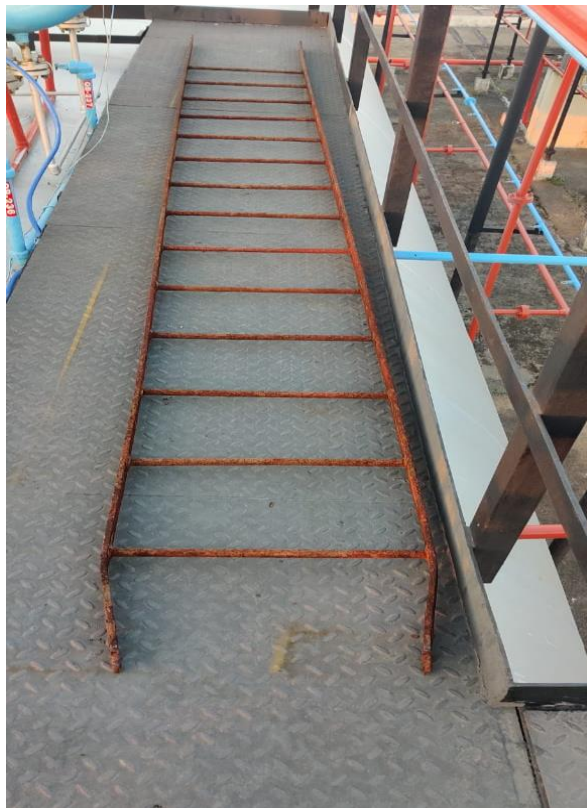
**LADDER OF BULLET REMOVED FOR  
TAKING OUT THE BODIES**

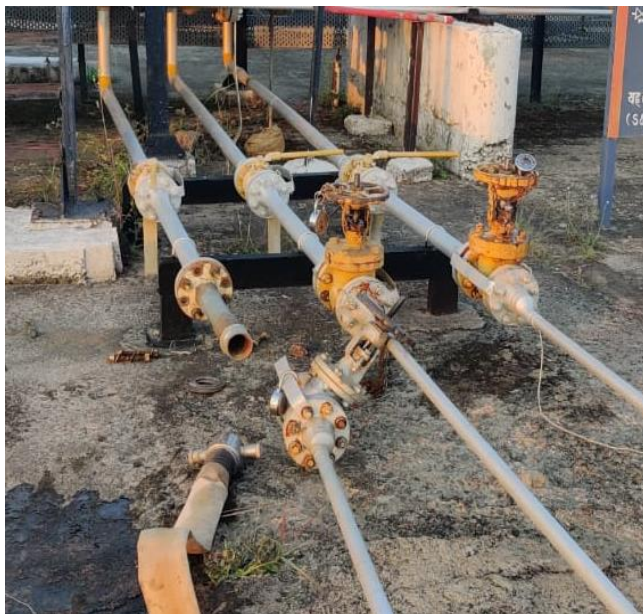
For degassing of bullet no. 3, fire hose was connected from one Double Hydrant at water drain point of bullet no. 3, through a spool piece having male part for hose connection. To speed up the water filling for degassing of bullet no. 3, another fire hose was connected from another Double Hydrant up to the top of bullet no. 3 for water filling through manhole. For this purpose, top manhole was opened and both the deceased person in presence of HSE officer tried to hold/ fix the fire hose in manhole and in this process one person fell inside the bullet and second person went inside the bullet to save first person.

**HOSE CONNECTION FOR WATER FILLING  
IN BULLET THROUGH WATER DRAIN LINE**

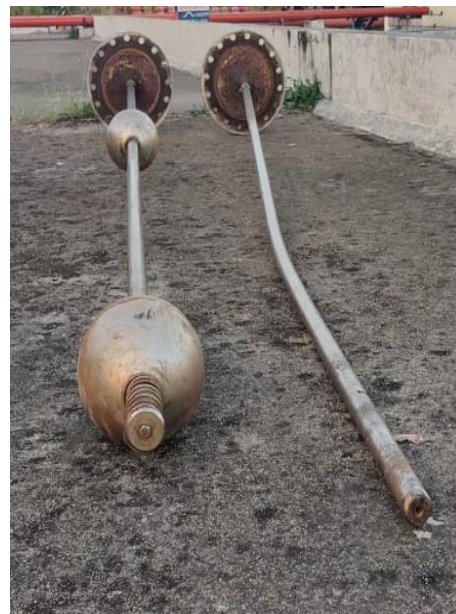
- a. Each bullet is having two level gauges i.e. Rochester gauge and Magnetic Level gauge, however reading of only Rochester gauge is being entered in the LPG Pump House dip book. Magnetic Level gauge of bullet no. 3 was not working and reading of the same was not being recorded in dip book. Plant is not aware since when this gauge was not working.

**LEFT (MAGNETIC LEVEL GAUGE)  
RIGHT (DEFECTIVE MAGNETIC  
LEVEL GAUGE)**

- a) To ensure logging/ entry of daily activities and sequence of operation performed in the log book of respective area where maintenance work is being carried out.
- b) Logbooks should be reviewed and countersigned by the role holder officer on daily basis.
- c) Reading of both the level gauges provided on LPG storage vessels should be recorded in log book/ dip book irrespective of which gauge reading is used for stock accounting purpose.
