Site Survey Report

Site Name: URAN

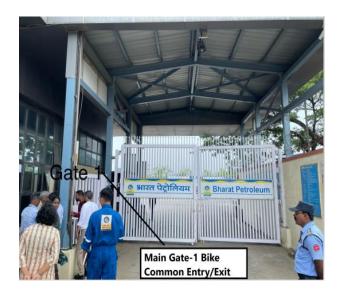
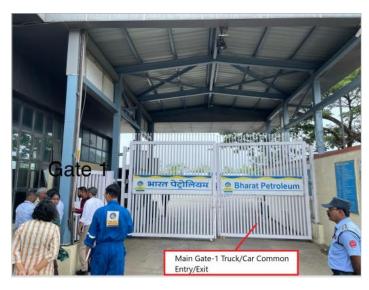
1b. MAIN GATE-1 (Bike- Common Entry/Exit)

Item	Nos	Make	Model	Site Readiness	Remark
Boom Barrier	1			Not ready	Existing boom barrier is Malfunctioning 10- year-old system. Needs to be replaced
Reader	2	ZKT	Face+ Finger+ Card	Not Ready	2 no. from main gate to be installed here. Integration to be done with new system.
Push Button	0			Ready	Existing to be used

Feasibility to check integration of boom barrier with existing reader

Currently manual entry and exit checking of ID Card by security guard

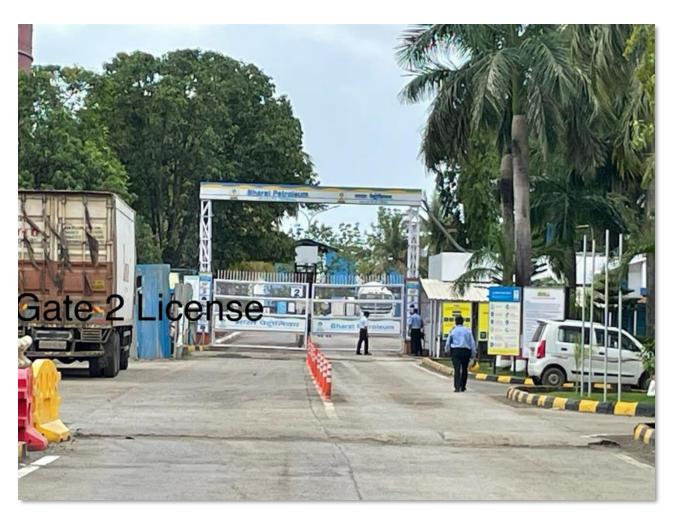
License Gate 2- Truck Common Entry/Exit

No system to be installed at this location.

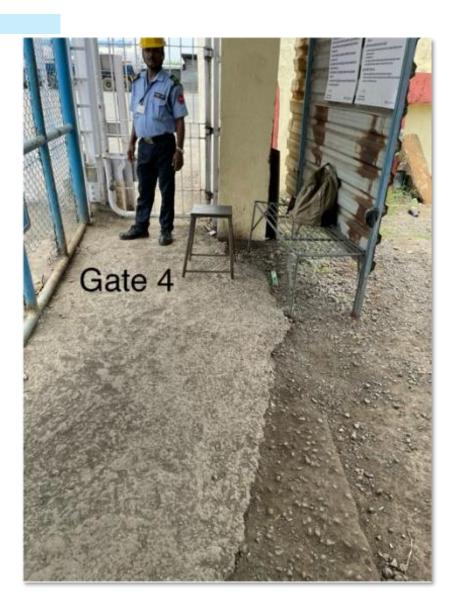
3.LICENSE GATE-4(Common Pedestrian Entry/Exit)

Currently no Flap barrier and readers installed.

No zero-level flooring available at site

No Canopy available

No Network Point@ gate 4 security cabin

Existing 2 nos. of flap barrier & 2 readers from main gate to be installed. BPCL point of discussion
