AGFA 🐠	DR 100e	Type 6012	No. 47
Radiology Solutions Services	DR 100s	Type 6013	No. 46
	DR 400	Type 5520	No. 165
	DR 600	Type 5530/100	No. 210
	DR 800	Type 6010	No. 55
	DR Retrofit	Type 5400	No. 131
	DX-D 100	Type 5410	No. 137
	DX-D 100 Wireless	Type 5411	No. 186
	DX-D 300	Type 8207	No. 170
	DX-D 400	Type 5420	No. 125
	DX-D 600	Type 5430	No. 191
	Valory	Type 5540	No. 09
		D

Document ID: 79488020

Service Bulletin

Service Quality Test Tool version 2.2 released

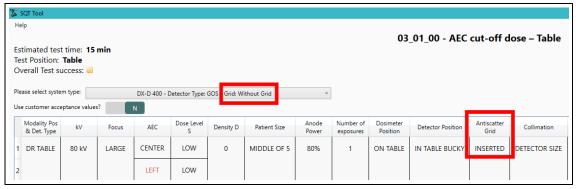
Figure 2

1.1.3 SQT test 3.1 (AEC cut-off dose) for DX-D 300, DX-D 400, DX-D 600: Unclear instructions with respect to antiscatter grid [PRB2000674]

In SQT test 3.1 (AEC cut-off dose) for DX-D 300, DX-D 400 and DX-D 600, it is possible to select whether an antiscatter grid is present or not.

However, when selecting "Without Grid", the SQT 3.1 setup instructions still indicate that the antiscatter grid should be inserted.

Cause Fault in SQT requirements
