**UK FAME RELATED JET FUEL PRODUCT QUALITY INCIDENT ON 14th May 2008 – BRIEFING NOTE**

Bulletin No. 16

June 2008

Summary of report of visit to BP Kingsbury and BPA Kingsbury as a part of Midlands Airport IncidentIntroduction

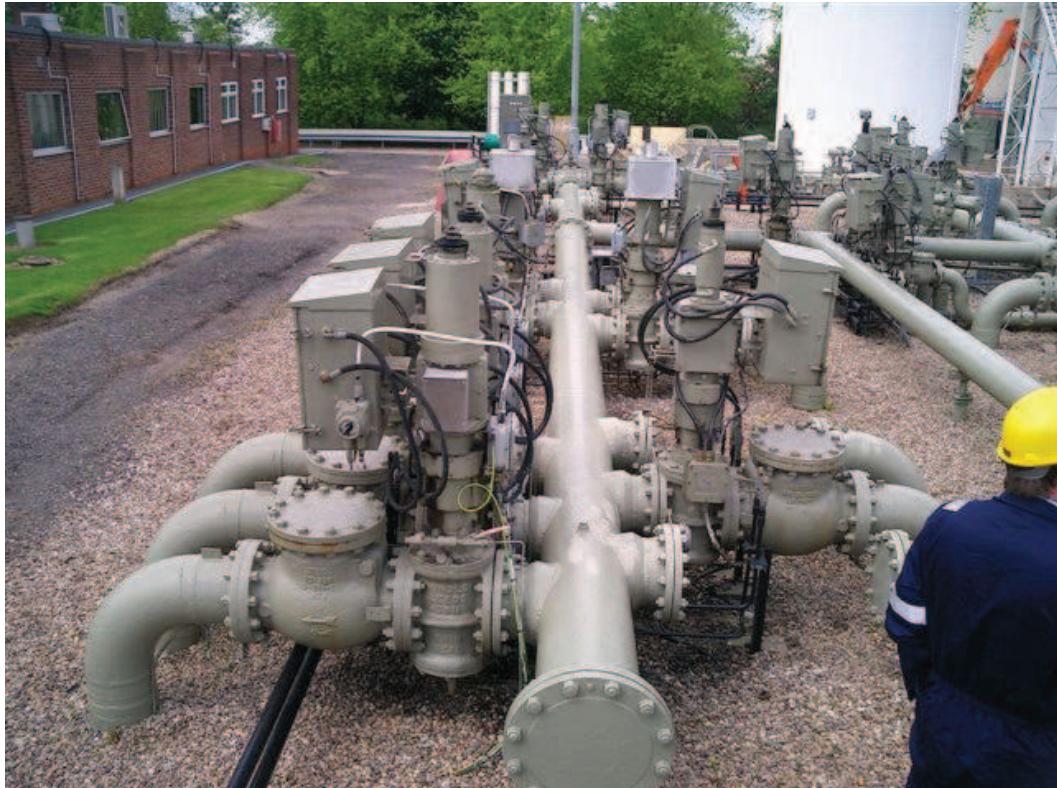
Distillate Manifold

The 12" diameter pipe work length of the distillate manifold is approx 22 meters in length containing approx 77 litres per meter, which equates to approx 1.7m³ of product. This manifold is shared between BP and WOSL (see picture below)

Following a DIESEL parcel, this entire line is left filled with DIESEL – 1.7m³.
Following a JET A-1 parcel, this entire line is left filled with JET A-1 – 1.7m³.

JET A-1 parcels following GASOLINE are transferred into BP Kingsbury via the distillate manifold. If there have been no KEROSENE parcels or buffers since the previous DIESEL parcel receipt, this manifold contains approx 1.7m3 DIESEL. Of this DIESEL, 1m3 is displaced directly into the BP Kingsbury JET A-1 tanks by the incoming JET A1 parcel.

When a BP JET A-1 parcel is directed to BP storage the WOSL portion of the distillate manifold still contains approx 0.7m3 DIESEL. Depending on flushing efficiency, this volume may leach in to the JET A-1 continuously during the receipt as product turbulence flushes the manifold.

It is believed that the practice described above is the immediate cause that has allowed the mixing of DIESEL containing FAME with JET A-1 in the distillate manifold. The end result was unacceptably high levels of FAME in JET A-1 in BP storage.

If a JET A-1 parcel receipt of 6000m³ is contaminated by 1.7m³ of DIESEL containing 4.8% FAME (typical B5 grade) then the mixture will contain 14ppm FAME. The exact volume of cross contaminating DIESEL is not known. This calculated result is consistent with the FAME content of the JET A-1 tested in BP JET A-1 tanks 5 (22ppm) and 3 (19ppm).

- BP requested BPA to introduce the following procedures to eliminate the immediate cause:
 1. Drain the distillate manifold before ingress of ALL JET A-1 parcels
 2. Use a 250m³ buffer to proceed the receipt of ALL JET A-1 parcels
 3. Use a 250m³ buffer to trail the receipt of ALL JET A-1 parcels
