## केस स्टडी/ CASE STUDY

OISD/CS/2026-27/P&E/11

- Title:** Fatal incident during transportation of HDPE wax-filled jumbo bag by forklift
- Location:** Road between the Wax Draining Station and Wax Storage Yard (approx. 140 mtrs), HDPE Unit of a Petrochemical Complex
- Loss/ Outcome:** Fatality of forklift operator and damage/toppling of forklift

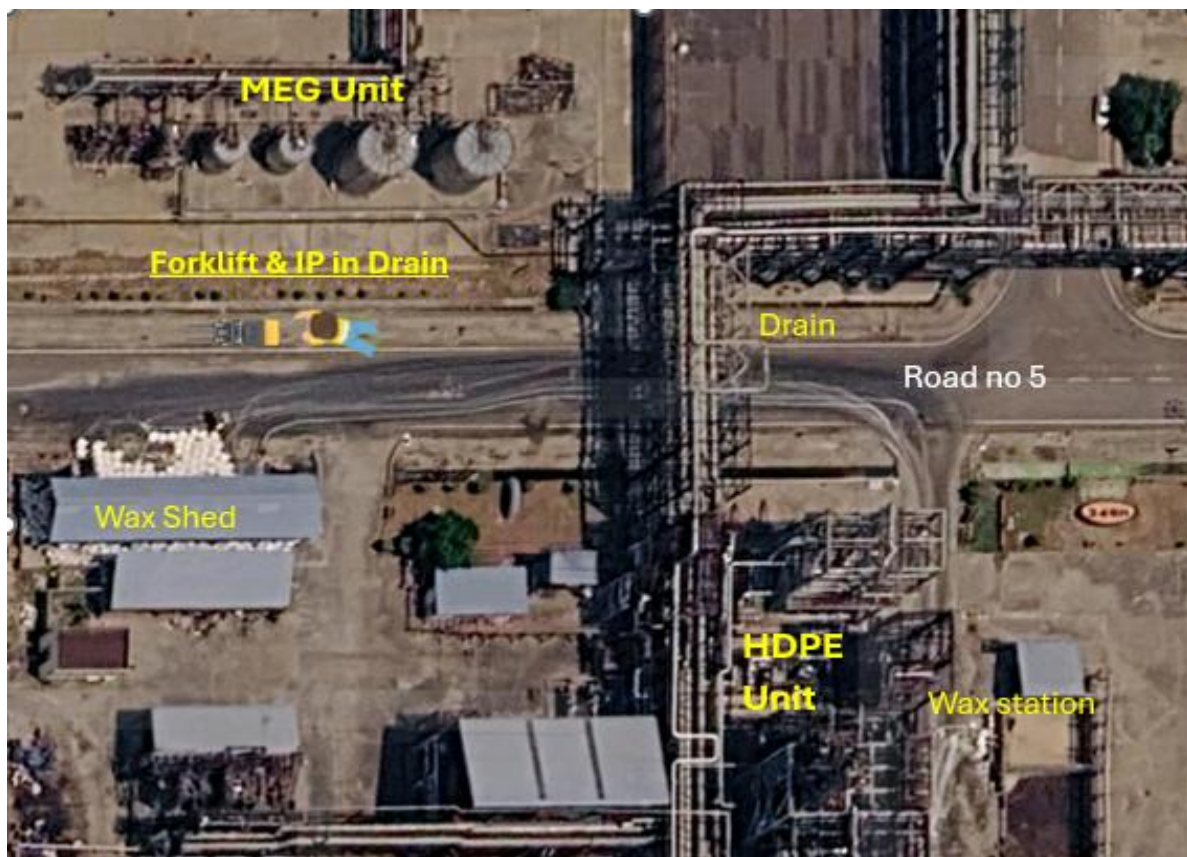
A fatal incident occurred during transportation of a wax-filled jumbo bag by forklift from the Wax Draining Station to the Wax Storage Yard in the HDPE Unit of a petrochemical Complex. The Wax Storage Yard was located approximately **140 m** from the Wax Draining Station. The filled jumbo bags, weighing approximately **500 kg each**, were routinely transported through the main road (11 m wide).

When the forklift did not return within the normal travel time of approximately 4–5 minutes, the Production Junior Executive Assistant and contractor helper proceeded towards the Wax Storage Yard to ascertain his whereabouts. The forklift was found by them toppled inside an open trapezoidal dry drain approximately 1.0 m deep and 2.4 m wide, opposite the Wax Storage Yard on the other side of the lane in which the forklift was supposed to normally traverse. The operator was found unconscious beside the toppled forklift. He was then shifted to the First Aid Centre and next to nearby Civil Hospital, where he was declared brought dead.

3. Each one-way forklift trip took approximately 4–5 minutes,
4. The traversing road was observed to have considerable wax deposits on its surface, apparently resulting from spillage from the wax-filled jumbo bags. The roadway had an open trapezoidal storm-water channel approximately 1 m deep along its side, without adequate roadside protection/curb arrangement to prevent unintended vehicle movement into the drain.

5. Appropriate roadside protection, such as curb stones, crash barriers or equivalent vehicle restraint systems, shall be provided along identified forklift travel routes adjacent to storm water drains or other roadside hazards to prevent unintended vehicular movement.
