## केस स्टडी/ CASE STUDY

OISD/ CS/ 2026-27/ P&E/12

**Title:** Fatal incident during scaffolding dismantling work  
**Location:** Power Plant stack of a refinery  
**Loss/ Outcome:** 1 Fatality

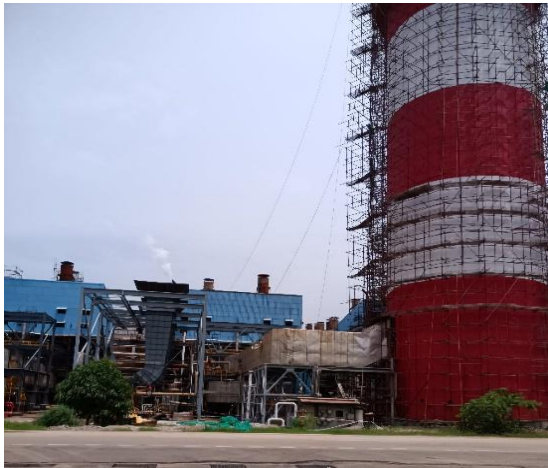
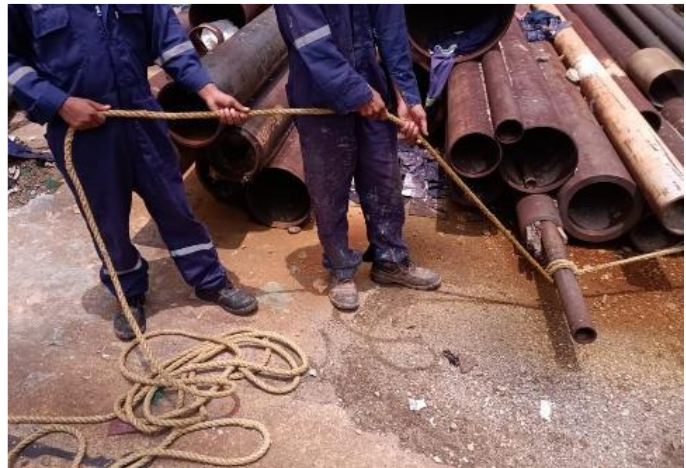
1. The scaffolding pipes being lowered (allegedly 3 to 4 bundled each time) were 40 NB MS tubes, medium class 6 m in length, each weighing around 21.4 Kg. Total weight of the load including pipe and clamps was roughly 85-90 Kg. However, it could not be authenticated that not more than 4 pipes were lowered each time.
2. The rope used for lowering the dismantled scaffolding pipes, was passed over a pulley at top of scaffolding. On the ground a makeshift arrangement was used. The rope was looped around a 3" pipe inserted in 6" pipe and secured with wooden packings. The arrangement didn't have any standardised safety equipment like winch, free-fall arrester, stopper/ locking arrangement to prevent the rope from slipping off, etc.

1. For any lifting/ lowering jobs, suitable engineered mechanisms (like manual or power operated Brake Winch with free fall arrest system) shall be explored and used.

2. The JSA for erection/ dismantling of high-rise scaffoldings should include requirement of task specific rigging plan for manual lifting/ lowering of heavy materials specifying load limits, method & equipment to be used, communication protocol, competency requirement, etc. Usage of quantitative methods for risk assessment in JSA may be explored.
