MOISTURE PERFORMANCE AND VERTICAL MOVEMENT

MONITORING OF PRE-FABRICATED CROSS LAMINATE TIMBER –

FEATURED CASE STUDY: UBC TALLWOOD HOUSE

G. Mustapha, K. Khondoker, J. Higgins

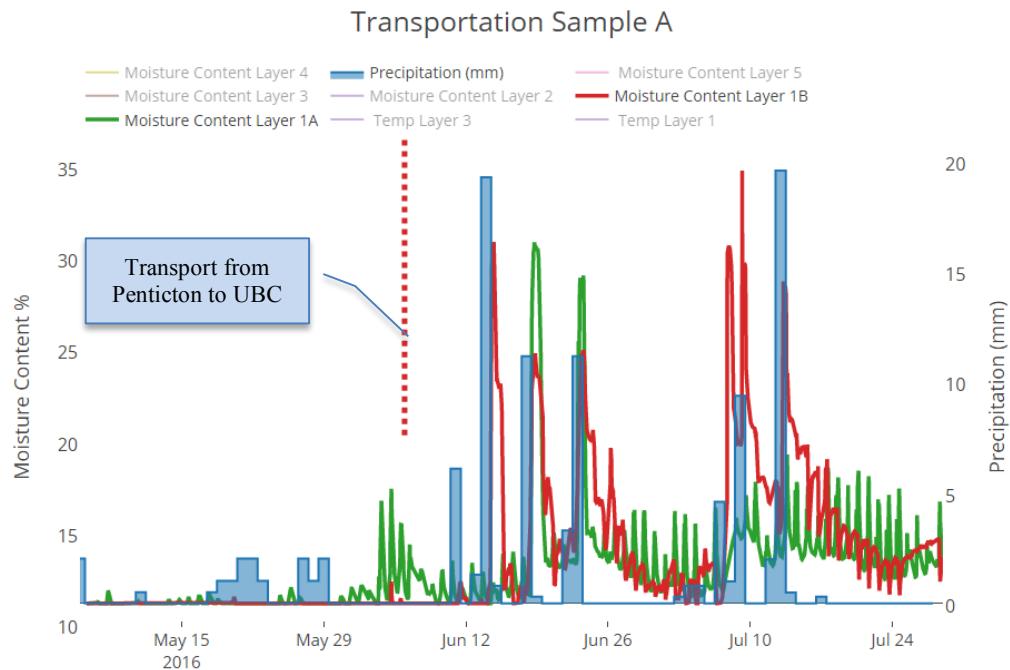
Figure 9: Analysis of Sample A during Transport

Data from Transportation Sample A which arrived and was uncovered to reflect the conditions of the CLT of the structure showed the effectiveness of the processes the CLT manufacturer implemented while storing and transporting the CLT panels for this project. As seen in Figure 9 prior to shipping, moisture levels in the CLT samples stayed very consistent and were did not appear to be exposed to moisture.

Once uncovered and exposed to a series of rainfall events, the effects can clearly be seen in a spike of moisture levels in the topmost layer of the sample. Data from the top layer of CLT is shown in Figure 9 with the dotted red line indicating the day of transport from Penticton to the building site at UBC. The rapid decrease of sample moisture demonstrated the drying ability of the fully-exposed CLT. These observations of the CLT are consistent with observations which were made in later analysis of the in-building moisture levels during construction.

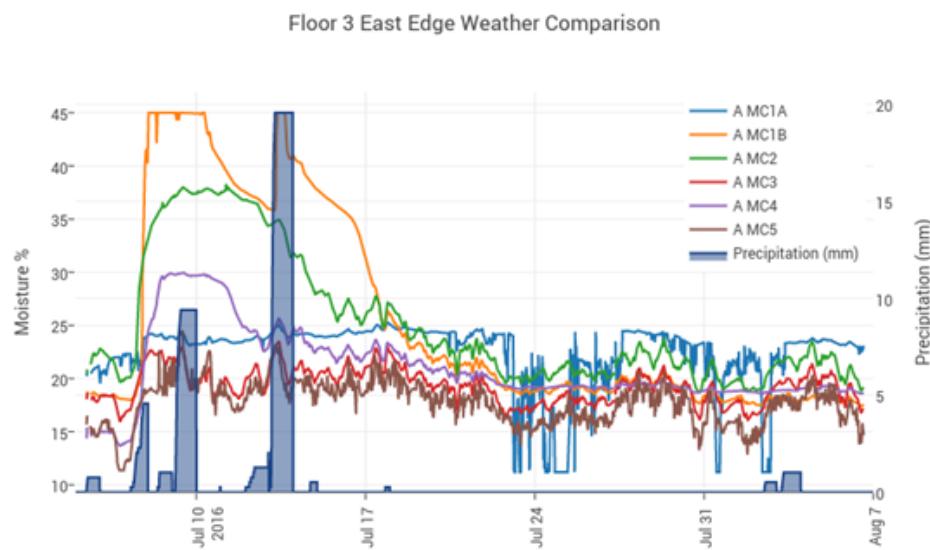
Figure 14: CLT Moisture Performance After Exposed Precipitation Event

As discussed in the transportation study and the previous section, the CLT panels within the building dried to acceptable moisture levels during the year-long monitoring. While collecting data during construction the data-collection units had to be removed and reinstalled several times to work within the schedule of other contractors. This process can be refined in the future with increased conversation between contractors and involvement with the sequencing schedule. In Figure 14 CLT moisture performance after an exposed rainfall event is shown

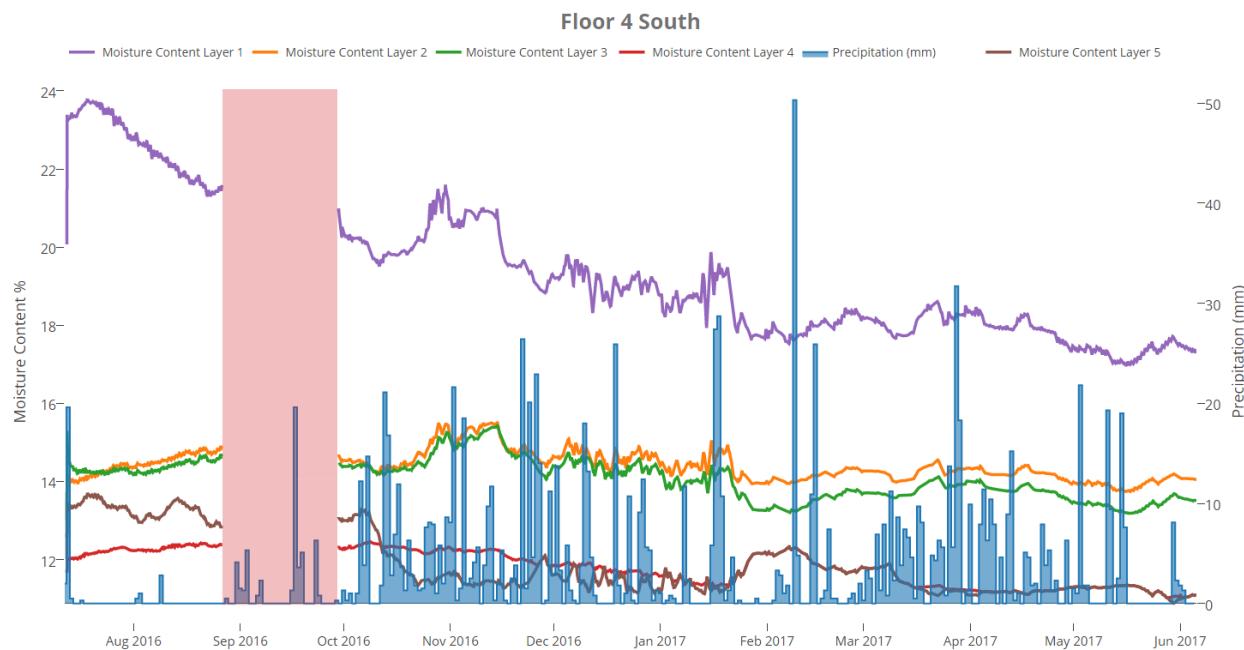
Figure 15: Year Long CLT Moisture Performance

Moisture performance of the CLT panels was analyzed with respect to these events as it was theorized that the CLT panels moisture levels would rise with the completion of the concrete floor topping. However, unless direct precipitation was in contact with the panels, the moisture levels did not change substantially. In event of direct moisture contact CLT panels would then quickly dry to acceptable levels. With the completion of the on-site water sealer used to improve the moisture protection of the CLT panels on-site and envelope panels, the overall moisture performance of the CLT panels became much more resilient to moisture. Year-long moisture performance of one location of the CLT is detailed in Figure 15.

In Figure 15, moisture data collected over the course of a year is shown with precipitation as represented by the blue bars. Despite periodic precipitation, the CLT continued to dry during construction and after the building had been closed. The red area is a gap in data due to removal and reinstallation of the data collection unit to work around other contractors.
