MOISTURE PERFORMANCE AND VERTICAL MOVEMENT

MONITORING OF PRE-FABRICATED CROSS LAMINATE TIMBER –

FEATURED CASE STUDY: UBC TALLWOOD HOUSE

G. Mustapha, K. Khondoker, J. Higgins

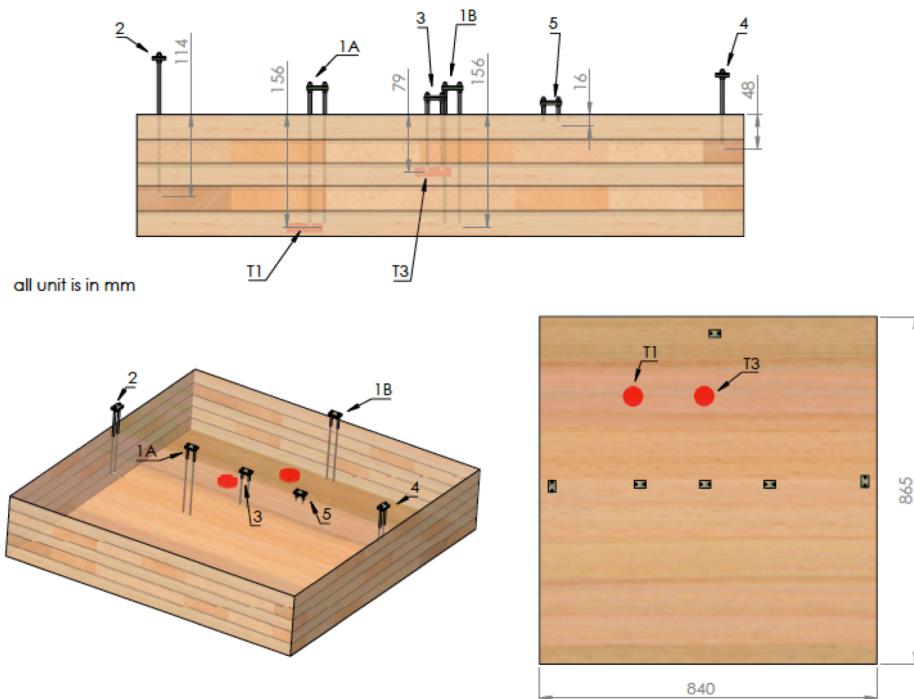
Figure 2: Probe Locations and Orientation

Detailed in Figure 2 a number system corresponding with drill depth was developed with #1 being the midpoint of the topmost layer and #5 being the depth of the bottom ply. Depths 1 and 2 utilized 200mm

probes, depths 3 and 4 110 mm probes, and 5 a 40mm probe. Thermistors were installed to depth 3 at the center of the panel, and to depth 1 at the top face.

The CLT panel grain orientation changes with each layer. Probes were installed parallel to the grain of the testing layer to gather consistent data.

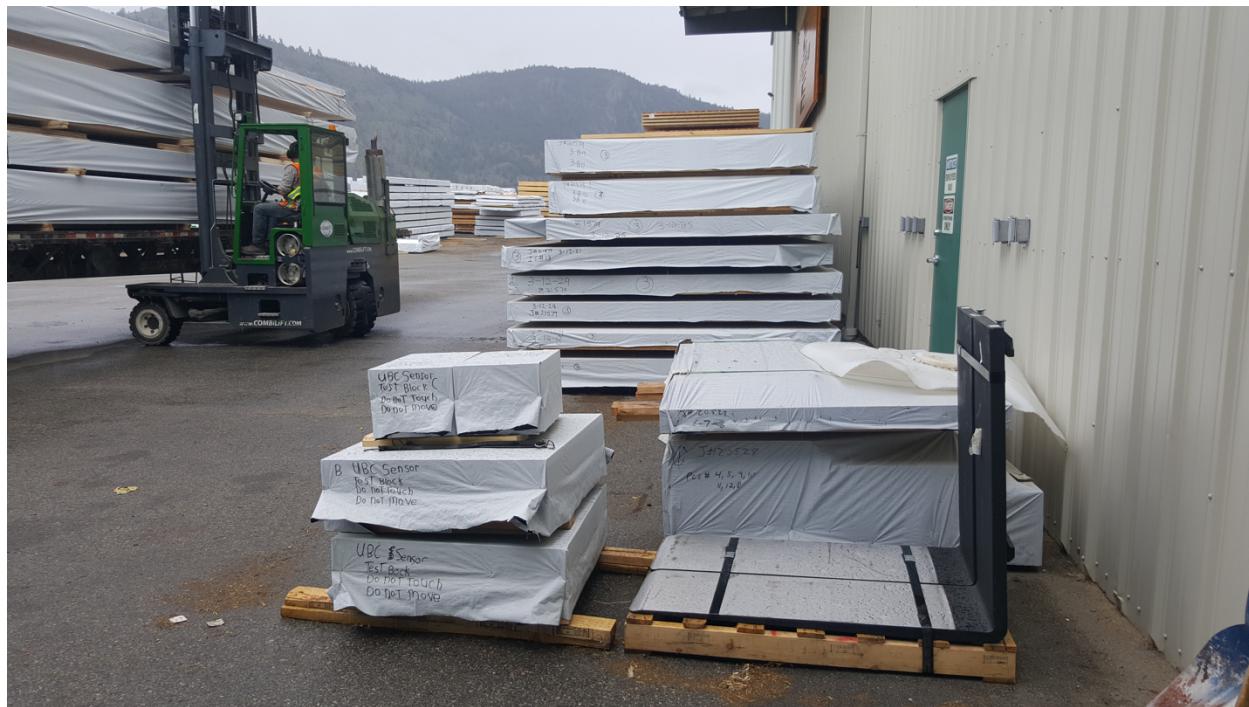
Figure 4: Off-cuts Stored outside alongside full size CLT panels

During the first trip, 2 large offcuts were outfitted with sensors, as well as 2 smaller CLT blocks. During the second trip, 6 large offcuts were instrumented and stored. All offcuts were coated with the same products and in the same manner as the full-size floor panels. The offcuts were then wrapped in plastic, stacked and stored alongside the full-size panels. Wood slats were placed in between each panel to increase airflow to the panels and prevent any potential moisture buildup, similar to how the full-size floor panels were stored.

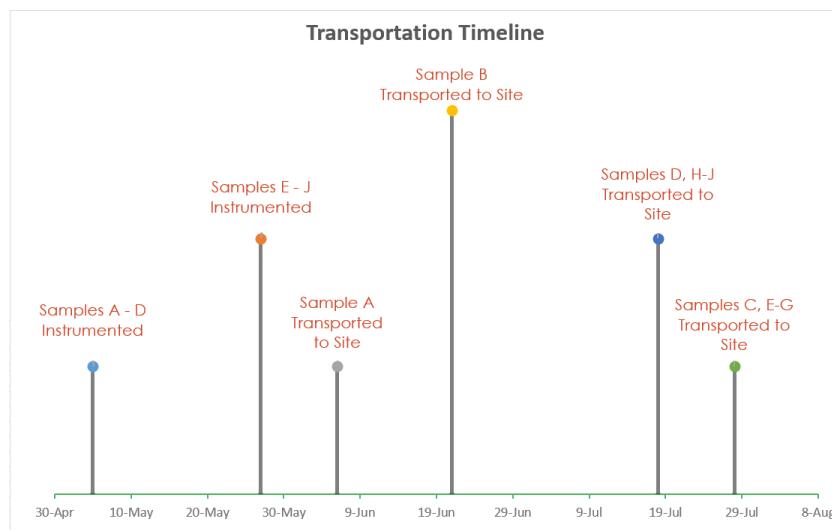
Figure 6: Transportation Timeline of Samples

The timeline and path of travel for the transportation CLT samples are as shown in Figure 6 and Figure 7 below. Samples were shipped with different floor panel shipments to create a diverse set of data with the possibility of varying environmental and logistical conditions.

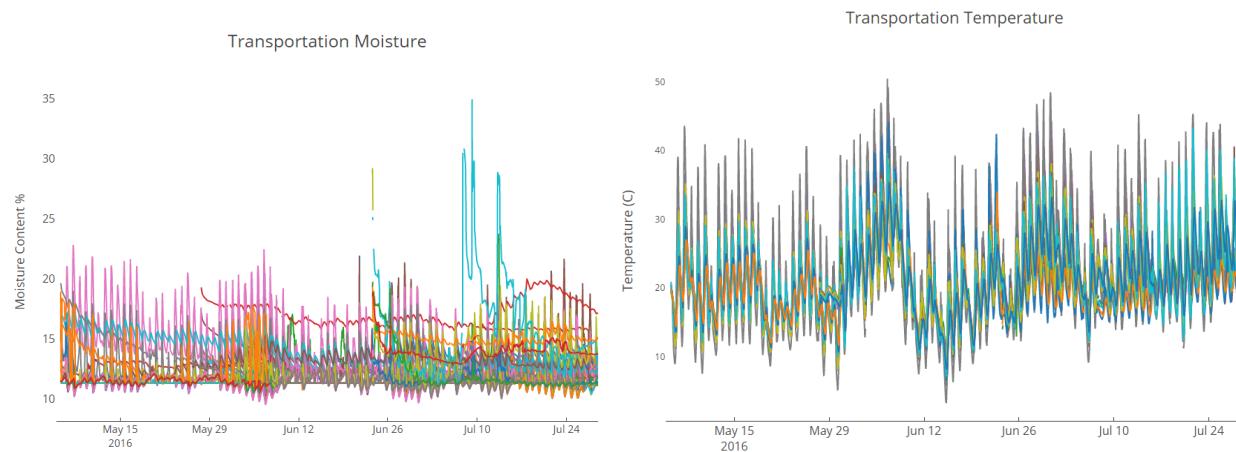
Figure 8: Transportation Moisture and Temperature Data

Moisture and Temperature data were collected by the wireless data loggers connected to each panel. These devices stored data regardless of where the sample was located and transmitted the data to the Internet upon arriving on-site. Results from 60 moisture content sensors at varying depths and 20 temperature sensors are shown in Figure 8.

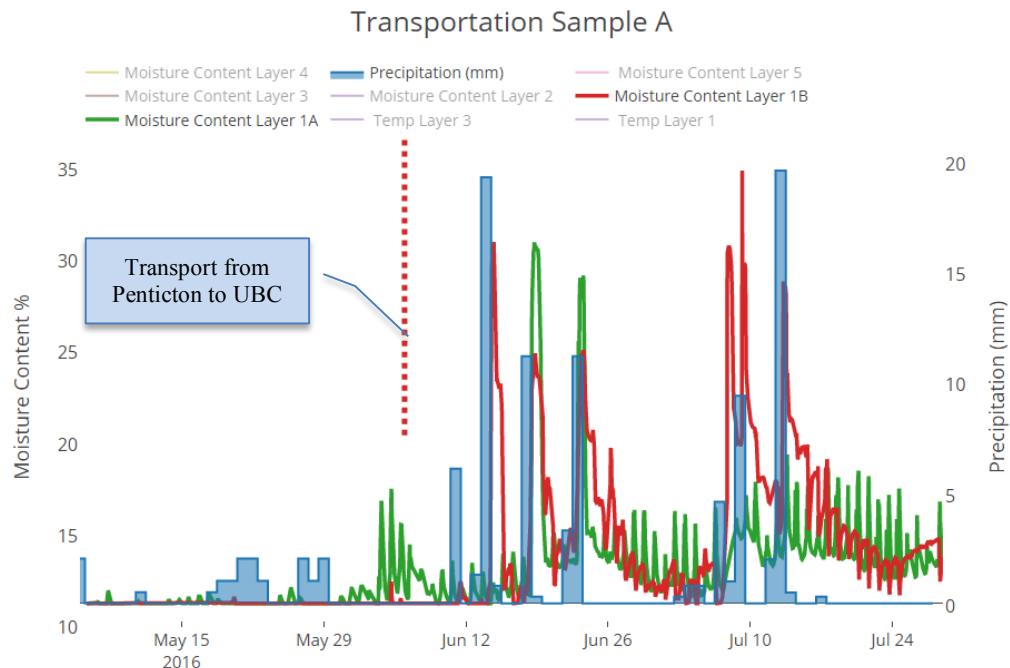
Figure 9: Analysis of Sample A during Transport

Data from Transportation Sample A which arrived and was uncovered to reflect the conditions of the CLT of the structure showed the effectiveness of the processes the CLT manufacturer implemented while storing and transporting the CLT panels for this project. As seen in Figure 9 prior to shipping, moisture levels in the CLT samples stayed very consistent and were did not appear to be exposed to moisture.

Once uncovered and exposed to a series of rainfall events, the effects can clearly be seen in a spike of moisture levels in the topmost layer of the sample. Data from the top layer of CLT is shown in Figure 9 with the dotted red line indicating the day of transport from Penticton to the building site at UBC. The rapid decrease of sample moisture demonstrated the drying ability of the fully-exposed CLT. These observations of the CLT are consistent with observations which were made in later analysis of the in-building moisture levels during construction.

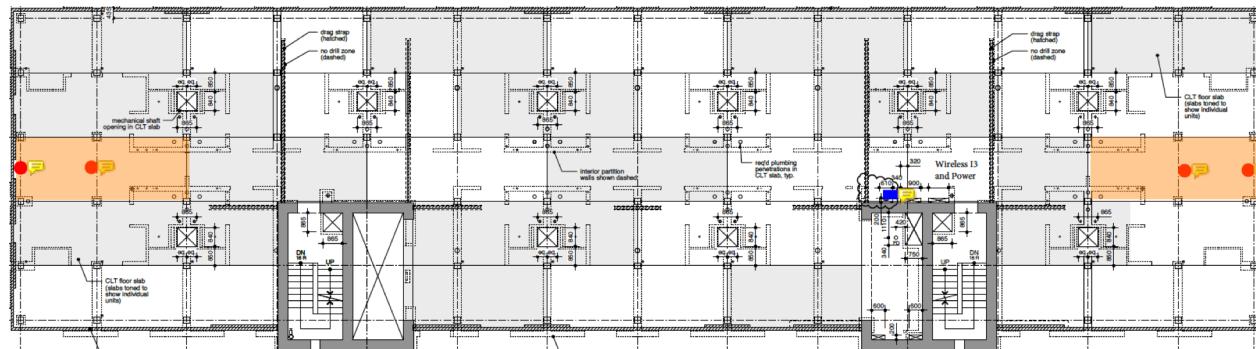
Figure 10: East West Moisture Monitoring Locations

Locations were selected with the intent of obtaining data representative of the majority of environmental and construction construction related factors that are present during different phases of construction. Instrumentation accounted for points accounted for points where CLT was uncovered, cement pours took place, floors changing from passive to active heating as active heating as the seasons shifted from summer to winter and material staging in the East wing. Recording a dataset that a dataset that will be representative of the entire building during occupancy was also considered as monitoring will will continue throughout the life of the building. Every second floor was monitored and areas alternated between North- between North-South and East-West locations as shown in Figure 10 and

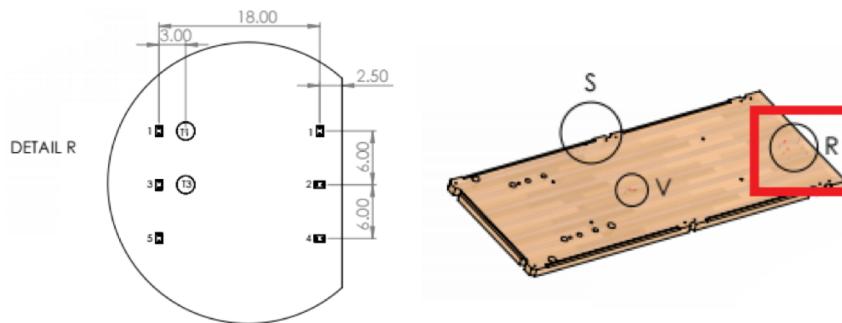
Figure 12: Edge Panel Moisture Probe Locations

Key considerations taken in the building study were that MC1B probes are in the plywood spline of non-edge locations. In edge installations MC1B measures moisture at the surface level as close to the edge of the panel as reasonably possible. These layouts are documented in the figures below

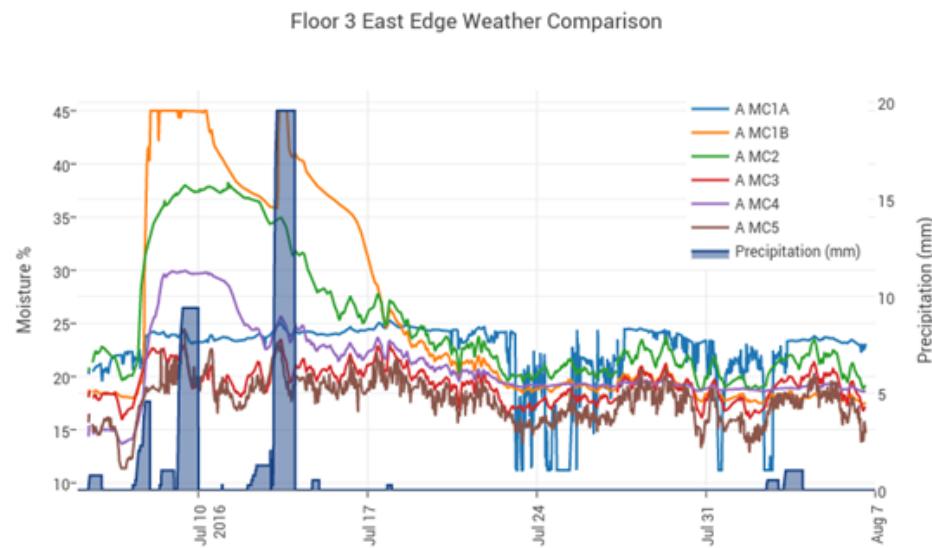
Figure 14: CLT Moisture Performance After Exposed Precipitation Event

As discussed in the transportation study and the previous section, the CLT panels within the building dried to acceptable moisture levels during the year-long monitoring. While collecting data during construction the data-collection units had to be removed and reinstalled several times to work within the schedule of other contractors. This process can be refined in the future with increased conversation between contractors and involvement with the sequencing schedule. In Figure 14 CLT moisture performance after an exposed rainfall event is shown

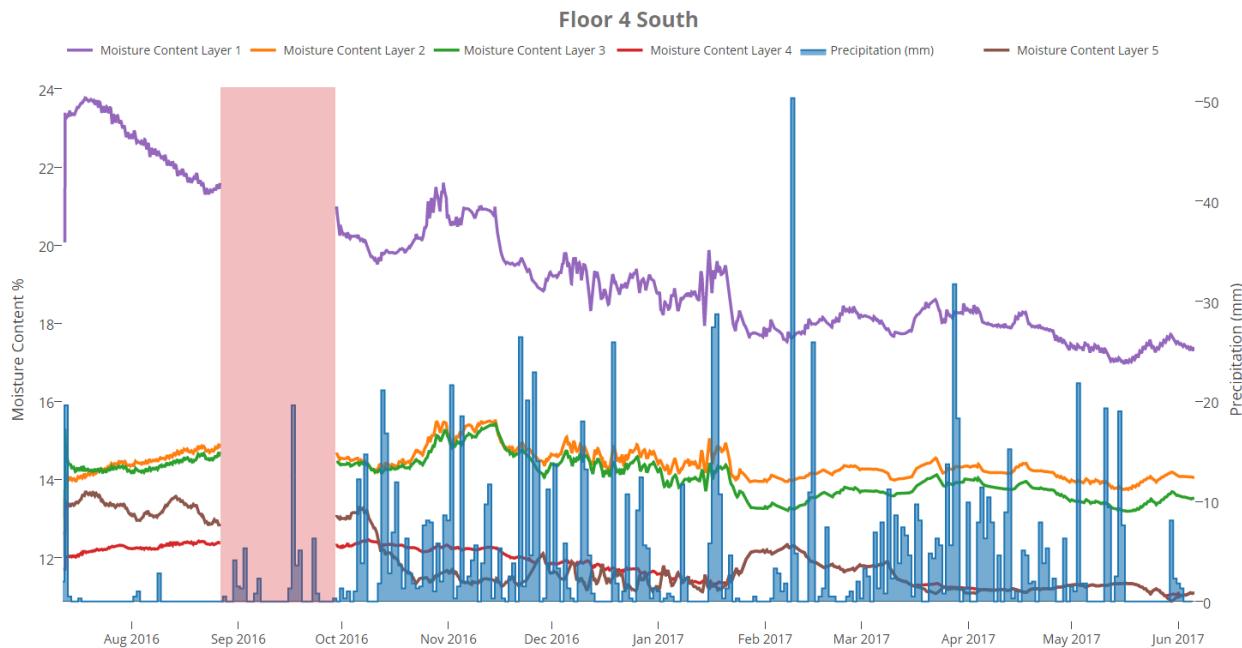
Figure 15: Year Long CLT Moisture Performance

Moisture performance of the CLT panels was analyzed with respect to these events as it was theorized that the CLT panels moisture levels would rise with the completion of the concrete floor topping. However, unless direct precipitation was in contact with the panels, the moisture levels did not change substantially. In event of direct moisture contact CLT panels would then quickly dry to acceptable levels. With the completion of the on-site water sealer used to improve the moisture protection of the CLT panels on-site and envelope panels, the overall moisture performance of the CLT panels became much more resilient to moisture. Year-long moisture performance of one location of the CLT is detailed in Figure 15.

In Figure 15, moisture data collected over the course of a year is shown with precipitation as represented by the blue bars. Despite periodic precipitation, the CLT continued to dry during construction and after the building had been closed. The red area is a gap in data due to removal and reinstallation of the data collection unit to work around other contractors.

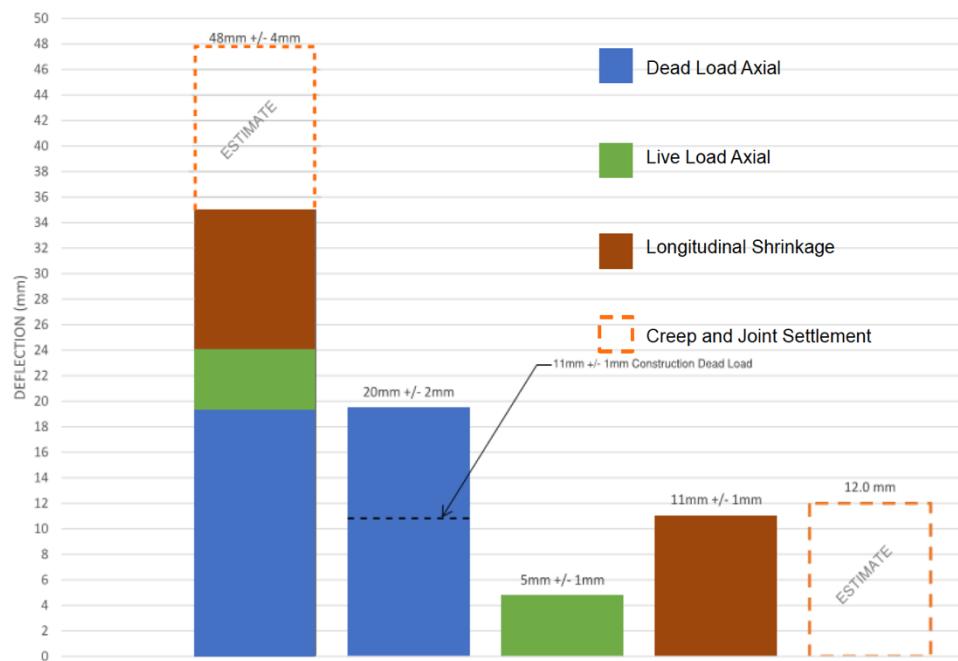
Figure 16: Column Shrinkage Estimation Calculated (Jackson, 2016)

The axial column shortening was calculated to be 48mm. Of this, an estimate of creep and joint settlement is 12mm as shown in Figure 16. (Jackson, 2016)

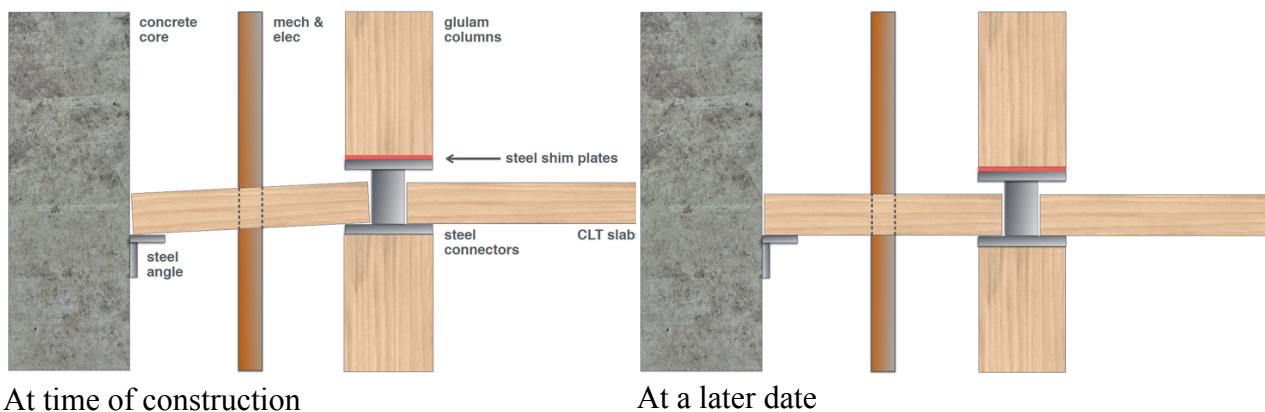
Figure 17: Setting Compensation in Structure Design (Acton, 2016)

The difference between the axial concrete core shortening and the timber shortening is calculated to be 24mm. Provisions for axial shortening were mitigated by offsetting the connections for the CLT slabs so that they will naturally align after the building settles. (Jackson, 2016)

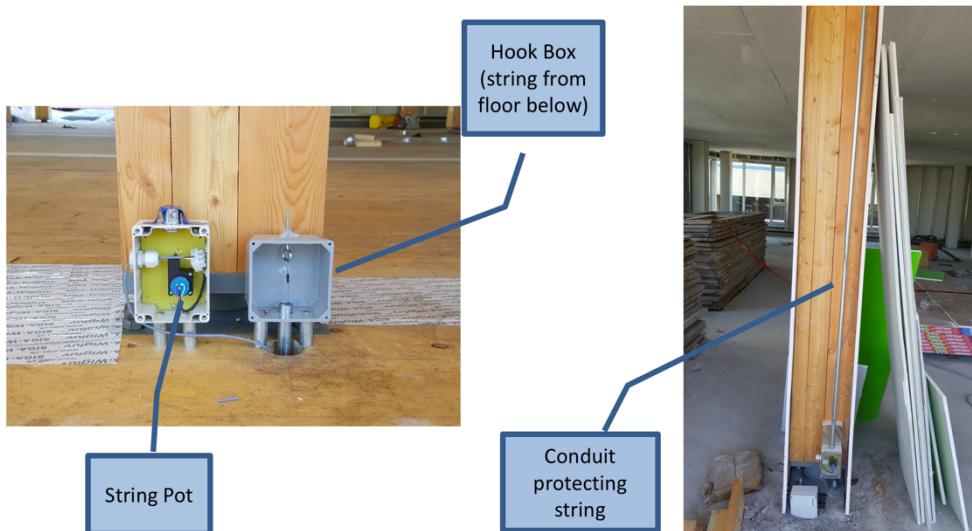
Figure 18: String Pot Units installed In Structure

The measurement method consists of using a string pot sensor that contains a cable actuated position sensor connected to a spring loaded spool. The string is elongated using downrigger stainless steel non stretch cable and connects from the base of a selected column to the top of the floor above capturing the compression of the CLT and wood column.

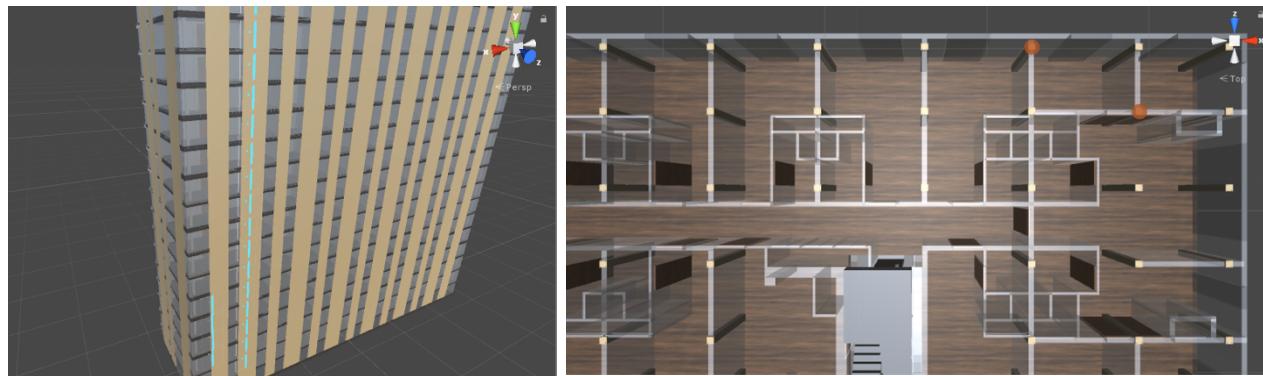
Figure 19: String Pot Locations

CLT columns from the base to the floor above were instrumented on the lower four inner floors and all exterior columns extending up all 18 floors. The locations are shown in Figure 19.

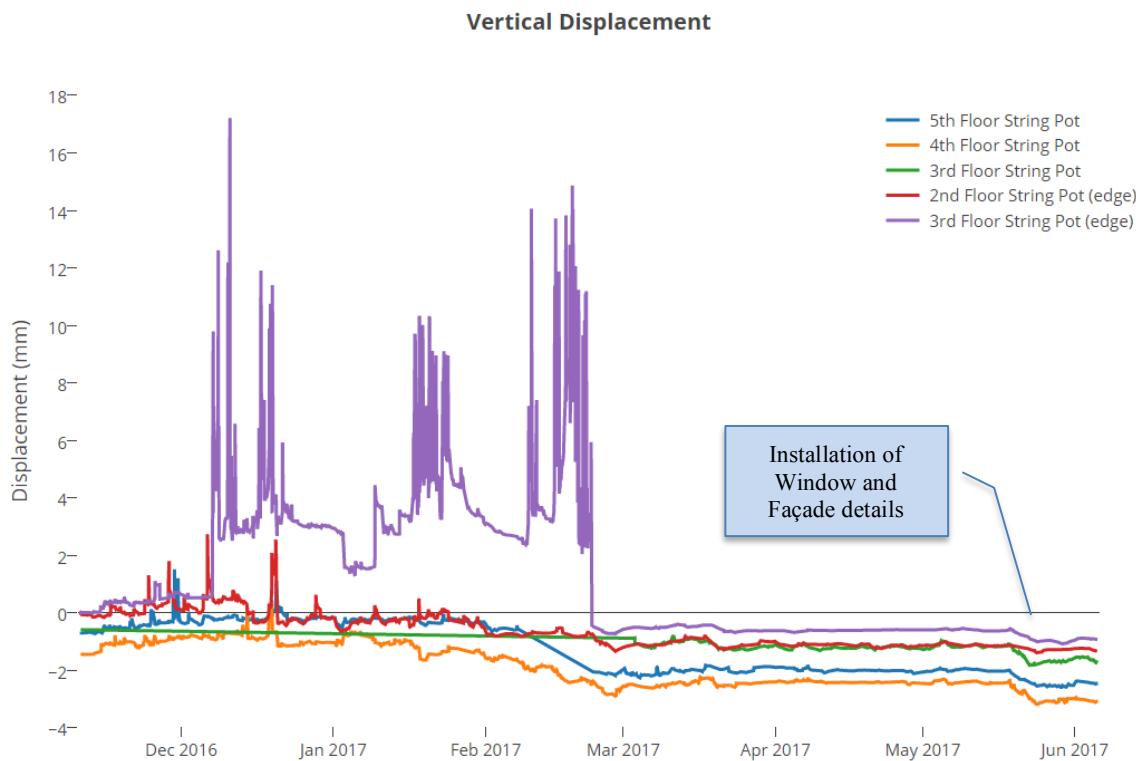
Figure 20: Vertical Displacement Sensor Data

Upon commissioning, the sensors started at 0 mm displacement; positive displacement indicates there was an expansion most likely due to the shoring; negative displacement represents vertical compression. Figure 20 shows the vertical displacement of selected string pot sensors during construction. Vertical displacement sensors were disturbed by shoring used to support outriggers during construction.

The shoring adversely affected the string pots while it was installed however after it was removed it did not appear to offset or skew the measurements. The edge columns and inner columns tracked each other as expected and the displacement on the outer column was less than the inner column as expected. Approximately 1mm displacement was observed on all floors in May 2017, this occurred when the window and façade details were completed on the end units after the outriggers were removed.
