Home Inspection Report

PROPERTY INSPECTED:
1713 Hilltree Drive
Anderson Twp, OH 45255

Date of Inspection: 07/05/2023

Inspection No. 24114-13045

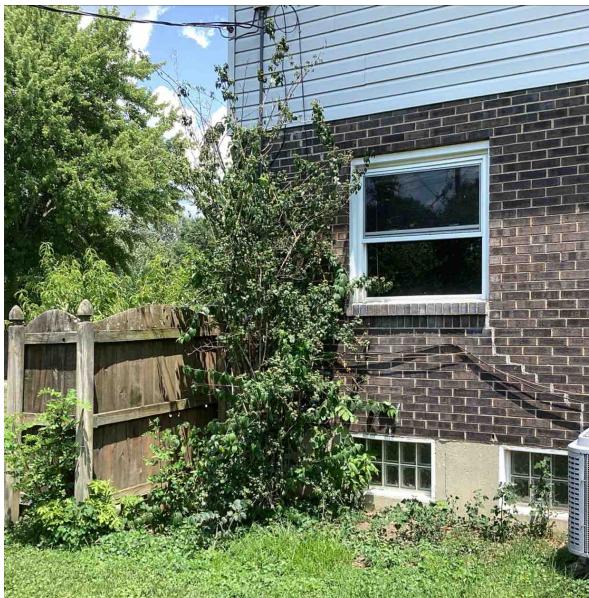
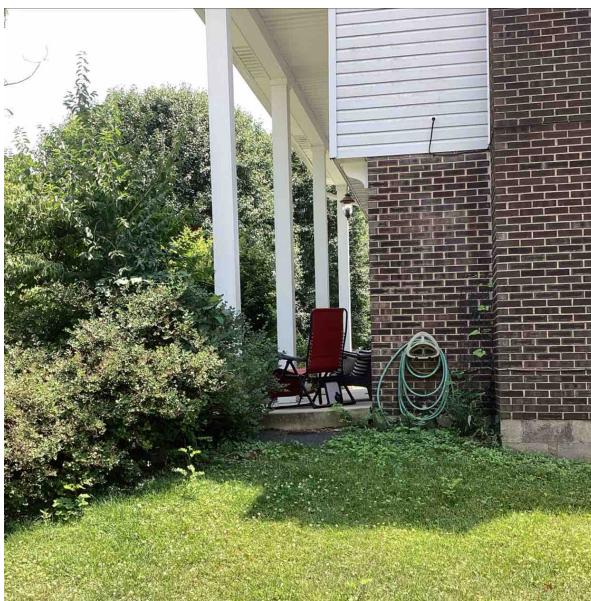
2.3.1 Trim vegetation away from the home to minimize damage / wear and to limit insect, rodent and animal access.

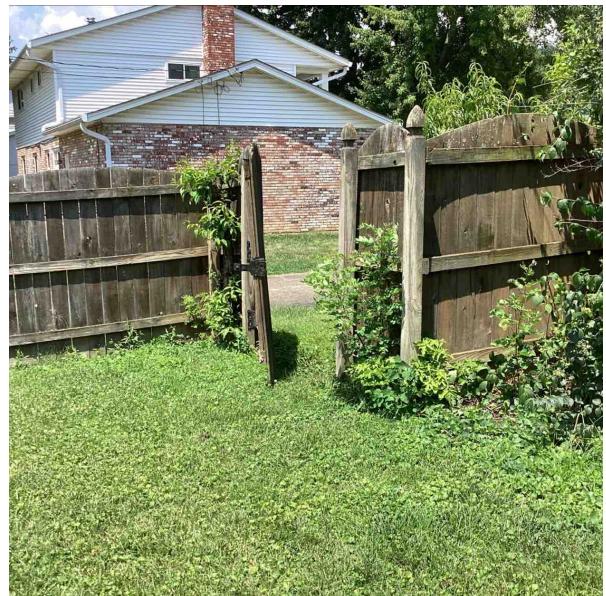
2.3.2 Fence gates are both sagging and difficult to operate. Corrections needed (**Exterior Rear**)

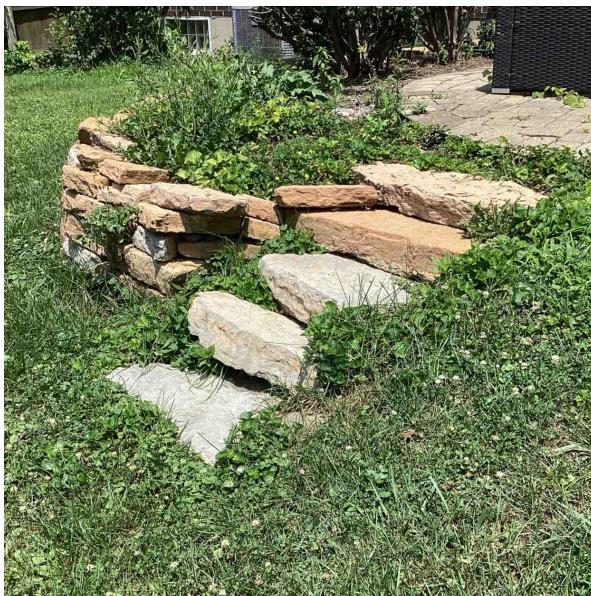
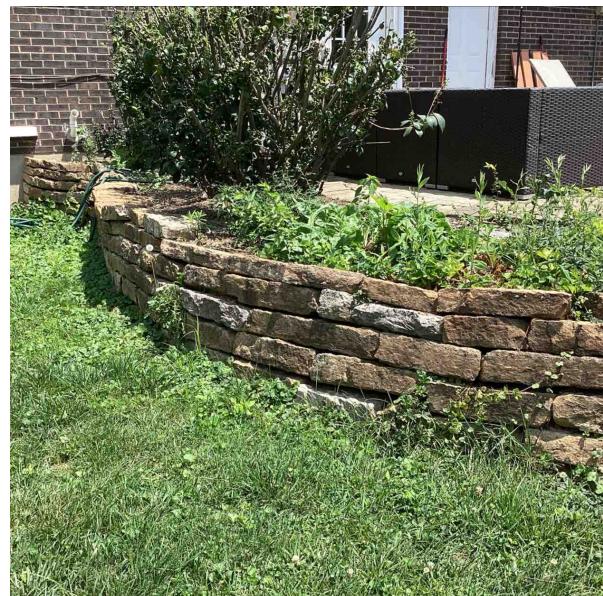
2.7.1 Stone retaining wall and steps are leaning. Recommend repairs (**Exterior Rear**)

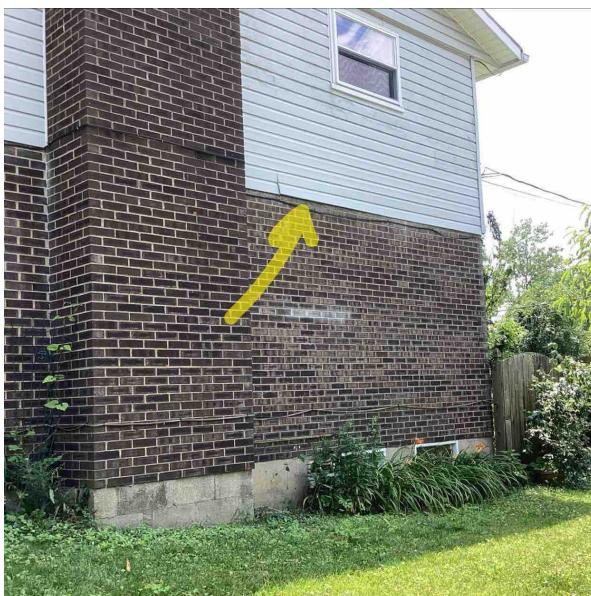
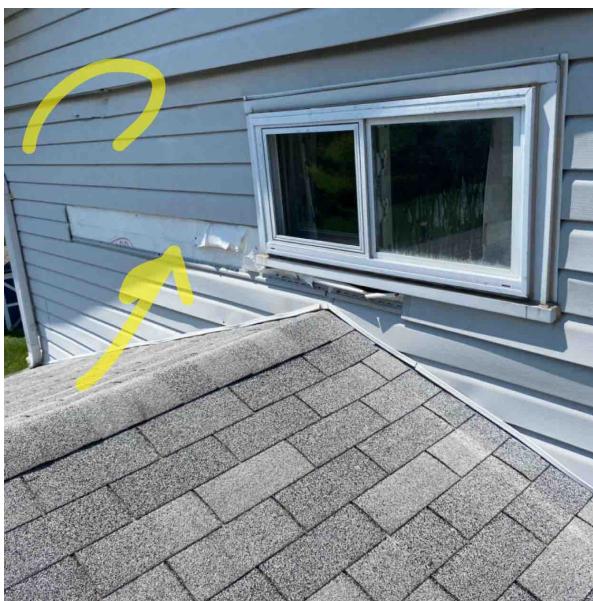
- Exterior Front
- Exterior Left
- Exterior Right

3.3.1 **Loose and missing pieces of siding observed. Recommend repairs where needed.**

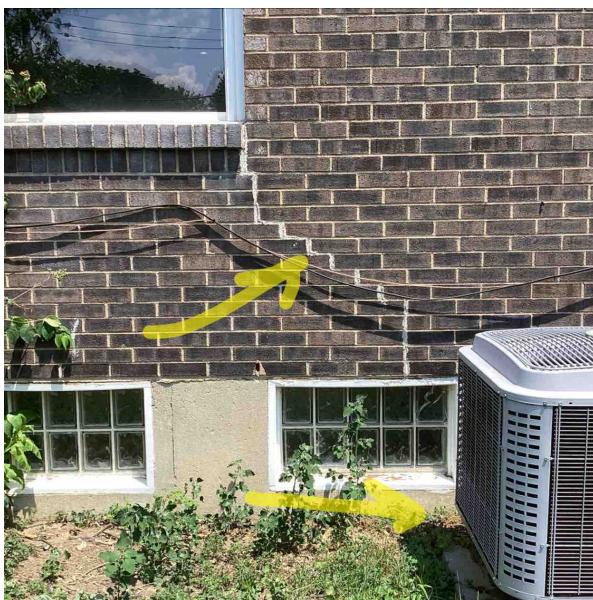
3.3.2 Cracked brick siding and foundation below rear breakfast area window indicates settling. Cracks have been sealed with no visible evidence of re-opening. Confirm details with seller and obtain any documentation related to past repairs. Maintain grading, vegetation around the home and proper gutter/downspout drainage,. Monitor for changes and consult a foundation contractor to evaluate and repair as needed (**Exterior Rear**)

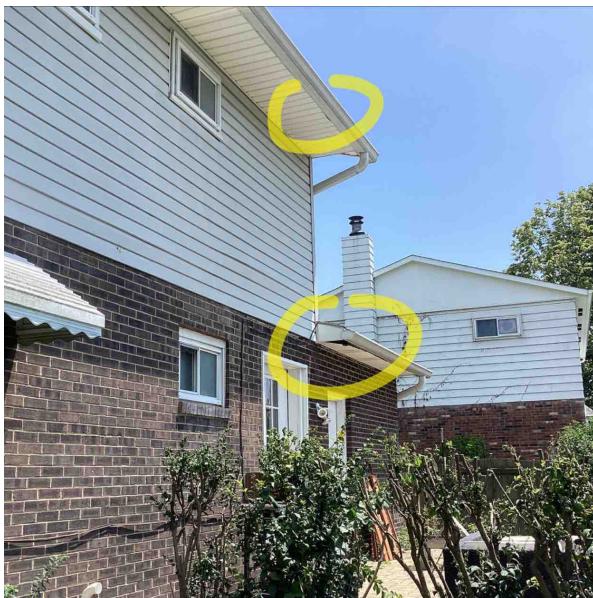
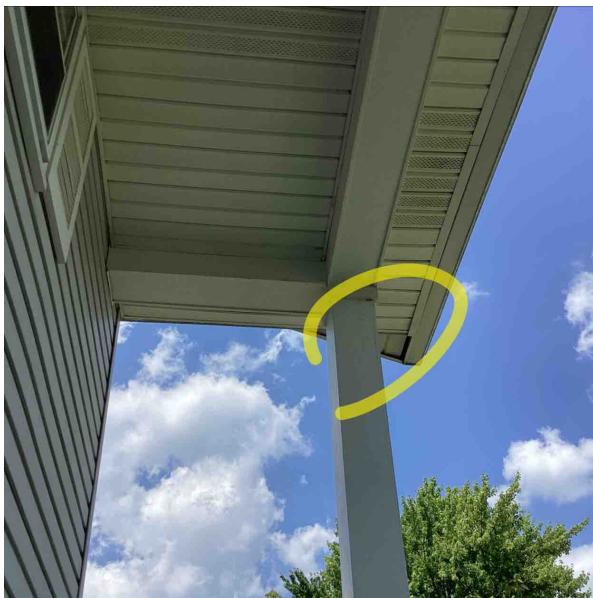
- Exterior Front
- Exterior Rear

3.4.1 Sections of fascia/soffit are loose. Secure fascia and soffit and seal all gaps to help prevent further damage and unwanted pest entry.

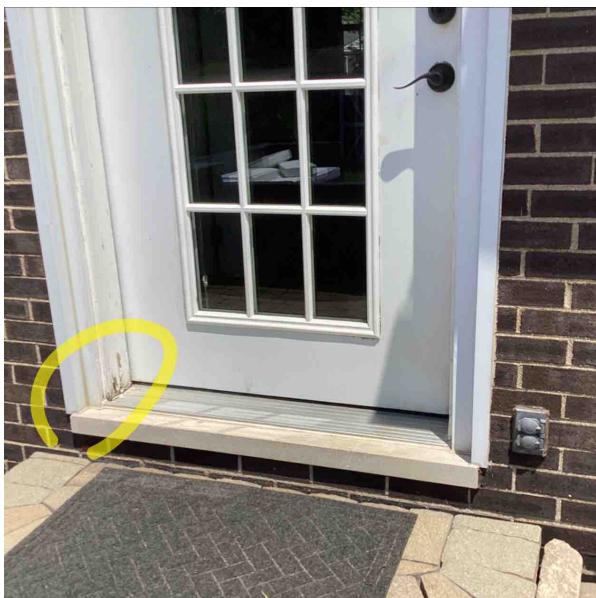
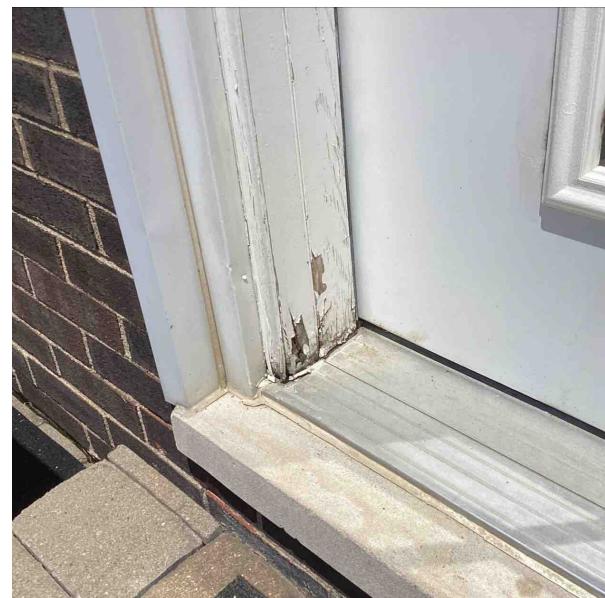
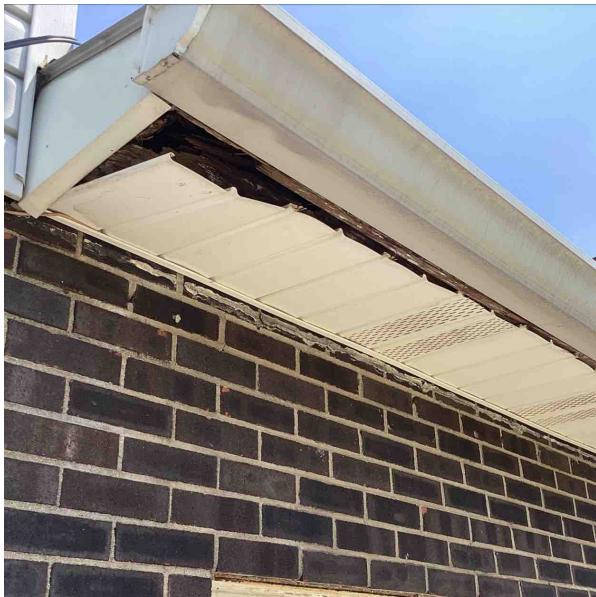
3.5.1 Peeling paint noted on exterior wood trim and / or paneling. Moisture damage at patio door trim and rear soffit. Recommend repairs, repainting where needed. (**Exterior Rear**)

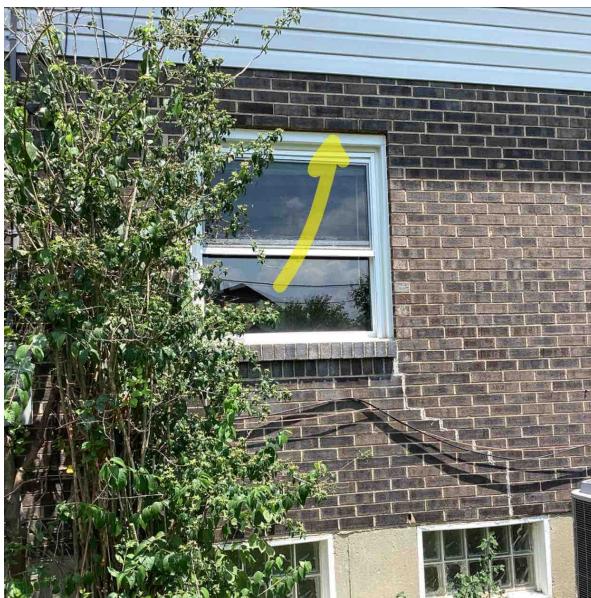
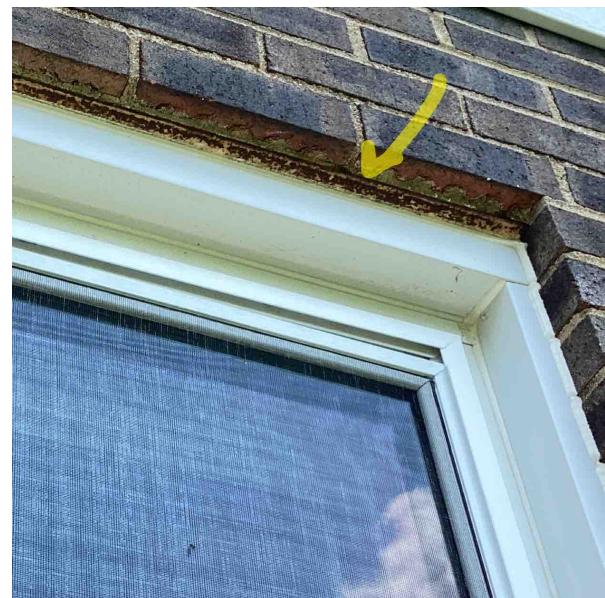
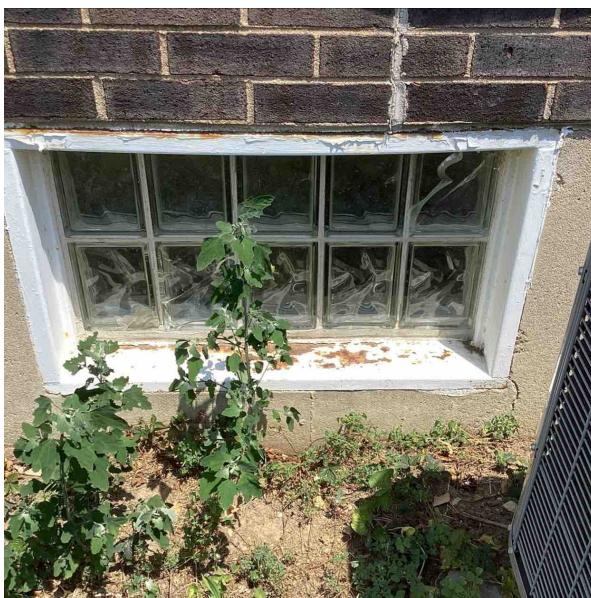
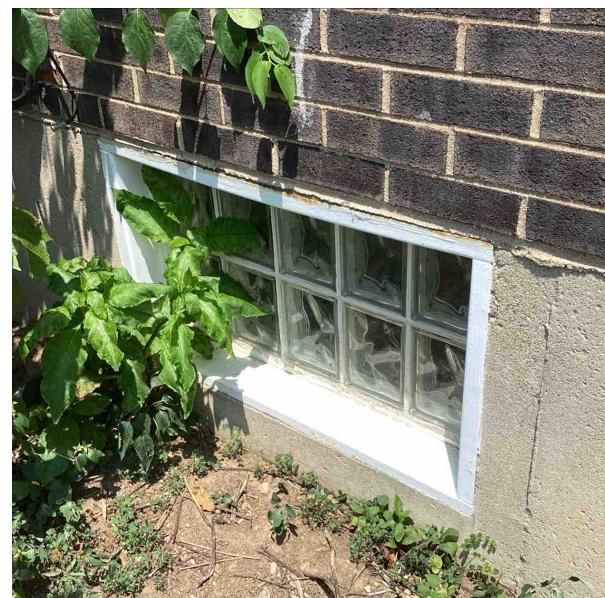
3.6.1 Rust at window lintels and steel frames for basement windows. Recommend preparing and painting all exterior steel lintels over windows and doors to reduce further rust, deterioration/expansion of steel, subsequent risk for damage to siding and moisture penetration to concealed areas (**Exterior Rear**)

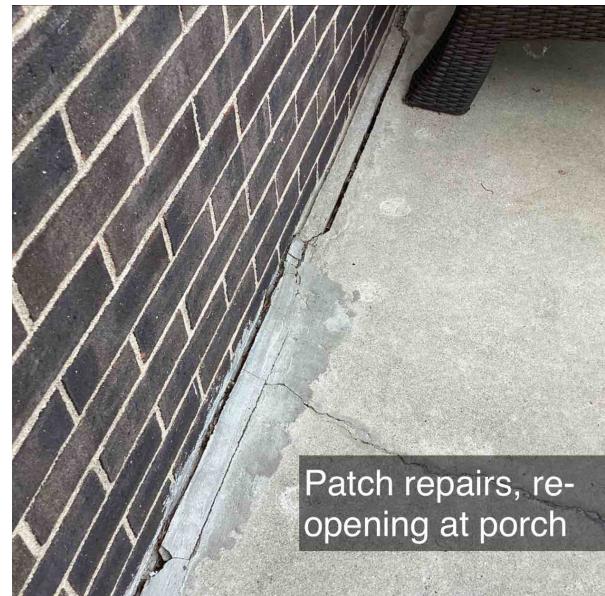
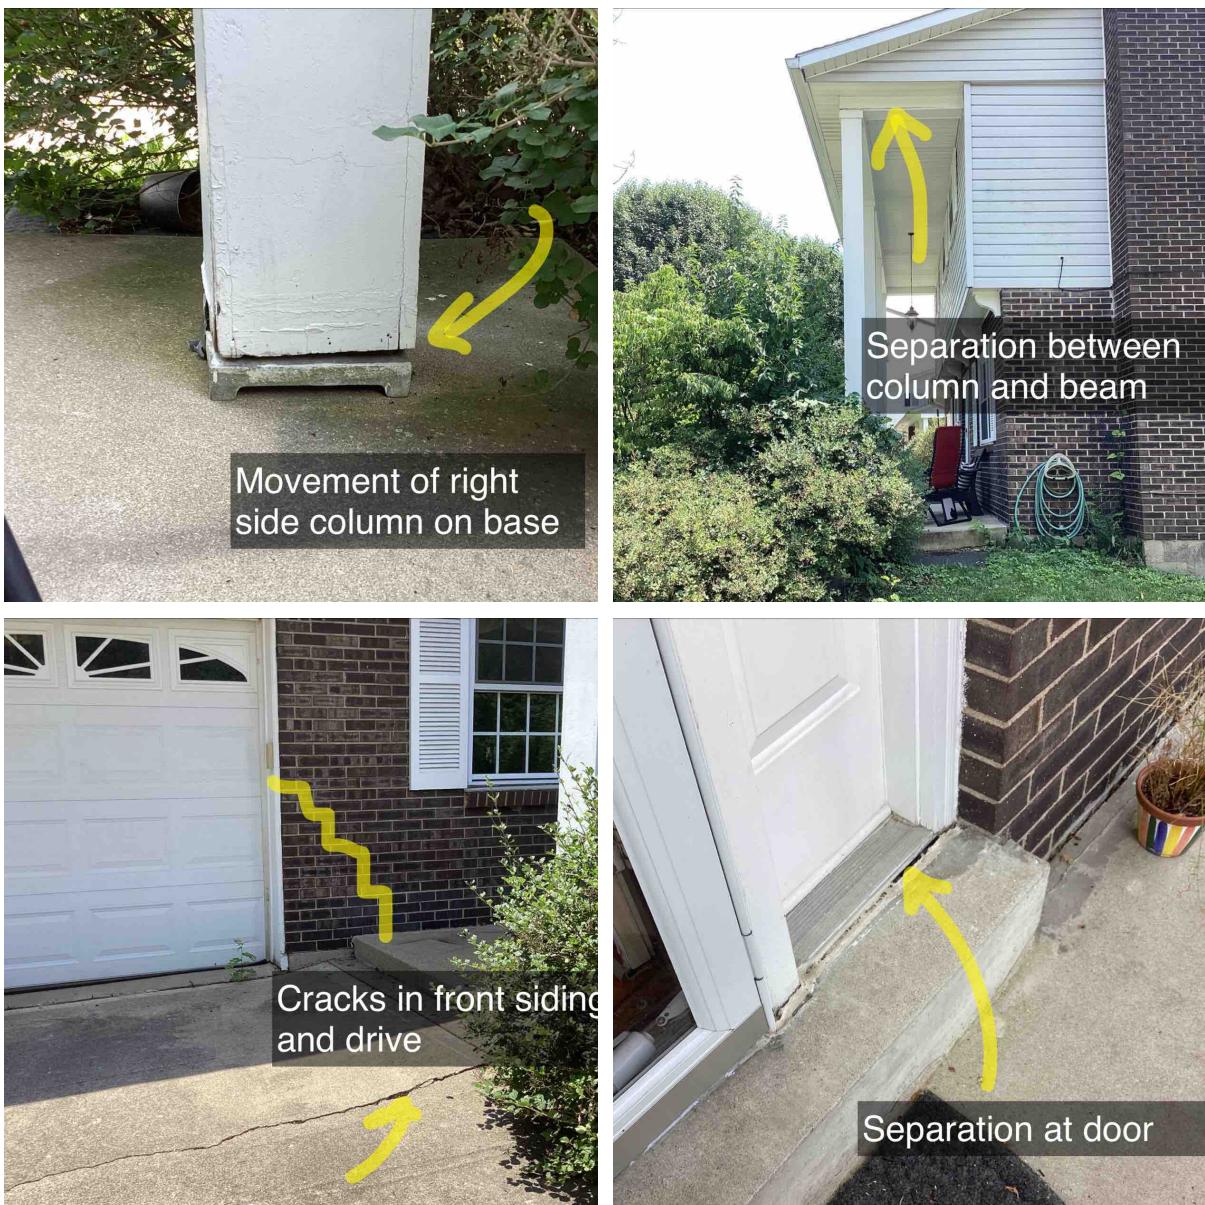
3.8.1 Front porch shows cracking and settling away from the front of the home; has affected front door installation and upper column/beam; recommend having a foundation contractor or structural engineer further evaluate to determine scope and costs of any action/repairs needed (Exterior Front)

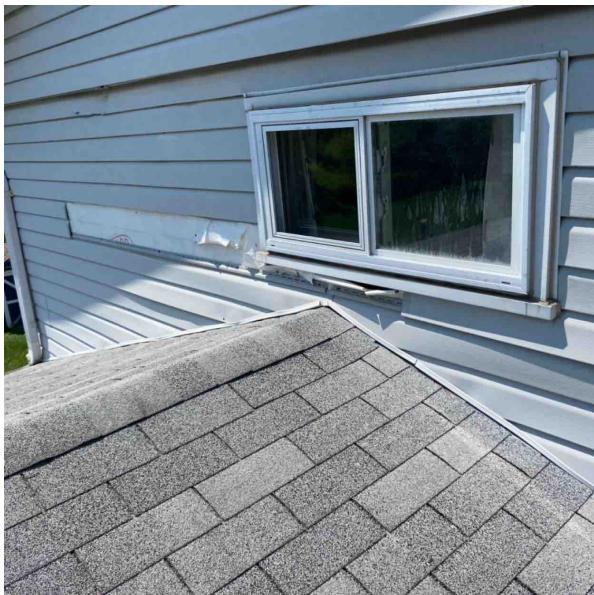
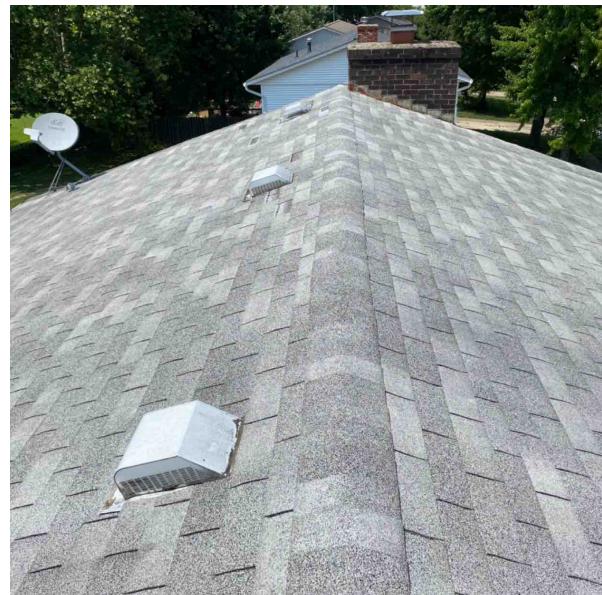
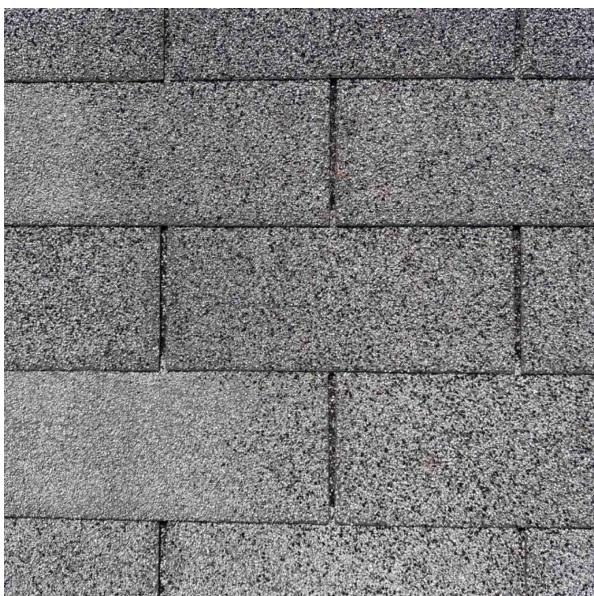
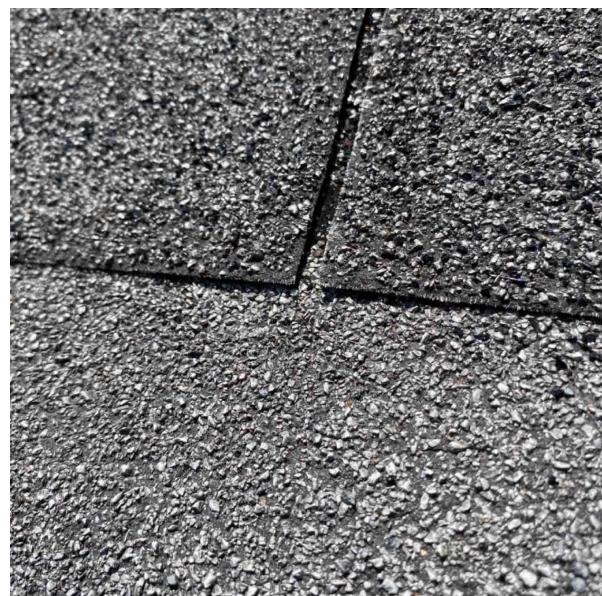
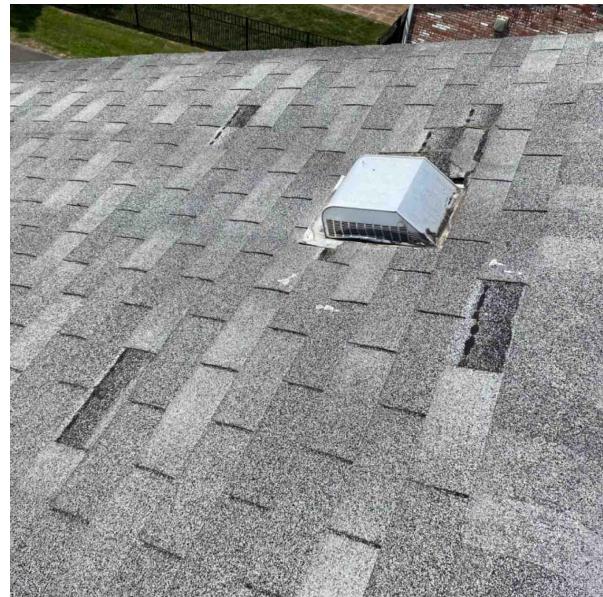
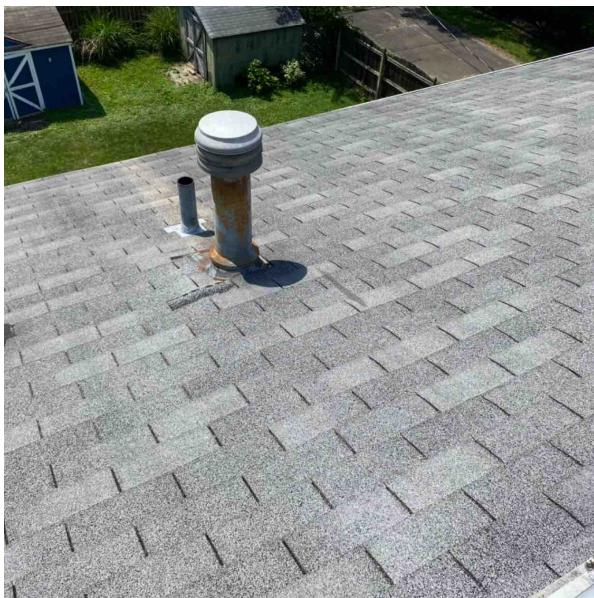
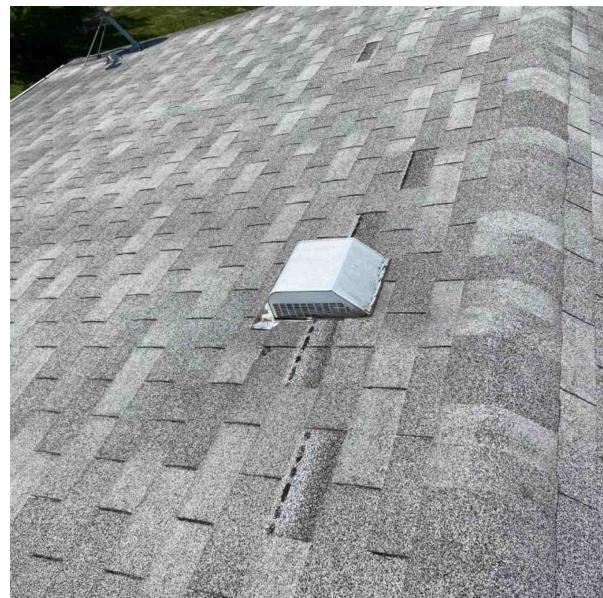
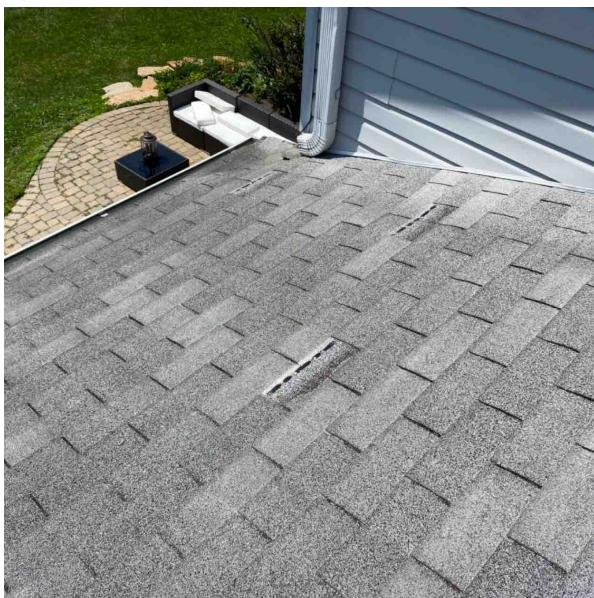
**4.4.1 The roof surface is at the end of its useful life expectancy with many damaged or missing shingles, damaged roof decking noted. Staining indicating leaking over right side bedroom.
Recommend having a roofer further evaluate for replacement (Exterior Front)**

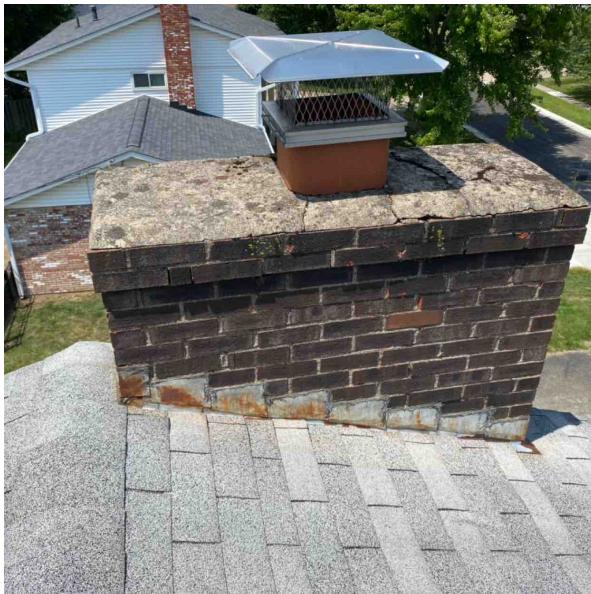
4.6.1 The chimney cap is cracked and deteriorated. If the cracks and deterioration of the chimney crown is left unrepairs the chimney structure could be affected. Insulation and flashing present closing off fireplace flue indicates past issues or damage. Recommend a certified chimney contractor further assess for repair. Due to conditions present, additional defects may be identified and need repaired. (Exterior Right)

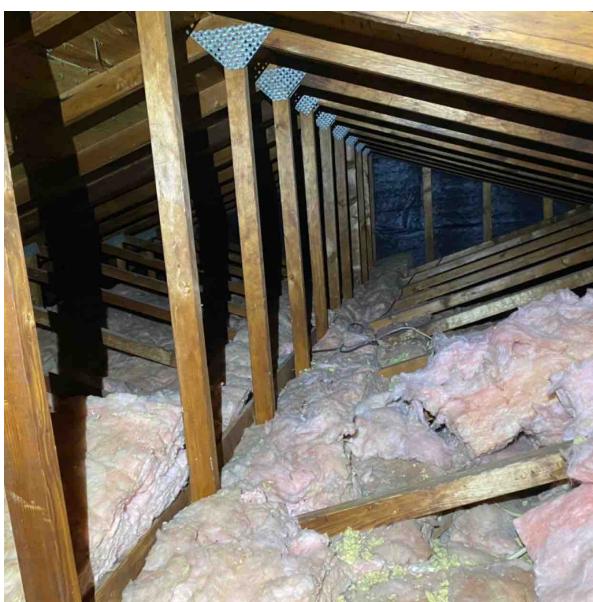
5.1.1 Attic inspection was limited due to insulation cover, limited space under and around framing and low height clearance in soffit areas. Some attic structure, electrical and HVAC ductwork is concealed and not visible for inspection

5.1.2 View of attic space

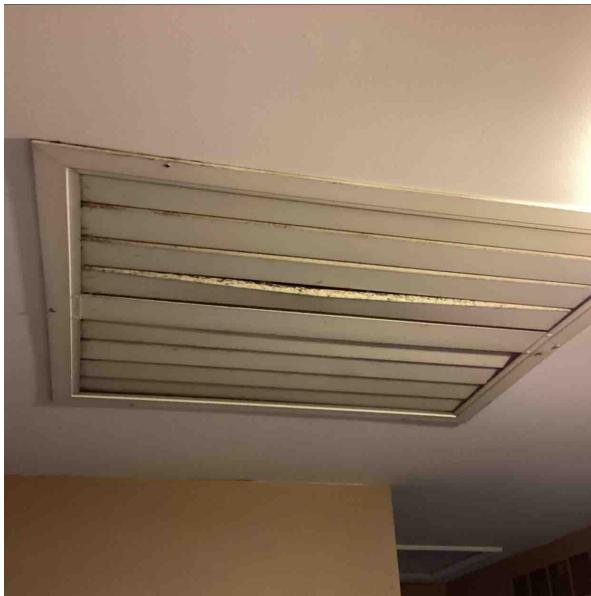
5.3.1 Whole house fan could not be tested. No switch found. Confirm details with seller (**Hallway**)

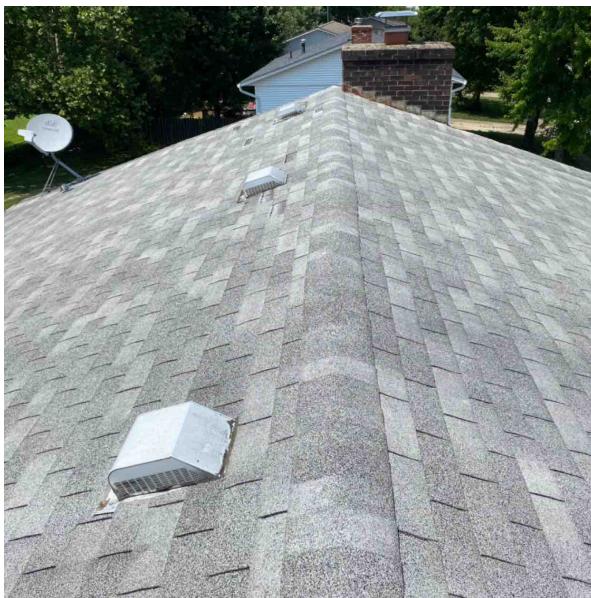
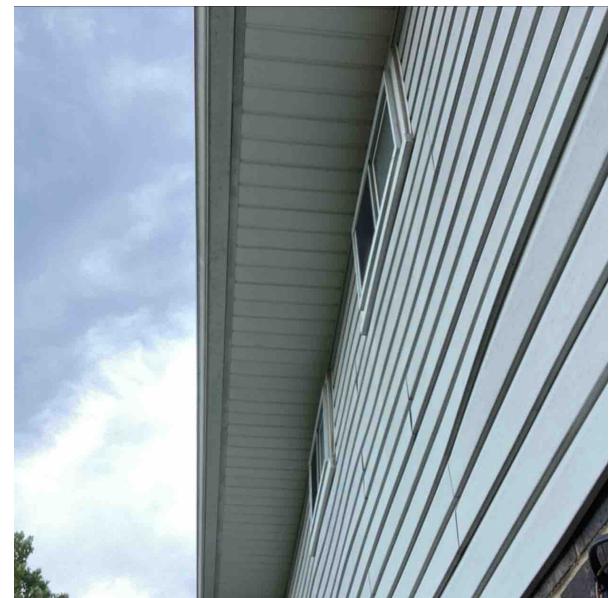
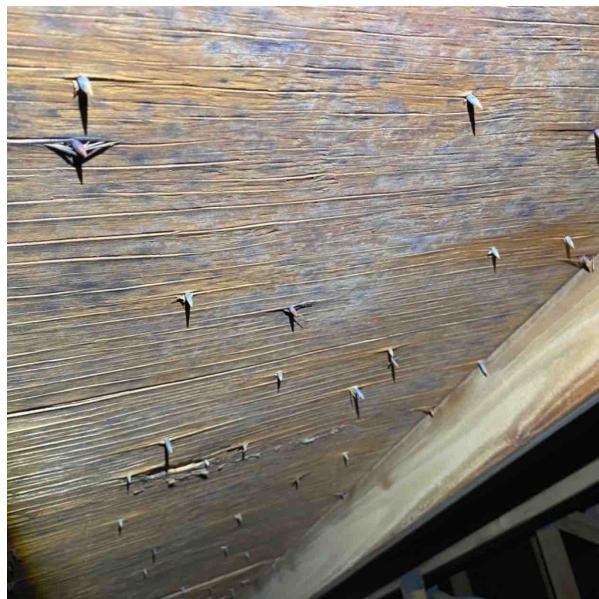
5.3.2 There are no soffit vents at the upper roof. No roof vents at lower roof. Without being paired with soffit vents, the roof vents will not perform as intended. Stains in attic indicate heat buildup. Expect costs for updates at next roof replacement

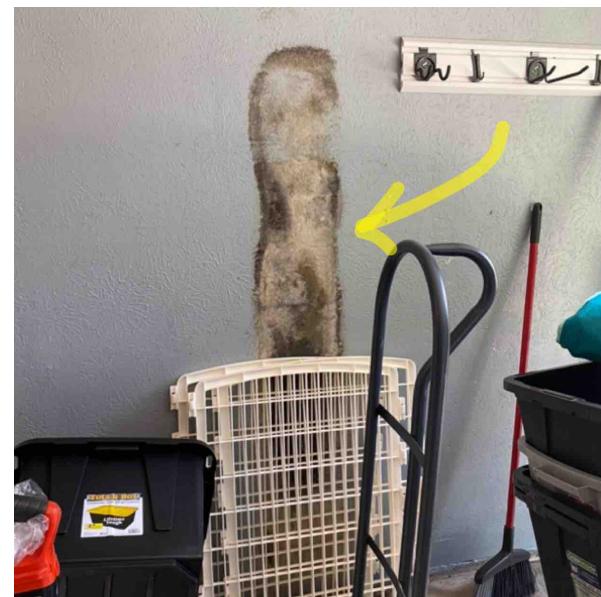
6.3.1 Potential mold, staining on wall in garage. Appears to be due to ductwork running through this wall, condensation due to differing humidity/temperature levels. Areas measured dry with a moisture meter. Recommend further evaluation by an HVAC professional to determine any action needed. Mold sampling should be considered to determine if any cleanup is needed (Garage)

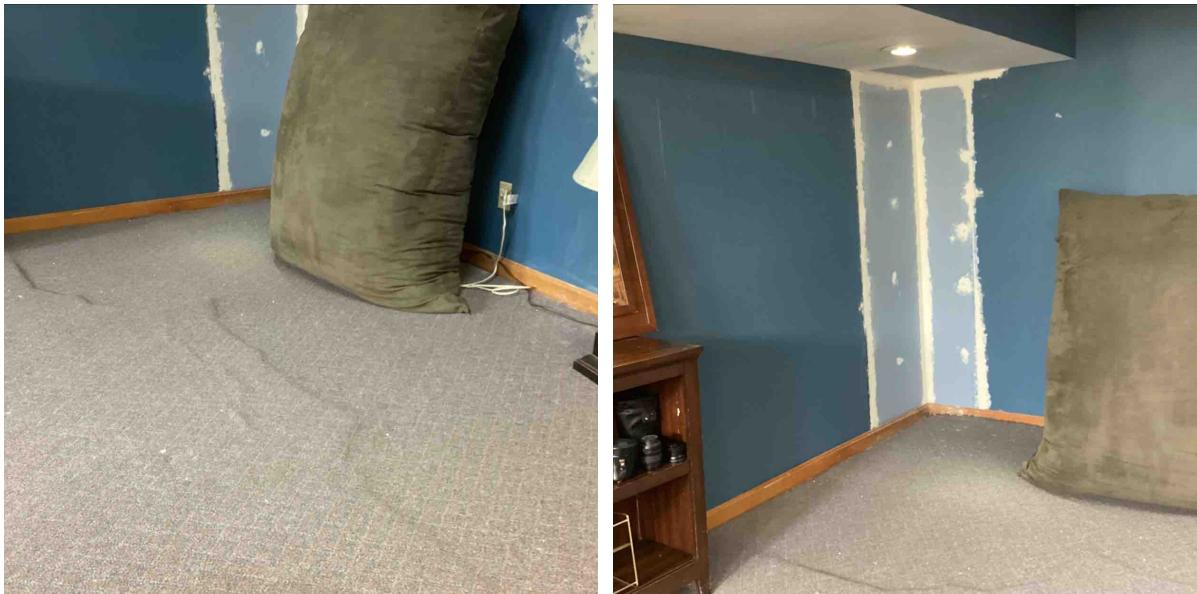
7.3.1 Patch repairs at front finished basement, removed carpet tack strip and pad indicating potential past water issues. Confirm details with seller. Recommend obtaining any documentation. If no documentation is available, recommend further evaluation by a foundation contractor (Basement)

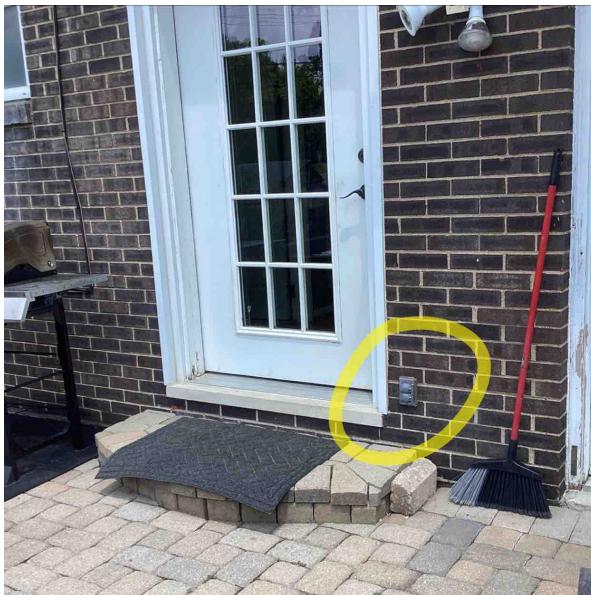
8.8.1 Open ground condition noted on receptacles. Recommend having an electrician further evaluate and repair for safety

- Dining room
- Front Bedroom
- Patio
- Primary Bathroom
- Primary Bedroom

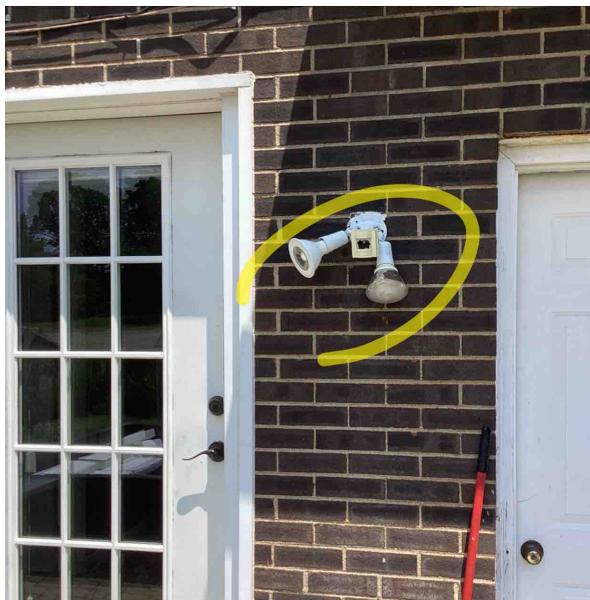
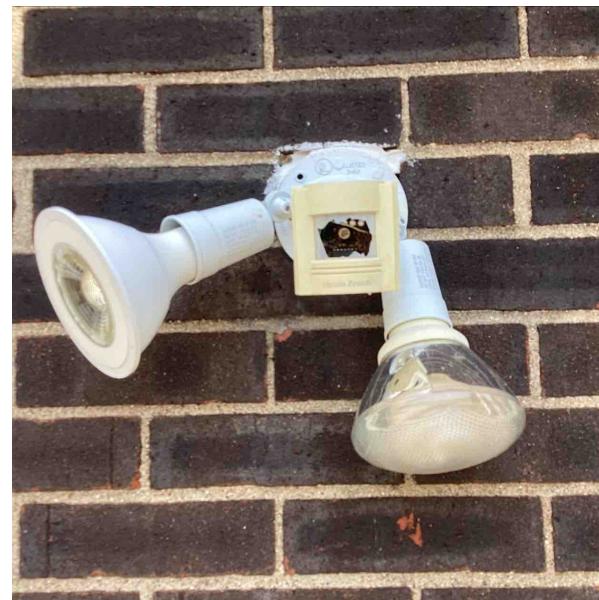
8.9.1 Broken lens at rear patio light. Recommend repair or replacement as needed (**Exterior Rear**)

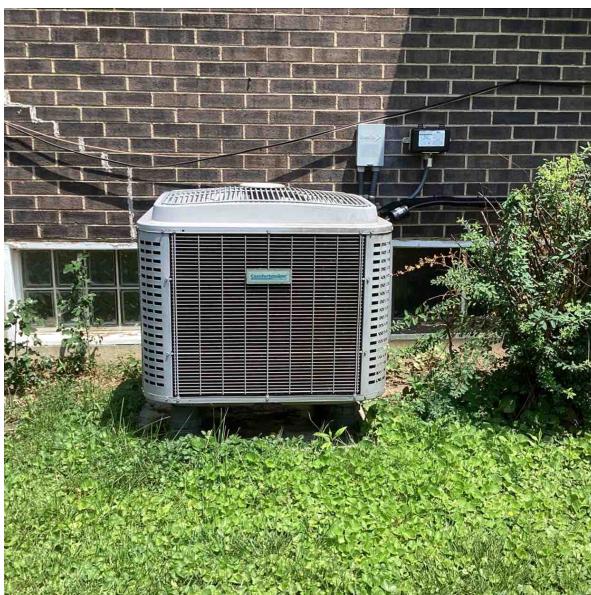
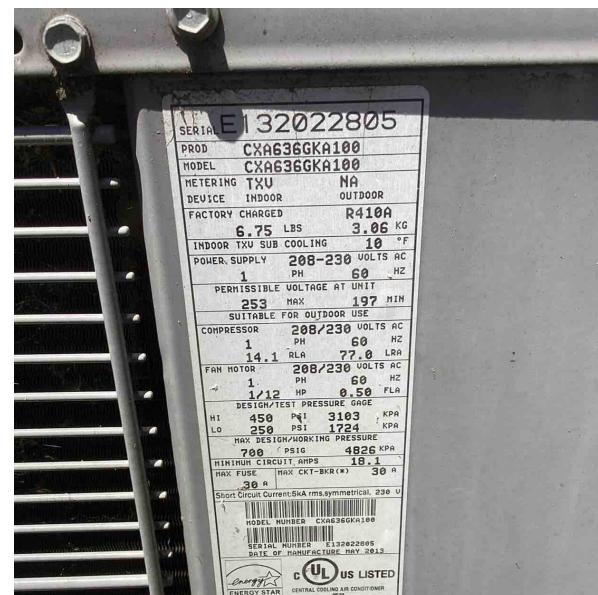
9.4.1 2013 International Comfort (Exterior Rear)

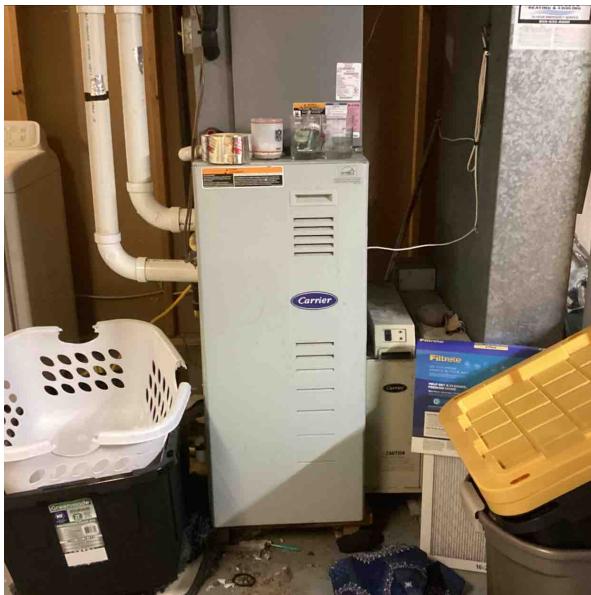
9.5.2 2000 Carrier

The furnace is at the end of a typical service life (**Basement**)

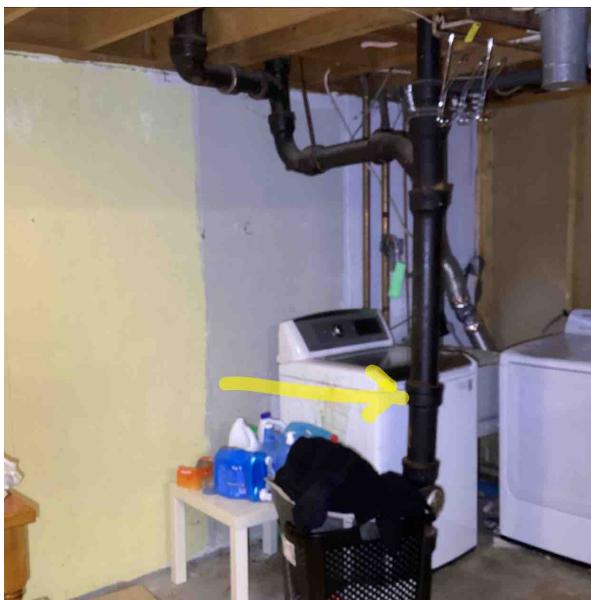
10.4.1 Cast iron waste drainage pipe is present. Cast iron is known to rust from the inside as it ages. No leaks observed, but costs for updates should be expected as areas are renovated or as needed over time.

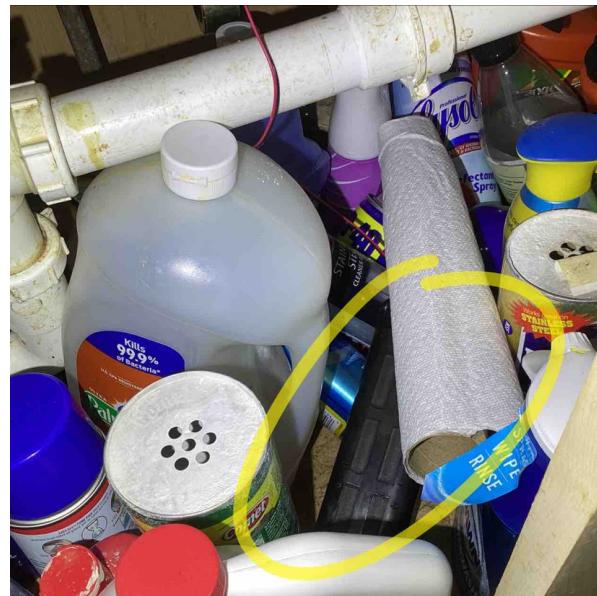
10.8.1 Kitchen faucet battery pack is not secured. Secure to reduce potential damage

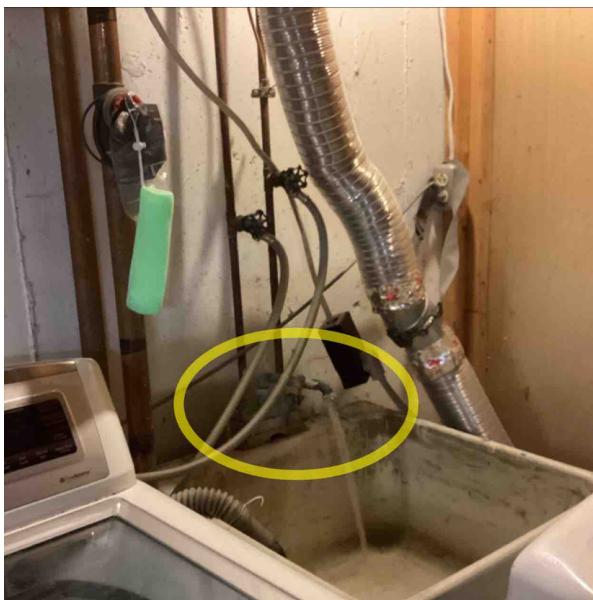
10.8.2 Drip leak at utility faucet. Recommend repair or replacement (**Laundry Room**)

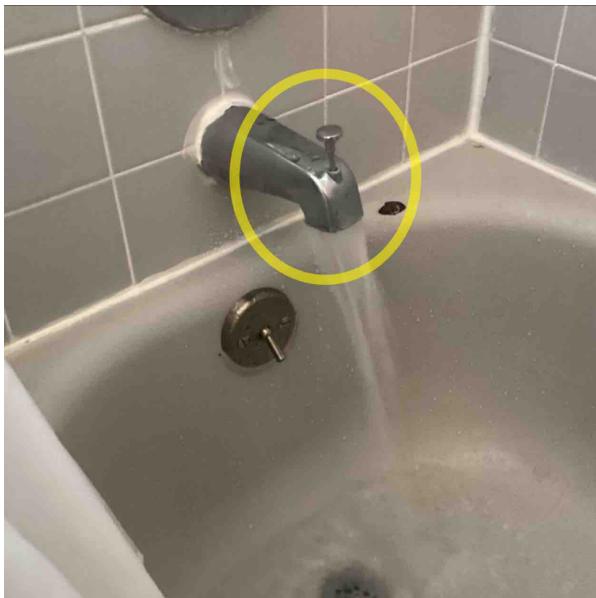
10.11.1 The shower diverter mechanism is not functioning properly. This should be repaired or replaced as needed. **(Hallway Bathroom)**

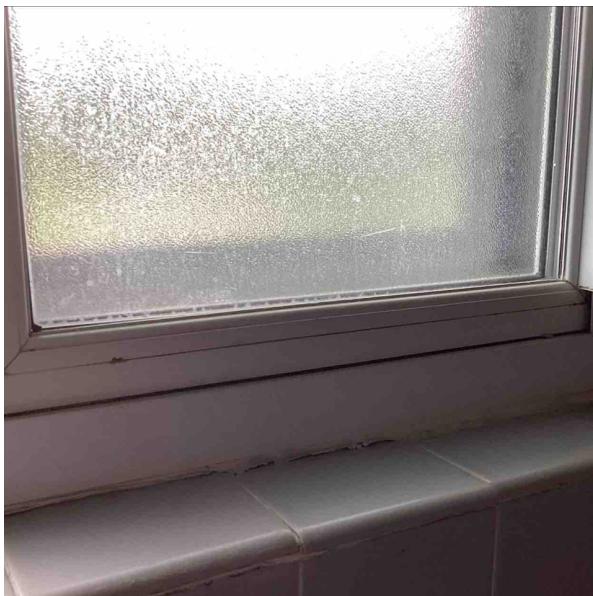
- Hallway Bathroom
- Primary Bathroom
- Primary Bedroom

11.4.1 Condensation / fog between the panes of glass on the window due to a defective thermal seal.

Recommend repairs.

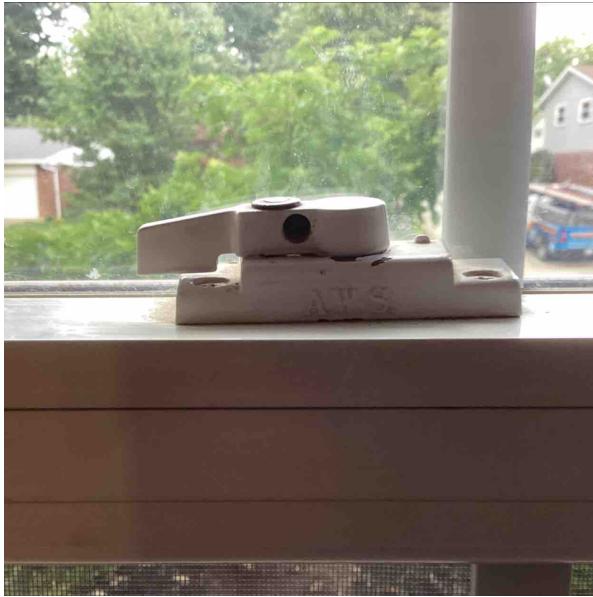
11.4.2 Sash locks stuck. Could not open window. Corrections needed (**Dining room**)
