PROJECT AD-KY041 • 123 Lexington Cir • Lexington, KY

# Strategic Thermal Reconnaissance Report

123 Lexington Cir • Lexington, KY • Scan 2026-06-24 • Ground-truth accuracy ±1.5 cm

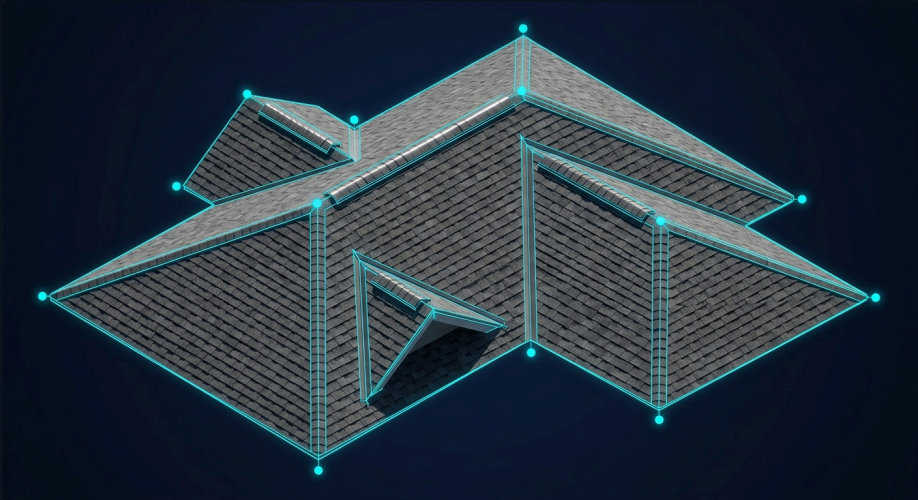
LAYER 01 • FINISHED SLATE

Squares 28.50 • Pitch 7/12
