# STRATEX™

// DRONE-SCAN COMPREHENSIVE REPORT

# 1247 Bluegrass Pkwy, Lexington, KY 40503

Prepared for The Whitaker Family • by Crown Roofing

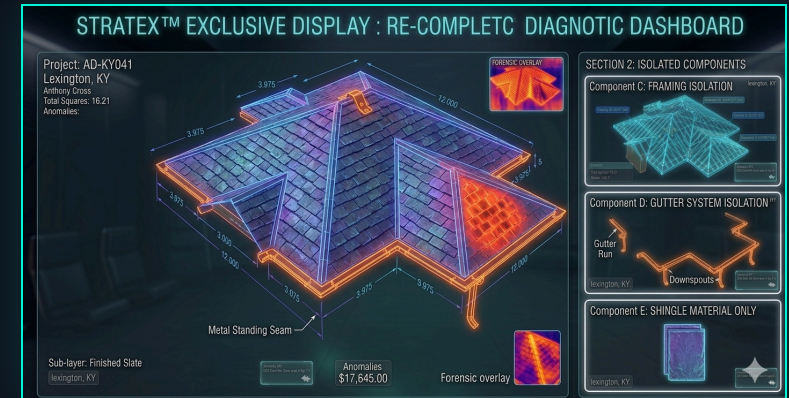
3D DIGITAL TWIN • FORENSIC OVERLAY

Trapped moisture detected. High risk of CDX deck rot and structural framing decay.

## Trapped Moisture / CDX Deck Rot

38.7 ft² affected · depth 0.55"

Remediation: Cut & replace 4×8 CDX section ·  
re-bed I&WS · color-match slate replacement
