PROJECT AD-KY041 • 142 Bluegrass Ridge • Lexington, KY

CONFIDENTIAL • STRATEGIC FORENSIC AUDIT

# Strategic Thermal Reconnaissance Report

142 Bluegrass Ridge • Lexington, KY • Scan 2026-06-24 • Ground-truth accuracy ±1.5 cm

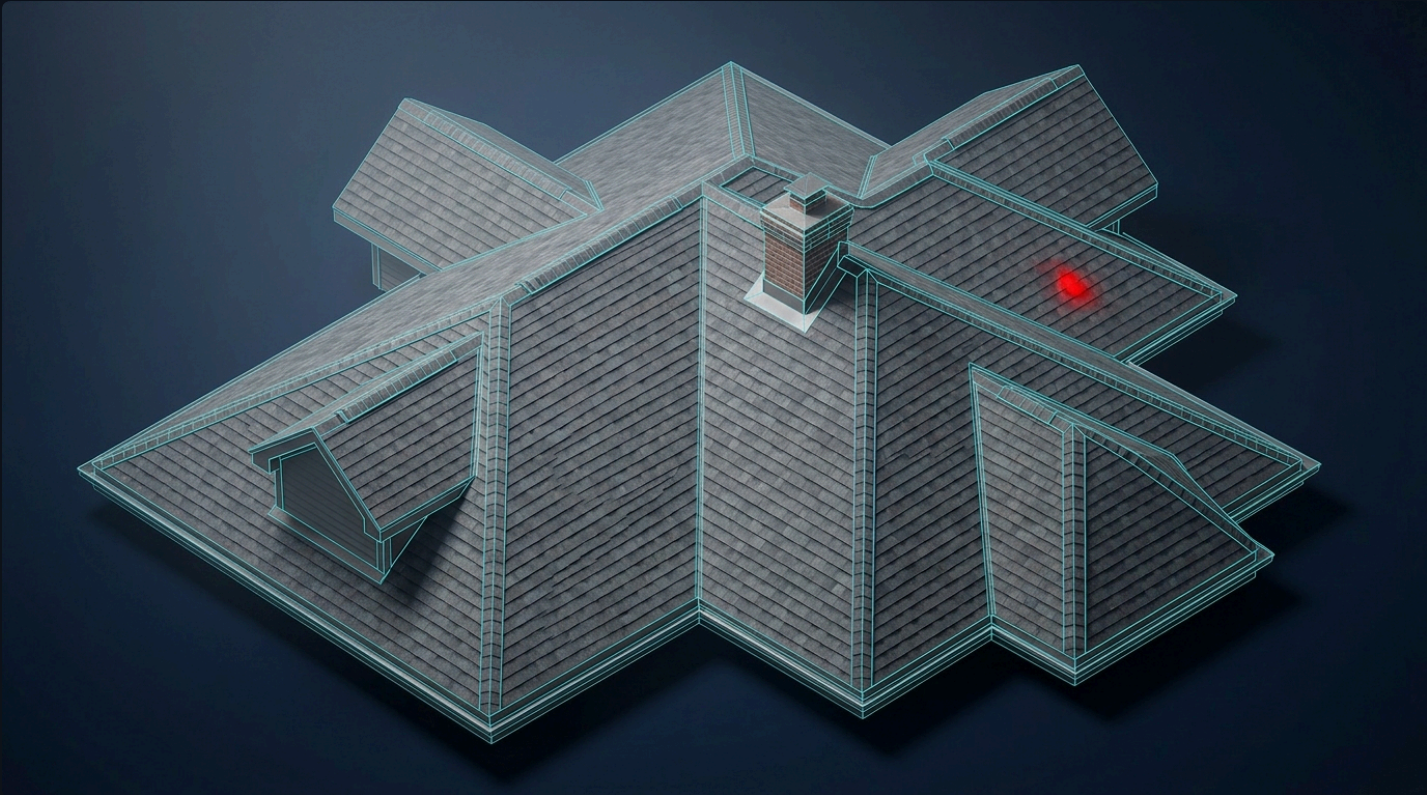
RADIOMETRIC OVERLAY • ROOF

| SEV | ID | TYPE | LOCATION | CONF | SF | DIAGNOSIS | EST |
|---|---|---|---|---|---|---|---|
| MED | A001 | Granule Loss | Front-right slope | 95.0% | 4.7 | Typical aging, indicative of advanced wear on south-facing slopes. Affects shingle integrity. | \$150.00 |
| HIGH | A002 | Vent Boot Seal Failure | Main plumbing stack vent, rear slope | 98.0% | 0.1 | Deteriorated rubber seal, high potential for water intrusion into attic space. | \$350.00 |
| MED | A003 | Curled Shingles | Various sections, predominantly south-facing | 90.0% | 9.3 | Age-related thermal cycling and moisture absorption, reducing wind resistance and weatherproofing. | \$200.00 |
| LOW | A004 | Missing Gutter Hanger | Front gutter, 3.5m from left corner | 99.0% | 0.0 | One gutter hanger detached, causing minor sag. Risk of increased sag and water overflow if not addressed. | \$75.00 |
