PROJECT AD-KY041 • 2440 Regency Road • Lexington, KY 40503

CONFIDENTIAL • STRATEGIC FORENSIC AUDIT

# Strategic Thermal Reconnaissance Report

2440 Regency Road • Lexington, KY 40503 • Scan 2026-06-25 • Ground-truth accuracy ±0.78 cm

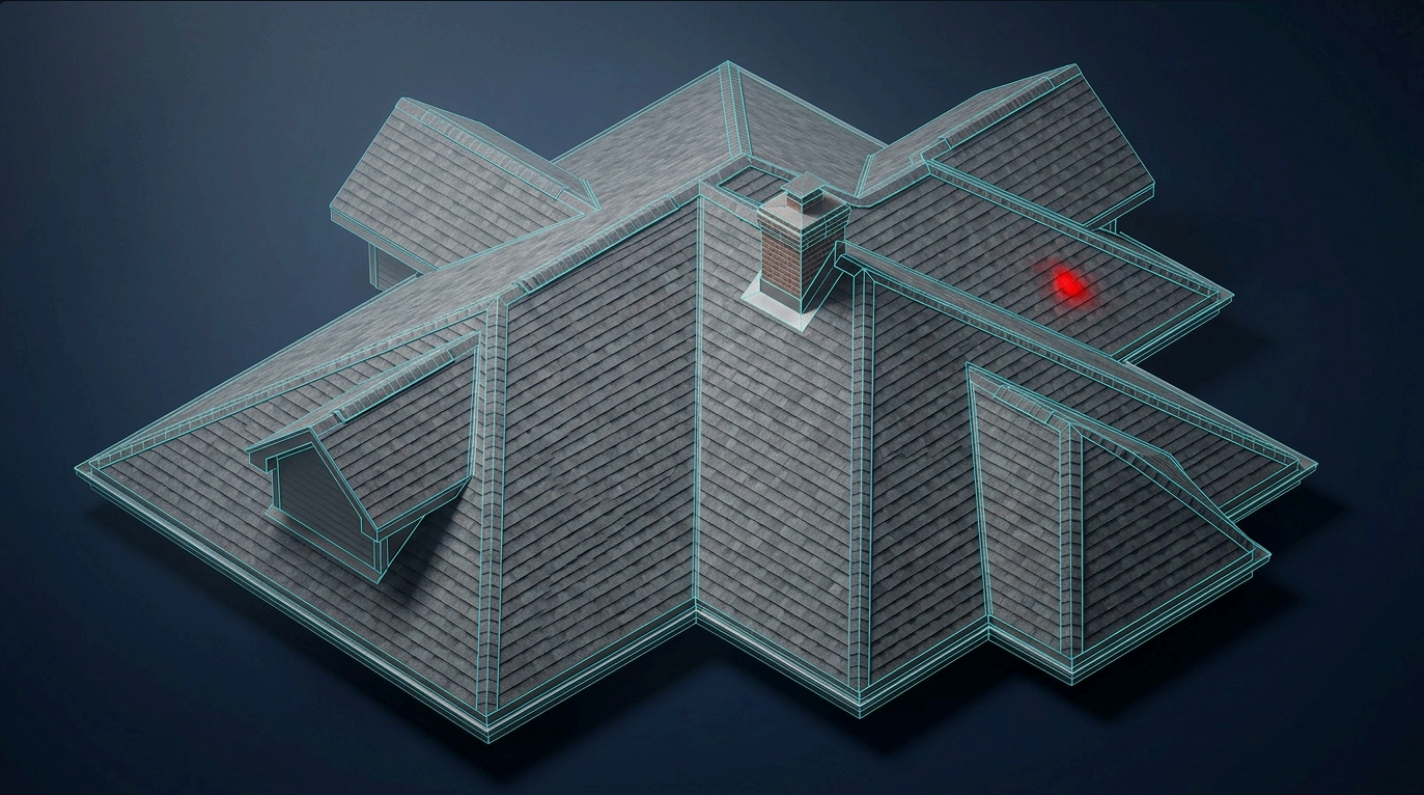
RADIOMETRIC OVERLAY • ROOF

CYAN: scan-vector overlay • ORANGE: thermal hotspot • Confidence threshold ≥ 85%

| SEV | ID | TYPE | LOCATION | CONF | SF | DIAGNOSIS | EST |
|---|---|---|---|---|---|---|---|
| URGENT | AD-KY041-004 | CDX Deck Rot | Facet F2 (Rear Hip) | 92.3% | 164.2 | Trapped sub-surface moisture, multi-season propagation. | \$17,645.00 |
| HIGH | AD-KY041-007 | Soffit Blockage | North eave run | 88.1% | 0.0 | Cellulose insulation blocking 14 of 22 soffit vents. | \$1,240.00 |
| HIGH | AD-KY041-011 | Window Header Leak | 2nd story front bay | 86.0% | 0.0 | Capillary water intrusion at flashing. | \$980.00 |

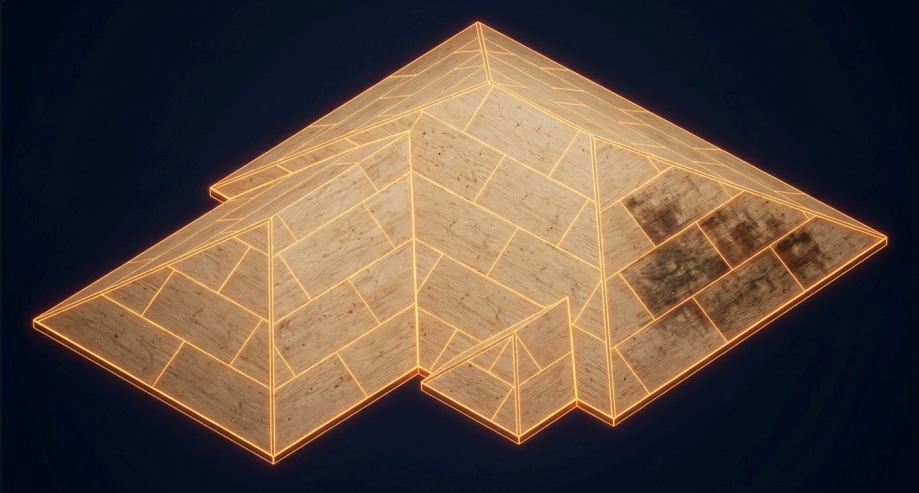
## LAYER 02 · DECKING + UNDERLAYMENT

7/16" CDX · I&W shield at valleys/eaves · 2 existing shingle layer(s)

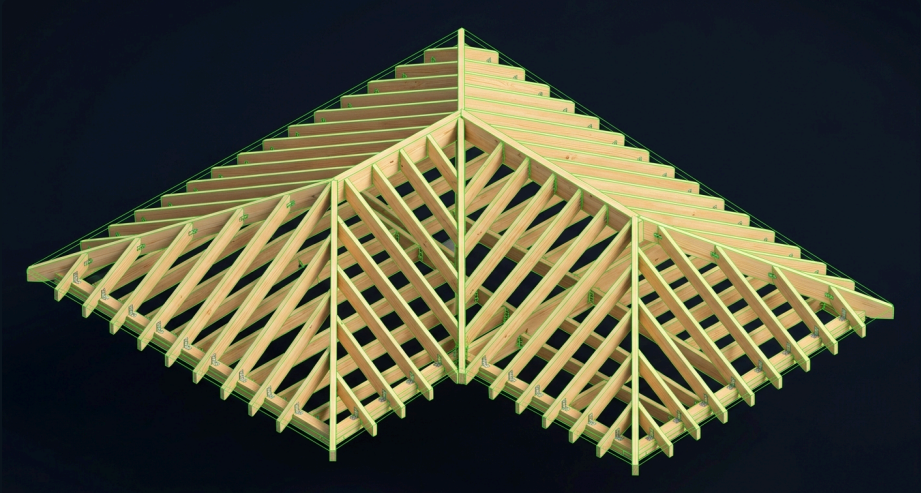
## LAYER 03 · STRUCTURAL FRAMING

2x8 rafters @ 16" o.c. · LVL ridge · Hurricane ties **VERIFIED**
