PROJECT AD-KY041 • 142 Bluegrass Ridge • Lexington, KY

CONFIDENTIAL • STRATEGIC FORENSIC AUDIT

# Strategic Thermal Reconnaissance Report

142 Bluegrass Ridge • Lexington, KY • Scan 2026-06-25 • Ground-truth accuracy ±0.78 cm

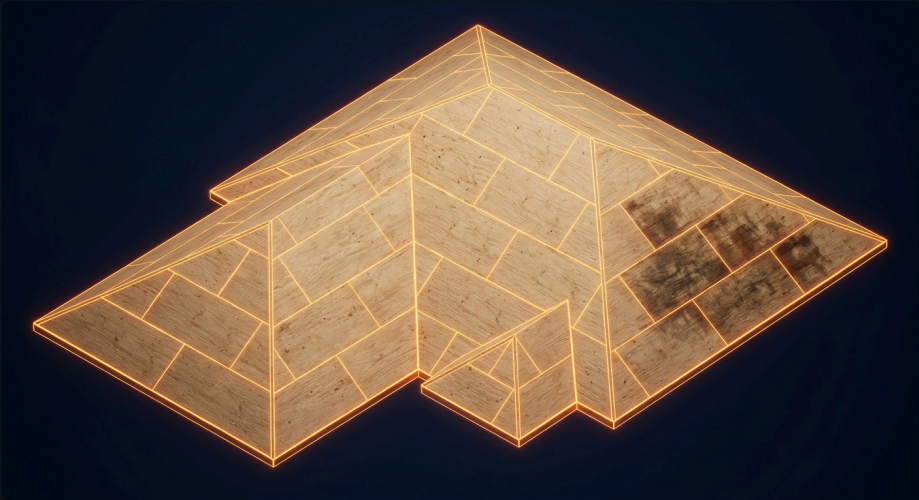
LAYER 02 • DECKING + UNDERLAYMENT

7/16" CDX • I&W shield at valleys/eaves • 2 existing shingle layer(s)

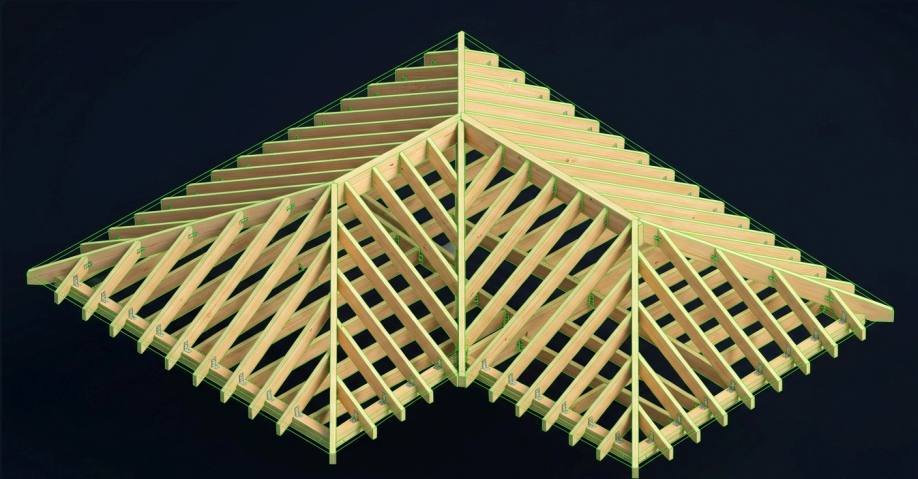
LAYER 03 • STRUCTURAL FRAMING

2x8 rafters @ 16" o.c. • LVL ridge • Hurricane ties **VERIFIED**
