# Experiences with Extra-Vehicular Activities in Response to Critical ISS Contingencies

E. A. Van Cise<sup>1</sup>, B. J. Kelly<sup>2</sup>, and J. P. Radigan<sup>3</sup>, C. W. Cranmer<sup>4</sup>  
NASA Lyndon B. Johnson Space Center, Houston, Texas, 77058

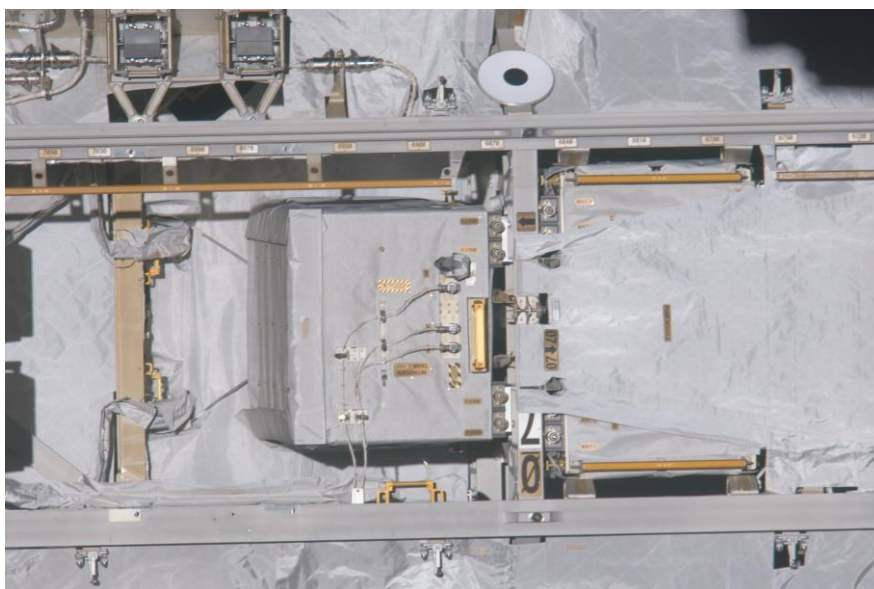
While working to disconnect the fluid connections on the failed pump module, one of the connections experienced a small ammonia leak. Given the toxicity of ammonia and that it is a valuable cooling consumable, immediate troubleshooting was required. The first response when this occurred was to cycle the quick disconnect, re-opening and then reclosing the valve that is a part of the connector. Upon re-closure the quick disconnect experienced a substantial ammonia leak and had to be reopened. The remainder of the EVA time was spent trying to troubleshoot the leaky quick disconnect and no additional work was completed toward the Pump Module removal. The crew returned to the airlock after 8 hours and 3 minutes (EVAs are generally planned to be 6.5 hours long). After completion of EVA 1, the Team 4 reconvened to discuss the system configuration after EVA 1, lessons learned applicable to EVA 2, required modifications to the EVA 2 timeline, and EVA/Airlock consumables required to support a third EVA.

Figure 2. Close up view of the Loop A Pump Module worksite on the front face of the S1 truss segment. NASA image s134e010540.

EVA 2 was performed on August 11<sup>th</sup> with the goal to troubleshoot, close, and demate the leaky quick disconnect, remove and stow the failed Pump Module, and prepare the new Pump Module for installation but leave it at its stowage location. The reduced pressure on the fluid lines, combined with additional techniques for operating the QD, allowed for the successful disconnection of the formerly leaking connection on the first attempt. The failed pump module was temporarily stowed and the new pump module was prepared for installation. Overall this second EVA lasted 7 hours and 26 minutes.

The crew went outside for the third and final EVA to restore functionality to the external thermal loop on August 16<sup>th</sup>. The goals for this EVA were to finish preparations of the spare Pump Module, install it into the system including mechanical, electrical, and fluid connections, and clean-up the EVA worksite. Updates to the quick disconnect mating sequence on the new Pump Module were made based on lessons learned from the previous two EVAs. While there were some minor difficulties encountered with the mechanical bolts and quick disconnect mating, the crew was able to successfully complete all of the tasks required to support successful reconfiguration and restart of the external thermal loop.
