Project Wind Turbine

Solution Engineering Report

Hanzehogeschool Groningen – Mechanical Engineering – Group 9 – Semester 4-6 – Fortis Montana Wind Turbine

Date: 14-06-2021

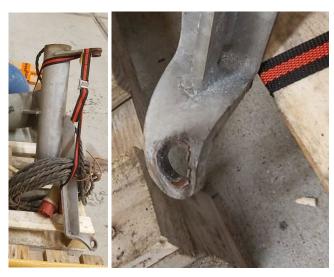
Figure 3.2.1 Pivoting shaft

- Electricity cables (missing).
- Pivoting shaft (broken) (figures 3.2.1)
- Tower (missing) (figure 3.2.3)
- Main axle (missing) (figure 3.2.2)

The solution for the missing electricity cables is worked out in "chapter 4 Electrical". And the broken pivoting shaft and the missing main axle will be replaced by an entirely new component.

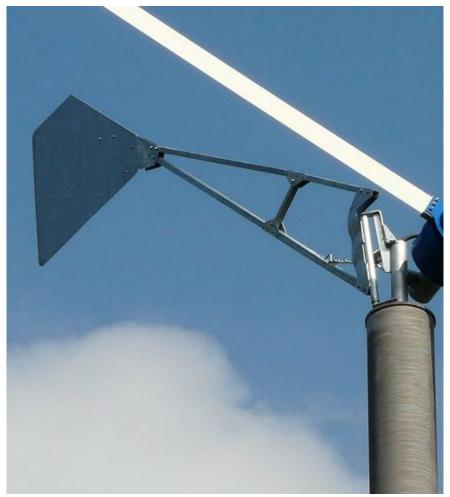
Figure 3.3.1 the tail

The tail is located behind the generator, it yaws the blades into the wind. The tail is fitted with a pin that can rotate; the pin is mounted between two holes see "figure 3.3.1: the tail". The tail can rotate a little bit before it starts moving the whole turbine, this is to prevent small wind direction changes making an impact on the yaw of the turbine.
