# IDENTIFICATION OF FACTORS IN ROAD ACCIDENTS THROUGH IN-DEPTH ACCIDENT ANALYSIS

Key Words: Investigation, Reconstruction, In-depth analysis, Event tree, Factors

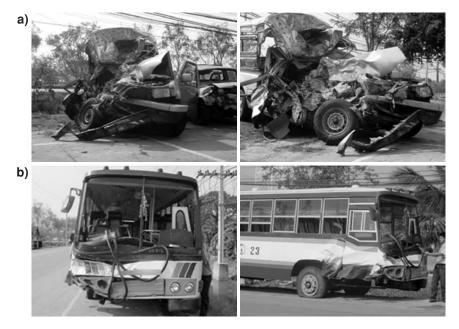
Fig. 5 a) Damaged pickup truck (left: front) and (right: right-corner), and b) Damaged bus (left: front) and (right: right-corner)

<u>Pickup truck</u>: Since pickup truck collided with the bus, the damage was very severe. The impact force of the bus was high enough to crush the major portion of crush zone and passenger compartment of the pickup truck. The measurements were not directly made due to the crash severity of the pickup truck. The external damage with internal intrusion of the damage resulted in eight fatalities out of nine passengers inside the pickup truck. The calculated delta-V for the pickup truck was about 89 kph. Figure 5 (a) shows the extent of damage of pickup truck from different angles.

<u>Bus:</u> The bus was higher than the pickup truck in terms of vehicle geometry and only the right side of the bus was damaged at the bumper and the right front fender. The direction of force (PDOF) passing through the centriod of the damaged portion was 8.4 degree (clockwise) with respect to the longitudinal axis of the vehicle. The extent of damage of bus was comparatively less. The calculated delta-V for the bus was about 24 kph. Figure 5 (b) shows the extent of damage of the bus from different angles.

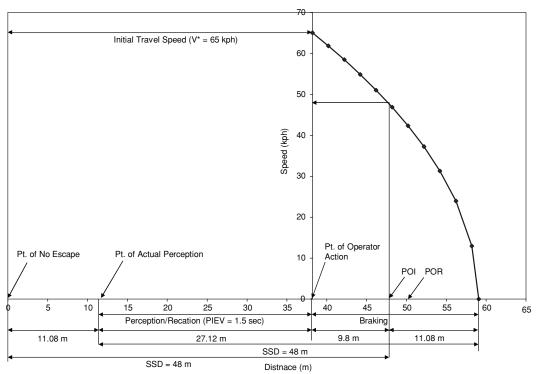
Fig. 10 Speed vs. distance profile for bus

<u>Bus:</u> It was traveling at about 65 kph after crossing the curve upstream. The required safe Stopping Sight Distance (SSD) was 48 m. Considering PIEV time of 1.5 second, PIEV distance was about 27 m and pre-impact skidding took 9.8 m which made about 37 m in total with initial traveling speed of 65 kph. According to the calculations, the bus driver could avoid the crash if he started braking at about 11 m before the actual braking position as shown in Figure 10. At x = 38 m, the bus driver applied braking and collided with the pickup truck at x = 48 m with about 47 kph.

Due to the misjudgment of the bus driver to the pickup truck speed which was traveling (pickup truck: 55 kph) 10 kph lower than the bus (bus: 65 kph) and also with no street lighting resulted in too late decision making by the bus driver to pass the leading vehicle (i.e. motorcycle). The misjudgment of a gap between the vehicles (i.e. bus and motorcycle) and high traveling speed of the bus resulted in passing and entering to the opposing lane. The late decision of passing maneuver of the bus led to the collision with the oncoming pickup truck even though the bus was applying the brakes. All these factors influenced the bus driver to cross the point of no escape at x > 0 as shown in Figure 10.

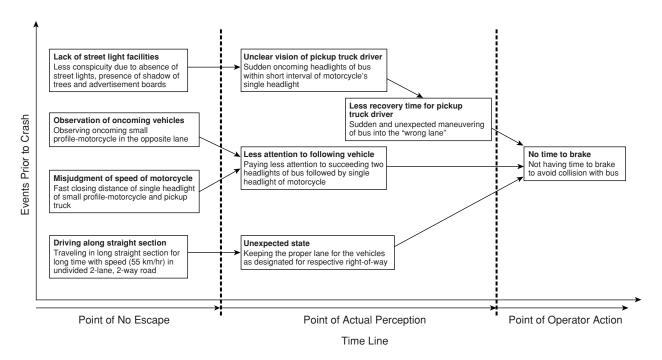
Fig. 11 Event tree for pickup truck

Pickup truck: Lack of street light facilities, misjudgment of speed of oncoming vehicles, and normal driving expectancy on the straight road affected unclear vision of the pickup truck driver, less attention to following vehicles and unexpected state for the pickup truck driver. The later caused less time to react and literally no time to brake to avoid the oncoming bus from the opposite direction. All these factors and consequences are interlinked to one another. The event tree for the pickup truck is presented in Figure 11 with events prior to crash vs. time line.

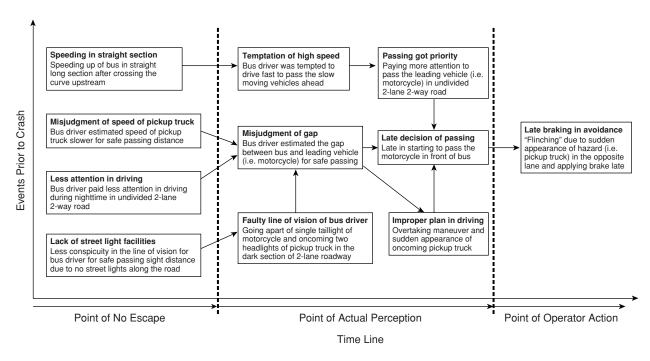
Fig. 12 Event tree for bus

<u>Bus:</u> Lack of street light facilities, together with misjudgment of speed of oncoming vehicles, and less attention in driving caused a faulty line of vision of the bus driver, misjudgment of gap between the leading and following vehicles, and temptation of higher speed. Consequently, the misjudgment of the gap caused improper plan of driving and temptation of higher speed to pass the leading vehicles causing a late decision for passing. This late decision of passing made the passing vehicle applied late braking to avoid the collision with the oncoming vehicle

from the opposite direction. The event tree for the bus is presented in Figure 12 with events prior to crash vs. time line.
