# Power-Share Setpoint Sweep under Trapezoidal Load: Bench Results, a Minority-Channel Dropout Limit Cycle, and Validation of Its Firmware Mitigation

Ricky Tan  
rstan@ucdavis.edu

2026-08-11 (revised 2026-08-12 with the firmware v3 and v4 validation sweeps)

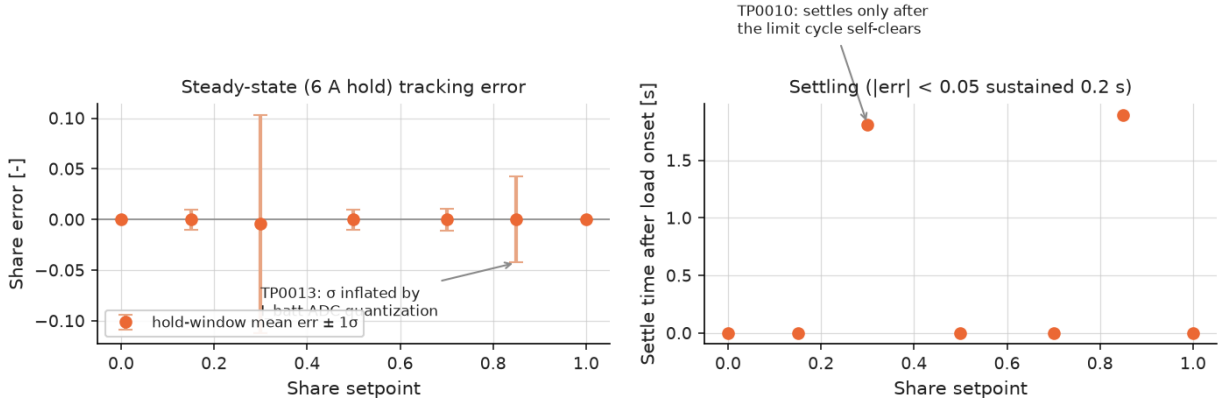
Figure 1 summarizes the sweep. Hold-window mean error is below  $10^{-3}$  at every setpoint from 0 to 1 — the integral action carries no bias anywhere in the span, matching the design intent of the Youla controller’s exact  $T(0) = 1$  constraint. Interior setpoints (0.3–0.7) show  $\sigma \approx 0.01$  with the droop-gain commands comfortably mid-band, and Figure 2 shows the representative clean run at  $r^* = 0.5$ . The endpoints are degenerate by construction: at  $r^* = 1$  the BT channel simply stops conducting and both MDAC commands sit pinned at the band edges (an open loop with zero error); at  $r^* = 0$  the loop freezes mid-range with the FC channel dark. Neither endpoint misbehaves.

**Figure 1:** Sweep summary. Left: hold-window tracking error is unbiased at every setpoint; the two inflated  $\sigma$  bars belong to the limit-cycle runs (TP0010) and the quantization-corrupted high-share run (TP0013). Right: settling time; interior and endpoint runs are within band at load onset, while the two anomalous runs take  $\approx 1.8$ – $1.9$  s.

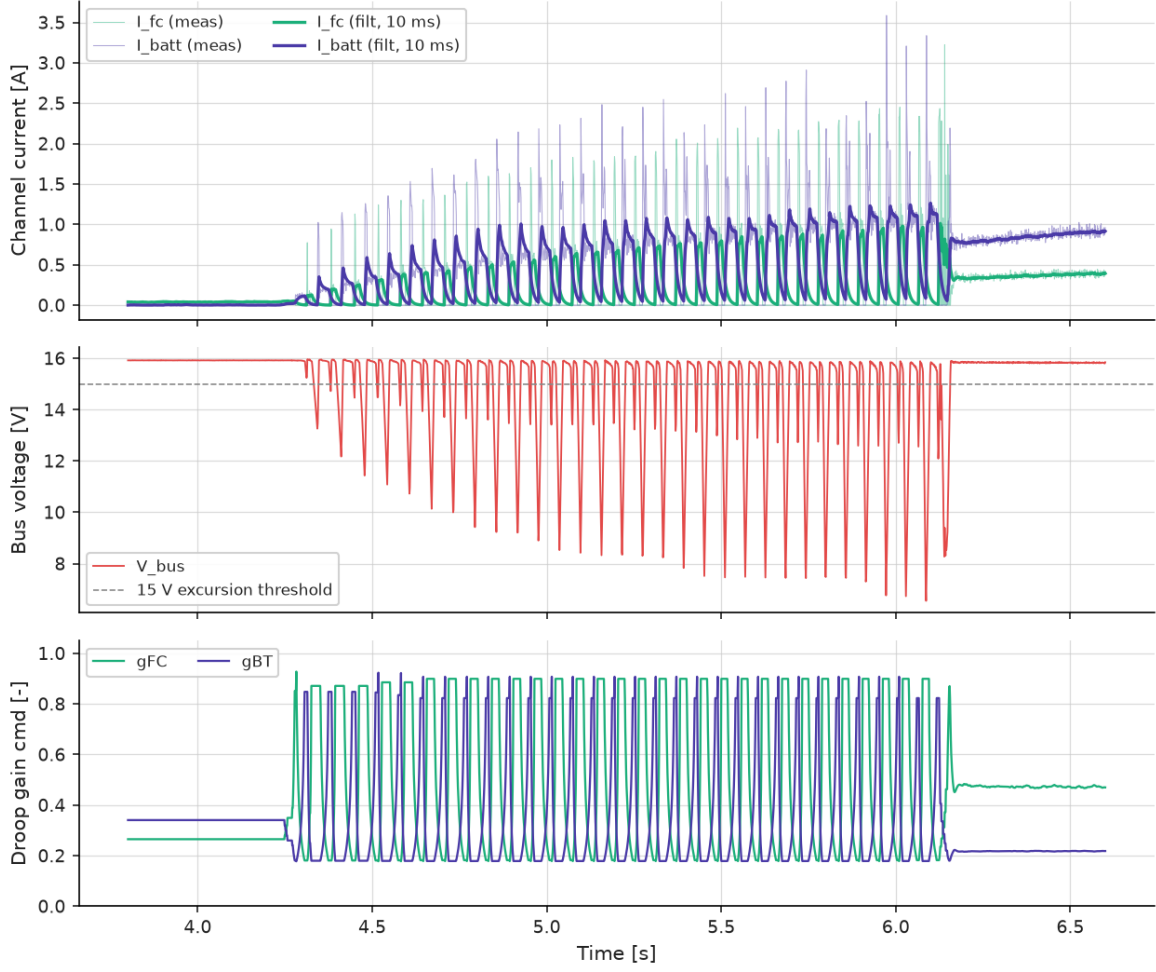
From  $t = 4.33\text{ s}$  to  $6.15\text{ s}$  — mid ramp-up, with the motor command between 4.3 and 6 A but total channel current still below  $\approx 1.2\text{ A}$  — the loop enters a sustained relaxation oscillation with a median period of 58–59 ms ( $\approx 17\text{ Hz}$ ). Figure 3 shows the full window; Figure 4 resolves individual cycles.

**Figure 3:** TP0010 limit-cycle window. Top: channel currents alternate with reconnect spikes growing to 3.6 A as the load ramp deepens. Middle: 64 bus excursions below 15 V, reaching 6.55 V; sag depth grows monotonically with the commanded load. Bottom: the droop MDAC commands bang between their extremes in antiphase. The cycle self-clears at  $t = 6.15$  s once total current exceeds  $\approx 1.2$  A, and the remainder of the run is clean.

Three features deserve emphasis. First, the collapse is real and repeated: 64 excursions below 15 V in 1.8 s, with sag depth scaling with the commanded load (13.3 V at  $I_{\text{cmd}} = 4.4 \text{ A}$  down to 6.5 V at 6 A). Second, *no fault was raised*: the `BENCH.TEST` build arms overvoltage checks only, and every excursion is downward — the event is invisible to `detectFaults()` as currently configured on the bench. Third, the cycle is self-limiting in this run: once the trapezoid pushes total current past  $\approx 1.2 \text{ A}$  the loop converges and the remainder of the run is indistinguishable from the clean runs ( $\sigma = 0.011$ , no saturation). A brief re-entry occurs on the low-current tail at  $t \approx 13.5 \text{ s}$ .

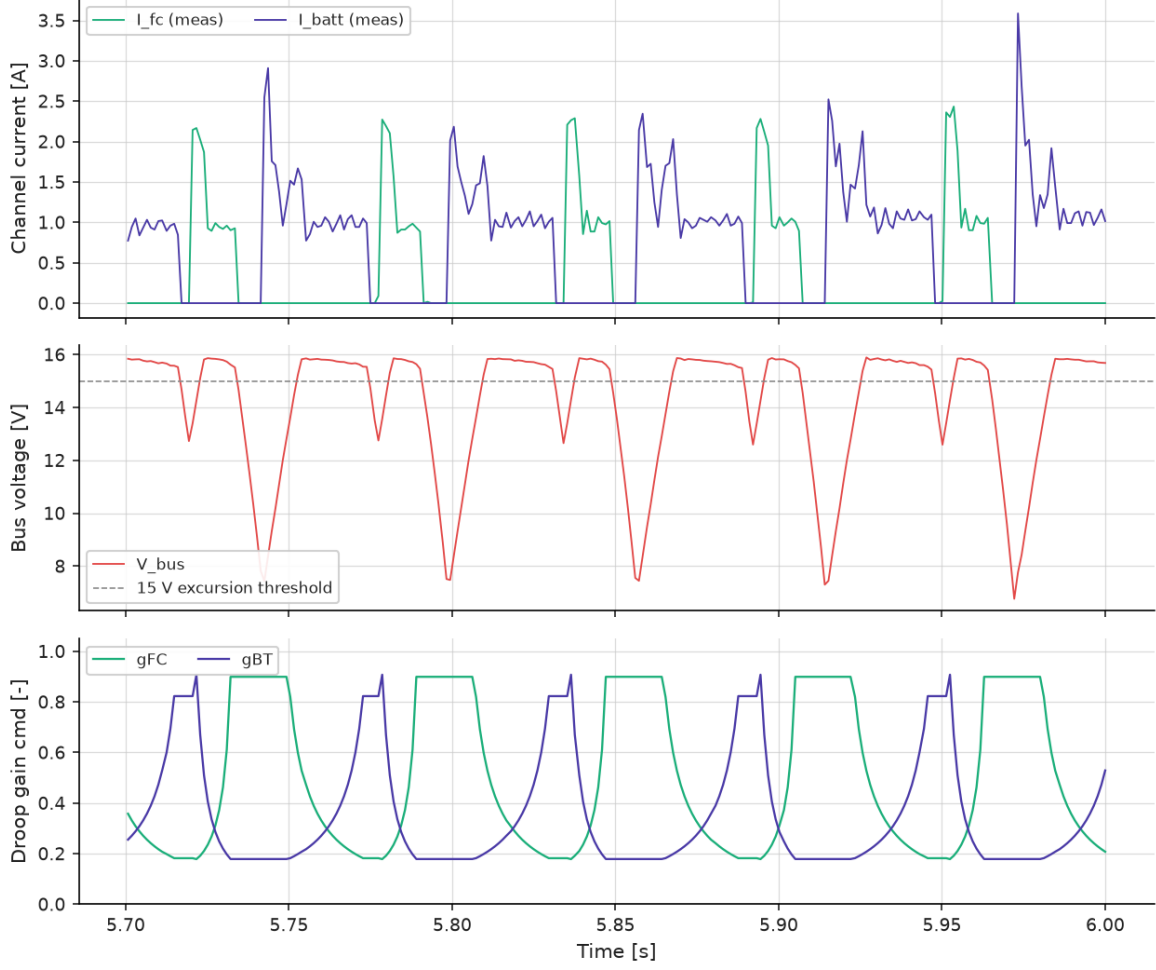
**Figure 4:** Five consecutive cycles of the TP0010 limit cycle. The two channels conduct *mutually exclusively* (both conducting in only 0.1 % of samples); each handoff includes a 10–18 ms window in which *both* channels read zero current and the bus — carrying only its  $\approx 40 \mu\text{F}$  of ceramics — falls as low as 6.5 V before the incoming channel reconnects with a 2–3.6 A spike.

The data support a *starved-minority-channel dropout loop*: at low total current, the droop command needed to hold the minority channel at a small fraction pushes that channel out of conduction entirely (its RT1987 ideal diode blocks once the droop-raised source characteristic falls below the

bus); the measured share then slams to 0 or 1, the controller drives both MDACs toward their rails, the starved channel reconnects with a large spike, and the cycle repeats. This explains the frequency similarity between the two runs, the mutual exclusivity, the confinement to low total current, and the self-clearing once the minority channel’s commanded current rises above its conduction floor.

Following the analysis above, firmware v2/v3 added three mitigations to the share loop. First, a *setpoint governor* clips the effective in-band setpoint so the commanded minority-channel current stays at or above  $I_{\min} = \text{SHARE\_MINORITY\_I\_MIN\_A} = 0.20$  A, computed against a low-pass estimate of total current; below  $2I_{\min}$  of filtered total the effective setpoint collapses to 0.5. Setpoints outside the droop band  $[0.15, 0.85]$  bypass the governor, on the design assumption that the channel-cutoff path owns them. Second, a *droop-ratio slew limit* of 0.02 per control tick replaces the rail-to-rail MDAC slams of Figure 3. Third, share-controller state is *reset at every profile start*, removing the cross-run contamination of Section 5.

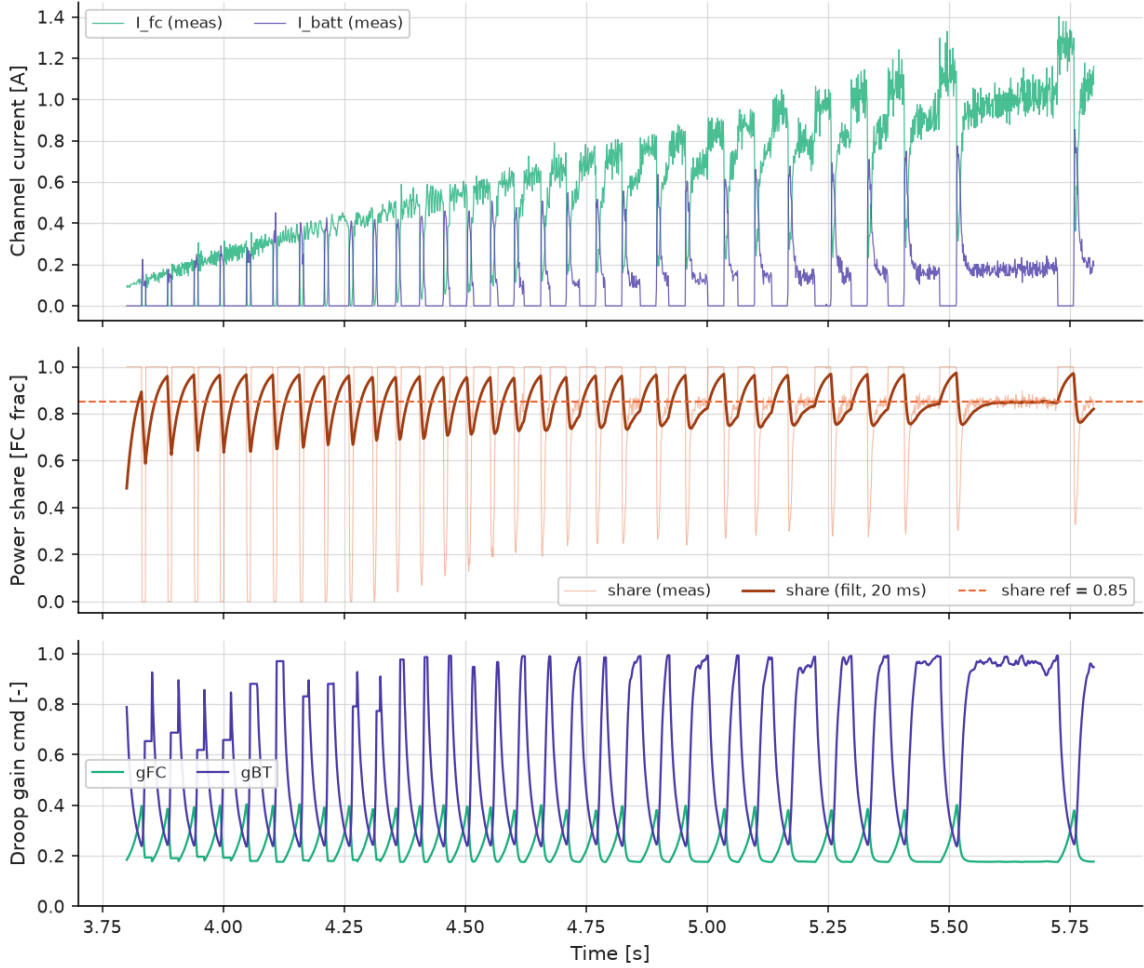
The mirror-side asymmetric setpoint shows the same signature at 18.5–18.7 Hz, but as minority-channel (battery) dropout chatter without bus collapse (Figure 5): during both ramps the BT channel repeatedly falls to exactly zero current (pinned there for 0.77 s of the 1.5 s ramp-up band and 1.36 s of the 2.1 s ramp-down band), the measured share slams to 1, and  $g_{\text{BT}}$  rails before the channel snaps back. Bus disturbance is limited to  $\approx 100 \text{ mV}$  notches. The run never meets the

**Figure 5:** TP0013 ramp-up dropout band. The BT channel (violet) repeatedly drops out of conduction entirely; measured share (middle) saws between the setpoint and 1.0 at  $\approx 18.5$  Hz;  $g_{BT}$  (bottom) rails toward 1.0 on every dropout while  $g_{FC}$  sits pinned at its 0.175 floor. Note the events thin out as total current grows toward the plateau.

A separate measurement artifact compounds the picture at this setpoint: the commanded battery current ( $\approx 15\%$  of  $\approx 0.5$  A  $\approx 75$  mA) is only  $\approx 9$  LSB of the 8.06 mA current-sense quantization, and  $I_{BT}$  quantizes to exactly zero for 23% of the loaded segment, pegging the computed share at exactly 1.0. Excluding those samples reveals a genuine  $-0.03$  share bias at  $r^* = 0.85$  that the raw mean coincidentally cancels. Setpoint 0.85 at these load levels is where the current-sense LSB begins to corrupt the share estimate itself.

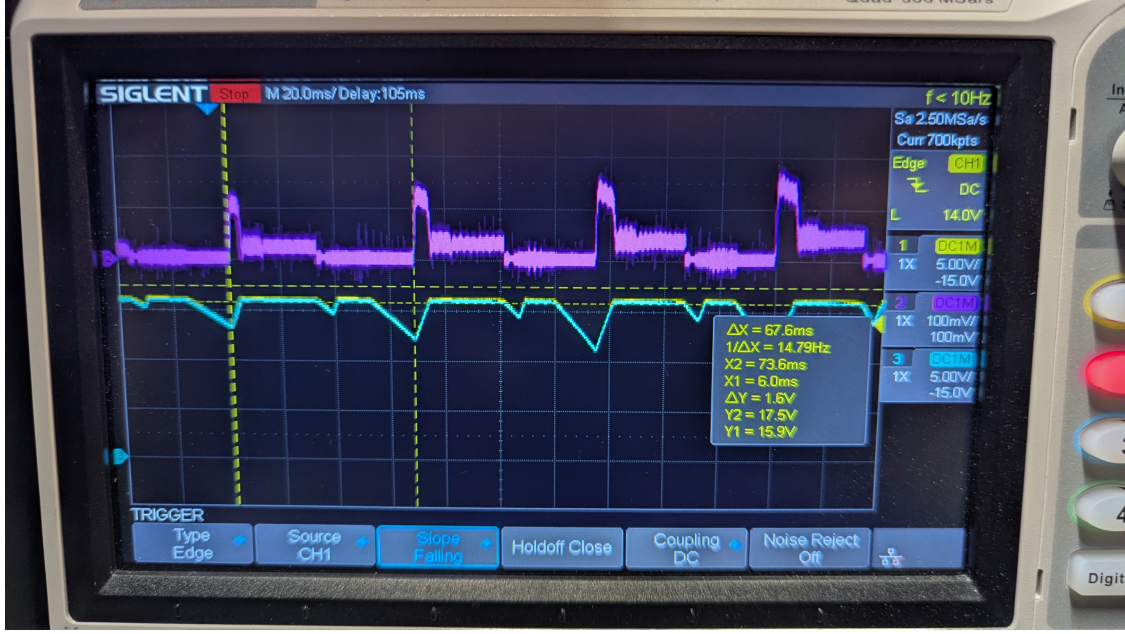
A scope capture aimed at this question was taken on 2026-08-11 (capture 12 in the bring-up record; Figure 6): a repeat of the TP0010 condition with VBUS, V-MOT, and the battery-channel INA monitored, single-shot trigger on VBUS falling through 14 V. It *narrows* the question without closing it:

- **Confirmed: the events are total source-feed dropout windows.** VBUS and V-MOT sag *together* — slow linear ramps of  $\approx 3\text{--}4$  V over tens of milliseconds at a 67.6 ms cursor period (14.8 Hz), each ended by a sharp recovery synchronized with a  $\approx 1$  A reconnect burst on the battery INA. Because the motor switch conducts throughout, the bus rides the combined  $\approx 1\text{--}1.5$  mF motor+VESC capacitance during each window — which is why the decay is slow, and which independently corroborates the SD log’s 10–18 ms both-channels-off reading.

- **Ruled out: the VBUS→V-MOT switch as a cutting element** (the two nodes track through every dip).
- **Still open: candidates (1) vs (2).** Both predict exactly this bus signature, and the 67.6 ms period is consistent with either (the RT1987 retry timer is 64 ms; the SD-log median was 58–59 ms). The sharper discriminator, if needed: probe a *boost output* alongside VBUS during a dropout — reconnect at the voltage crossing indicates droop-commanded blocking, reconnect on a fixed 64 ms cadence indicates SCP.

**Figure 6:** Capture 12 (2026-08-11): TP0010-condition repeat, 20 ms/div. CH1 VBUS (yellow, 5 V/div) and CH3 V-MOT (blue, 5 V/div) overlap and sag together in  $\approx 3\text{--}4\text{ V}$  sawtooth ramps at a 67.6 ms period (cursors); CH2 battery INA (purple, 1 A/div) shows the dropout–reconnect–spike–conduction pattern synchronized with the voltage recoveries. The flat yellow line near 15.9 V is the Y1 measurement cursor, not the VBUS trace.

Practically, the discrimination no longer gates the fix: both surviving candidates are downstream of the droop loop railing both MDACs antiphase, so the mitigation set of Section 7 (feasibility-gated integrator hold, MDAC slew limiting) is the correct next step under either mechanism.

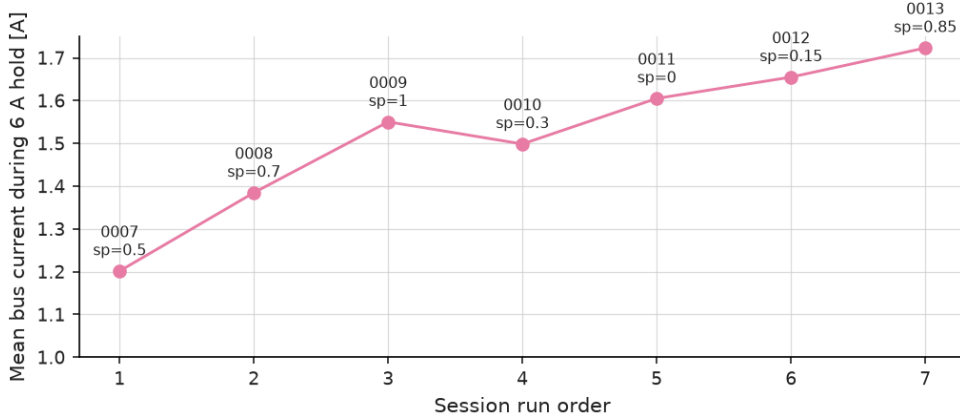
**Run-order drift.** At the identical 6 A motor command, mean bus current during the hold climbs monotonically with session order — 1.20 A (TP0007) to 1.72 A (TP0013), +44 % (Figure 7) — consistent with battery depletion and/or motor heating across the session. Cross-run comparisons are therefore made at a slowly drifting operating point; future sweeps should interleave or randomize setpoint order.

**Figure 7:** Session drift: mean bus current during the 6 A hold vs. run order. The +44 % monotonic climb tracks session order, not setpoint.

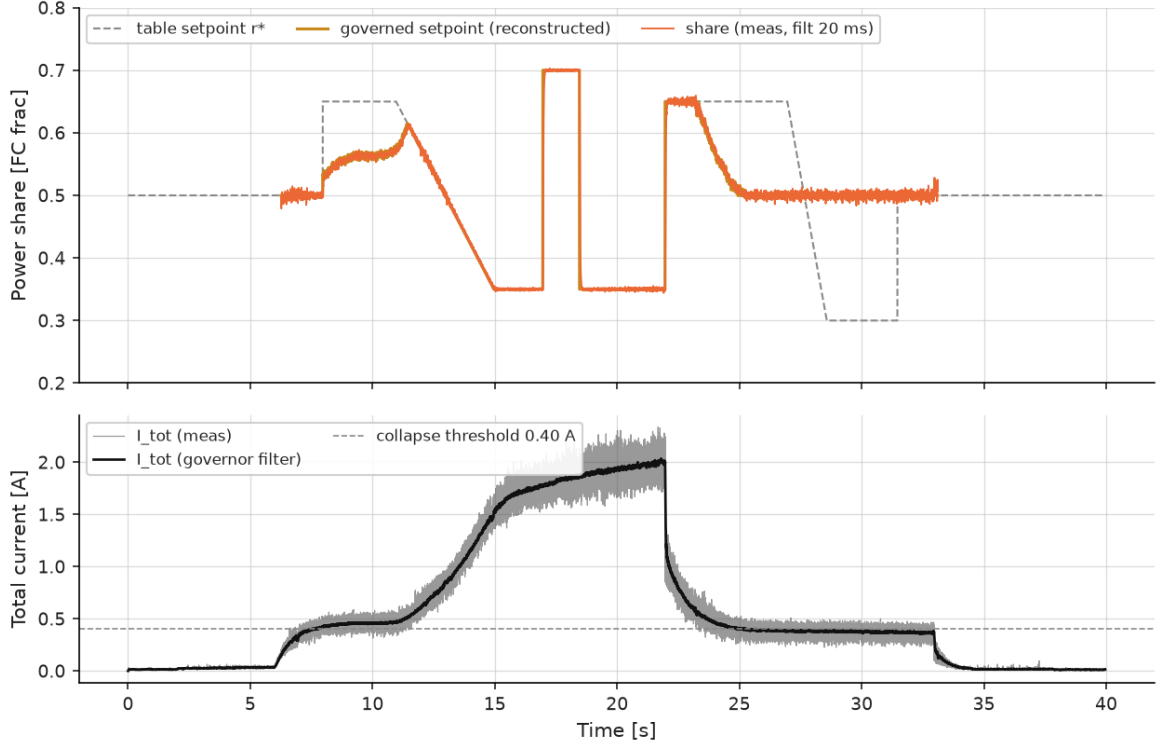
The moving-setpoint run WP0040 (Figure 9) extends the validation to simultaneous setpoint and load steps: across all sixteen table regions, the measured share tracks the *reconstructed governed setpoint* with residuals at or below  $2 \times 10^{-3}$ , including three regions where the governor clips a 0.65 command down to 0.54–0.57 at low current and two regions where it collapses a 0.30/0.65 command to 0.5. The apparent tracking “errors” against the raw table setpoint are therefore entirely commanded governor action. Region boundaries traverse ratio steps of up to 0.34 in about 20 slew-limited ticks with  $\approx 0.06$  overshoot and no bus disturbance beyond 0.20 V.

**Figure 9:** WP0040 (moving setpoint and load): measured share (orange) against the raw table setpoint (dashed) and the governed setpoint reconstructed from the firmware’s clip law (mustard). The measured share follows the governed command everywhere the share is measurable; the flat 0.5 stretches at  $t = 25\text{--}33\text{ s}$  are the designed collapse below  $2I_{\min}$  of filtered total current, not tracking failure.

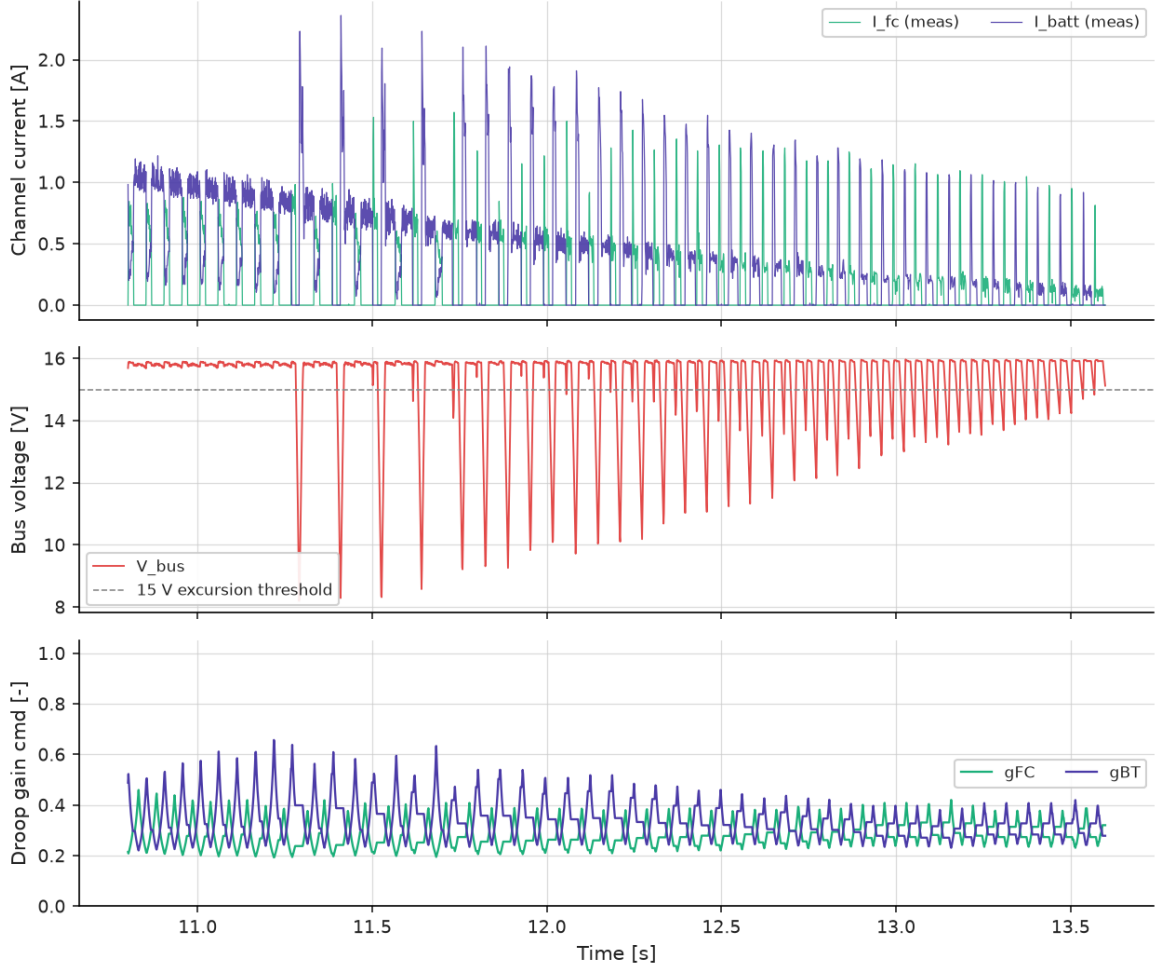
The single in-band failure is the band-edge setpoint itself. TP0016 ignites the limit cycle at  $t = 6.14\text{ s}$  — the precise instant the governor releases, when total current grows past  $I_{\min}/0.15 = 1.33\text{ A}$  and the commanded minority current passes down through  $0.20\text{ A}$ . Zero dropout events occur before that instant; the cycle then runs continuously through the hold (56 events at  $19\text{ Hz}$ , bus intact) and deepens through the ramp-down (Figure 10): 44 bus excursions below  $15\text{ V}$ , reaching **8.20 V**, with  $2.4\text{ A}$  reconnect spikes and simultaneous both-channels-at-zero windows — the same total source-feed dropout signature as TP0010, at roughly three-quarters its event count and  $1.6\text{ V}$  shallower minimum.

**Figure 10:** TP0016 ( $r^* = 0.15$ ) ramp-down window. The limit cycle survives at the in-band boundary: mutually exclusive conduction with reconnect spikes to 2.4 A (top), bus collapse deepening to 8.2 V as commanded current falls (middle), and the droop-gain commands cycling in antiphase — now confined to 0.2–0.65 by the slew limiter rather than slamming rail-to-rail as in fw 0 (bottom).

Two independent quantities corner this setpoint. First, the governor floor at the hold’s 1.63 A is  $0.20/1.63 = 0.122$ , below the setpoint — so the governor correctly declines to clip, and the commanded minority current (0.245 A) is evidently still inside the dropout region: the empirical conduction floor lies between 0.245 A (cycles, this run) and 0.29 A (TP0017 at  $r^* = 0.18$ , clean).  $I_{\min} = 0.20$  A therefore sits *on* the failure boundary rather than above it. Second, the commanded droop ratio in the hold tracks the setpoint to within 0.003 in every clean run, so  $r^* = 0.15$  parks the actuator directly on the `DROOP_R_MIN` rail — TP0016’s minimum hold margin to the rail is +0.0005, inside the 0.01 cutoff re-entry hysteresis. Ignition coincides with the ratio touching the rail. Raising  $I_{\min}$  alone addresses the first constraint; the second argues for narrowing the usable in-band span to approximately  $[0.18, 0.82]$  independent of load.

4.  **$I_{\min} = 0.20$  A sits on the failure boundary, not above it.** TP0016 ignites at the exact governor release instant; the empirical conduction floor lies in (0.245, 0.29) A. Raise SHARE\_MINORITY\_I\_MIN\_A to  $\approx 0.30$  A. Independently, the band-edge setpoint parks the actuator on the DROOP\_R\_MIN rail inside the cutoff hysteresis; treat the usable in-band span as  $\approx [0.18, 0.82]$ .

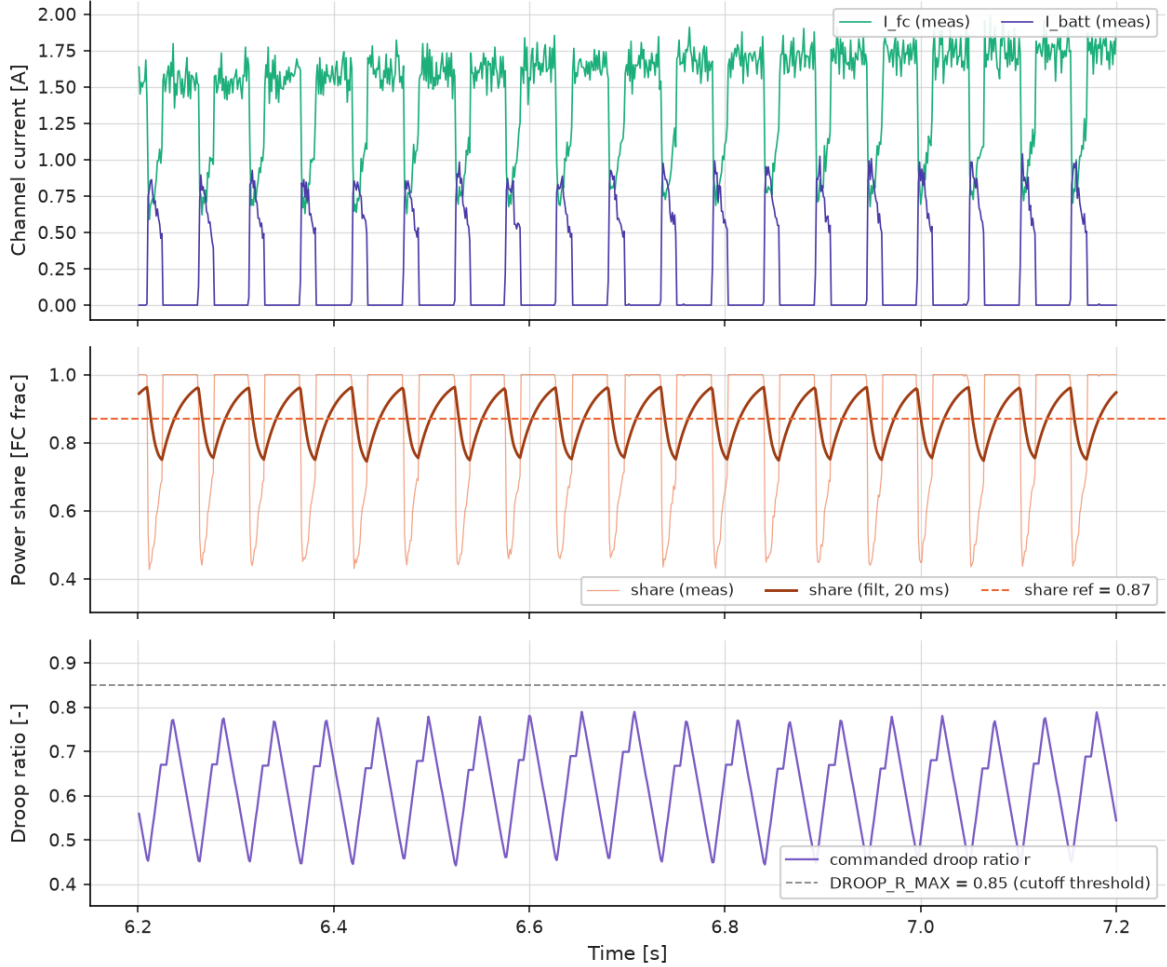
TP0037 exposes a structural gap between the two mitigation paths. The setpoint 0.87 is outside the droop band, so the governor is bypassed by design — the cutoff path is assumed to own it. But

the cutoff fires on the *controller output*  $r$ , not on the setpoint, and the plant needs only  $r \approx 0.84$  to realize a share of 0.87: extrapolating the clean runs' hold-window ratios (0.770/0.790/0.810/0.821 at  $r^* = 0.80/0.82/0.84/0.85$ ) puts the required ratio just *below* the 0.85 cutoff threshold. The measured ratio confirms it: maximum 0.789, never crossing (Figure 11, bottom). Setpoint 0.87 is therefore governed by nothing and cut off by nothing, and it runs the original limit cycle unmitigated: 172 dropout–reconnect cycles at 19.5 Hz, the BT channel off the bus for  $\approx 70\%$  of all loaded time at every current level — unlike fw 0, it does *not* self-clear above 1.2 A, because the ungoverned commanded minority current (0.13 of total) stays below the conduction floor at every point of this profile. Electrical severity stays low (bus ripple 0.33 V, spikes to 1.1 A), but the cycle is continuous. The unprotected window is approximately  $0.85 < r^* \lesssim 0.88$ , with a mirror on the low side — where it is compounded by a second mechanism: at  $r^* = 0.12$  (TP0015) the controller output *does* cross the low threshold, the cutoff opens the FC switch, but the standing share error then winds the ratio back over the re-entry hysteresis and the loop *hunts* — duty-cycling FC\_BUS\_ENABLE at 19.8 Hz, about 190 ideal-diode switch cycles per 13 s run. The deep endpoints 0 and 1 (TP0014, TP0038) latch cleanly, because there the realized share equals the setpoint and the error vanishes: the hysteresis never re-arms.

**Figure 11:** TP0037 ( $r^* = 0.87$ ) during the 6 A hold: the unmitigated limit cycle in the ungoverned window. The BT channel duty-cycles at 19.5Hz (top), the filtered share saws around the setpoint (middle), and the commanded droop ratio sawtooths between 0.45 and 0.79 — never reaching the 0.85 cutoff threshold (dashed, bottom), so neither mitigation path ever engages.

5. **Close the governor/cutoff structural gap.** The governor bypass tests the *setpoint* while the cutoff tests the *controller output*; setpoints in  $\approx (0.85, 0.88]$  (mirror  $\approx [0.12, 0.15]$ ) engage neither and run the original cycle unmitigated (TP0037). Either extend the governor to the full span and let the cutoff take over only once it actually latches, or gate the bypass on the cutoff state (`shareIsoFC/shareIsoBT`) rather than on the setpoint. The near-band cutoff *hunting* at  $r^* = 0.12$  (19.8 Hz switch duty-cycling) additionally argues for latching the cutoff while the setpoint remains out-of-band, releasing on setpoint change rather than on the ratio's re-entry hysteresis.

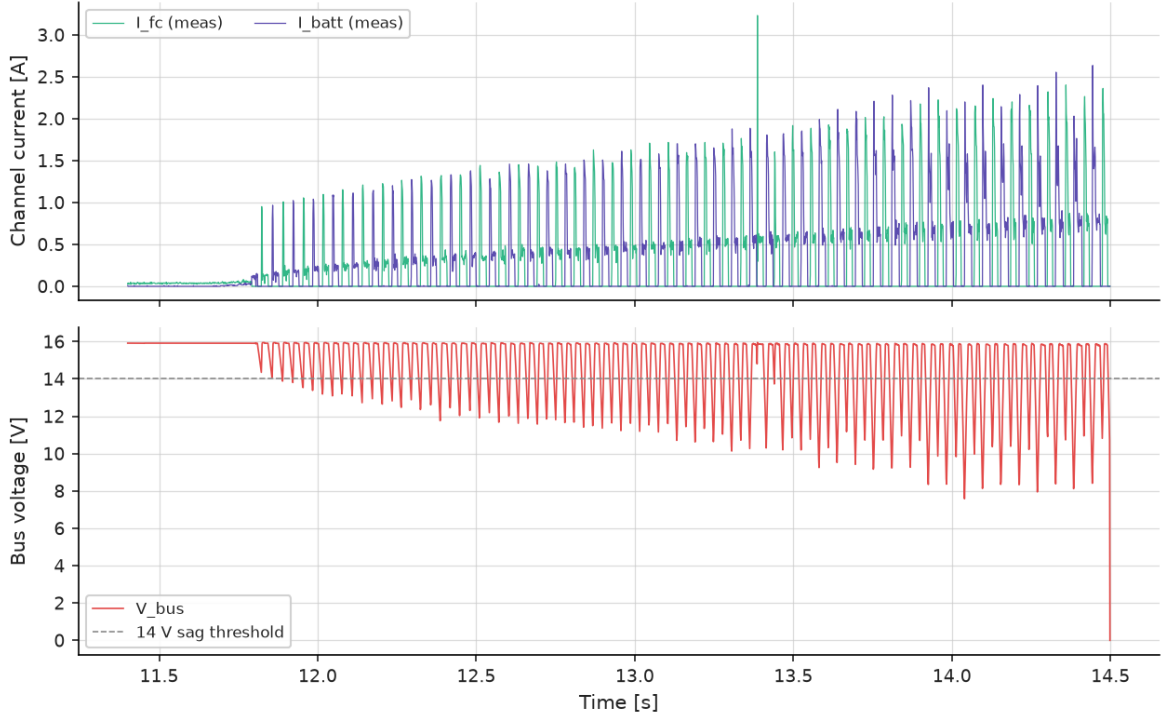
WP0039 (the first W combined profile,  $I_{\max} = 5$  A) is the campaign’s one destructive-class event. The run is quiescent for 11.8s — total channel current 0.03–0.08 A despite motor commands up to 3.4 A, indicating the motor was not accepting load (cause unconfirmed; a VESC in its brownout band would fit) — and then enters a 34 Hz total source-feed dropout cut/retry cycle: both channels drop to zero simultaneously, the motor-node capacitance ( $\approx 1.6$  mF inferred from the decay slope) discharges at  $\approx 465$  V/s, and one channel reconnects with a 1.4–3.2 A spike (Figure 12). The sag floor deepens monotonically from 13.9 V to 7.6 V over 89 cycles in 2.7 s, after which the bus enters free-fall and the log truncates mid-sample with no trailer — the signature of the board-powered Teensy browning out, not of an operator stop. No fault was latched at any point: the `BENCH_TEST` build arms overvoltage only, so 0.87 s of sub-14 V bus and  $\approx 90$  load-dump reconnects were invisible to `detectFaults()`. This is the capture-10/-12 event class (total source-feed dropout ratchet) rather than the minority-channel cycle the governor targets. One trigger correlation deserves a scope-armed re-entry: the share loop sat frozen below its 75 mA minimum-load threshold for the

whole quiescent stretch, unfroze at  $t = 11.75$  s with a large standing error, and traversed the droop ratio at the full slew rate ( $0.734 \rightarrow 0.394$  in  $\approx 40$  ms) — the first total dropout followed within 40 ms.

**Figure 12:** WP0039 final 3 s. Top: both channels drop out together and alternate 1.4–3.2 A reconnect spikes at 34 Hz. Bottom: the sag floor ratchets monotonically from 13.9 V to 7.6 V, then the bus free-falls and the log truncates mid-decay (no trailer) — consistent with an MCU brownout. `fault_flags` remained zero throughout.

6. **Arm a bus-undervoltage fault on the bench.** Both TP0016 and WP0039 put the bus below 9 V repeatedly with `fault_flags = 0`; WP0039 ended in an uncommanded MCU brownout. A persistence-filtered UV check (mirroring the existing OV filter) would have latched both runs into State 99 long before the ratchet deepened.

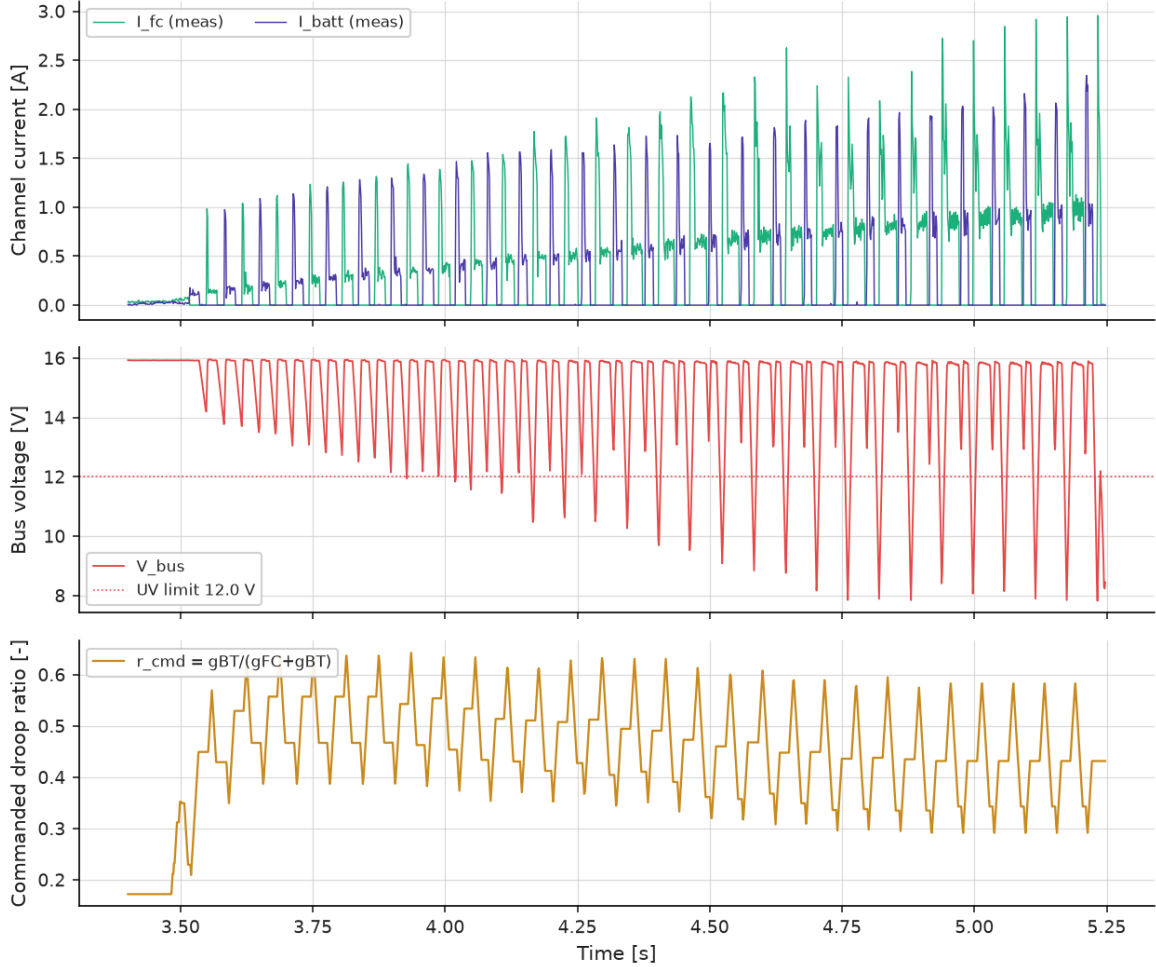
Six runs at fuel-cell-heavy setpoints latched `ERR_UV_BUS` (Table 2), at setpoints that were clean on firmware v3. The mechanism is not the minority-channel dropout cycle: the channels *alternate exclusive ownership* of the bus. Figure 14 shows TP0053. One channel conducts alone for tens of milliseconds while its droop gain climbs; at a reproducible commanded-ratio threshold, ownership commutates through a 7–12 ms window in which *both* channels read zero and the  $\approx 1$  mF motor node discharges unopposed; the other channel then reconnects with a 2–3 A burst and the pattern mirrors. The full period is 16–20 Hz. Because co-conduction never occurs, the hysteretic minority-dropout counter of Figure 13 reads zero for these runs — the counter discriminates the two topologies.

**Figure 14:** TP0053 ( $r^* = 0.70$ ): the source-commutation relay cycle. Top: FC and BT alternate exclusive conduction with 2–3 A reconnect bursts; co-conduction never occurs. Middle: each both-channels-off handoff window discharges the motor node, and the troughs walk monotonically down through the 12 V fault limit as the load ramp steepens the discharge slope. Bottom: the commanded droop ratio sawtooths between reproducible commutation thresholds at the slew-limited rate.

The entry condition is the governor’s own fallback. The share loop wakes at `SHARE_I_TOT_MIN_A` = 0.075 A of total current, and the governor filter — reset at profile start — reads well under the 0.60 A collapse threshold, so the effective setpoint is 0.5 in every run at wake. At 0.1–0.5 A of total current, however, a 0.5 split commands 0.05–0.25 A per channel — *below the 0.30 A floor the governor exists to enforce* — against a droop authority of order 20 mV, which the channel offset voltage  $\Delta V_0$  exceeds. The split is physically unachievable; the controller saturates at the slew limit and commutates ownership instead of sharing. The collapse-to-0.5 fallback therefore commands, throughout the window  $0.075 \leq I_{\text{tot}} \leq 0.60$  A, exactly the class of infeasible split whose avoidance is its purpose.

Why firmware v3 survived the identical setpoints and profile (TP0029–TP0033: zero events) is not settled. The leading candidate — **unconfirmed** — is the floor increase itself: on the fuel-cell-heavy side the raised clip demands 50 % more minority current through the whole escape window (at 0.6 A filtered total, v3 asks the battery channel for 0.20 A, v4 for 0.30 A), which plausibly explains failure to escape rather than entry. The asymmetry fits: below  $r^* = 0.5$  the collapse pulls

9. **Redesign the governor’s low-current fallback.** The collapse-to-0.5 branch commands 0.05–0.25 A per channel across  $I_{\text{tot}} \in [0.075, 0.60]$  A — below the floor it exists to enforce — and ignited a bus-collapsing source-commutation relay cycle in six runs at  $r^* \geq 0.67$  (Section 6.3). The fallback should command an *achievable* split at low current: hold the measured share (freeze the loop, as the setpoint latch already does out-of-band) or bias toward the natural topology, rather than force 0.5. Why firmware v3 survived the identical conditions is unconfirmed; the floor increase acting through the escape window is the leading candidate.

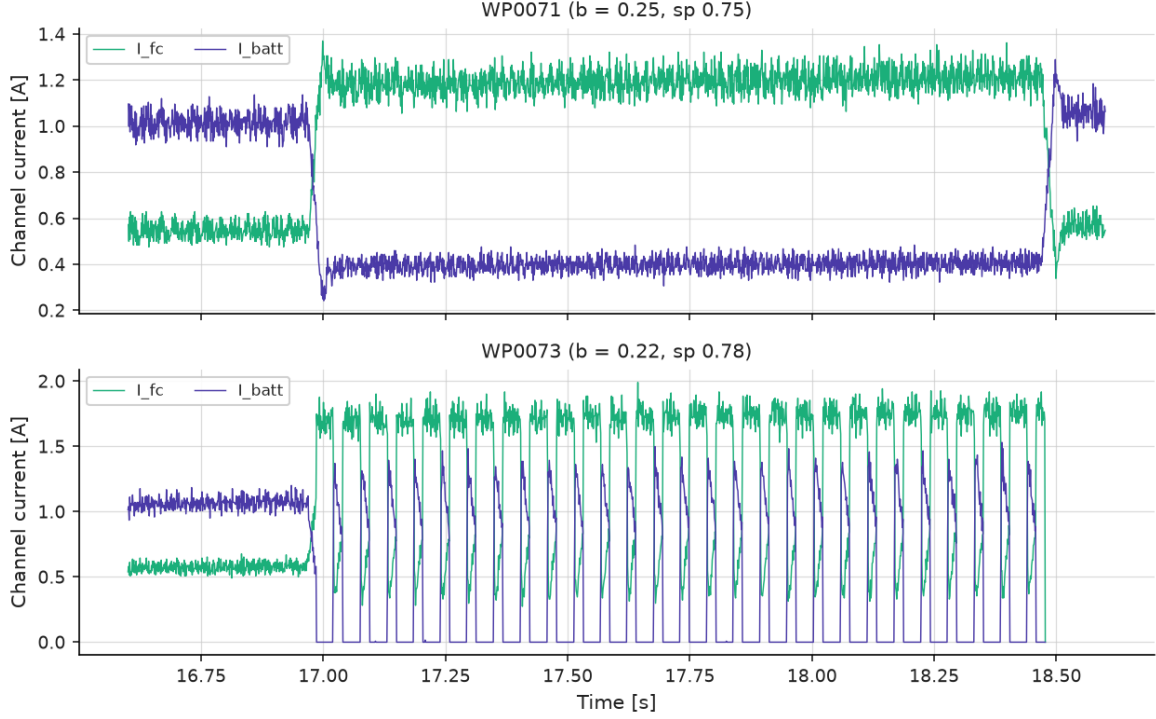
The five W runs ladder the clip bound  $b$ : 0.35, 0.30, and 0.25 complete cleanly; 0.20 and 0.22 truncate mid-run with no trailer — both at the same profile boundary, 18.470 and 18.477 s, where region R6 (share setpoint at the  $1 - b$  bound, 6 A command) hands off to R7. Figure 15 shows the failure boundary directly: at  $b = 0.25$  (setpoint 0.75, commanded minority 0.399 A) region R6 is a crisp step; at  $b = 0.22$  (setpoint 0.78, commanded minority 0.381 A) the battery channel chops at 18.7 Hz for the full region. The clean/cycling bracket (0.381, 0.399) A sits *above* the 0.30 A floor — and above the firmware-v3 bracket (0.245, 0.29) A measured at  $\approx 1.6$  A total. A single constant-current floor cannot satisfy both datasets. Either the floor scales with total current (a ripple-clearance reading) or the true limit is a minority *fraction* of approximately 0.22–0.25, in which case the usable droop band is nearer [0.25, 0.75] than [0.15, 0.85]. The two readings are inseparable in this data — total current spanned only 1.59–1.73 A across the boundary — and a two-axis sweep ( $I_{\max}$  at fixed setpoint, setpoint at fixed  $I_{\max}$ ) is the highest-value next bench session.

**Figure 15:** The floor-law failure boundary in region R6 of the W profile (share setpoint steps to  $1 - b$  at 6 A command). Top: WP0071 ( $b = 0.25$ , commanded minority 0.399 A) — a clean step and steady co-conduction. Bottom: WP0073 ( $b = 0.22$ , commanded minority 0.381 A) — an 18.7 Hz single-channel dropout cycle for the entire region; the log truncates at 18.48 s.

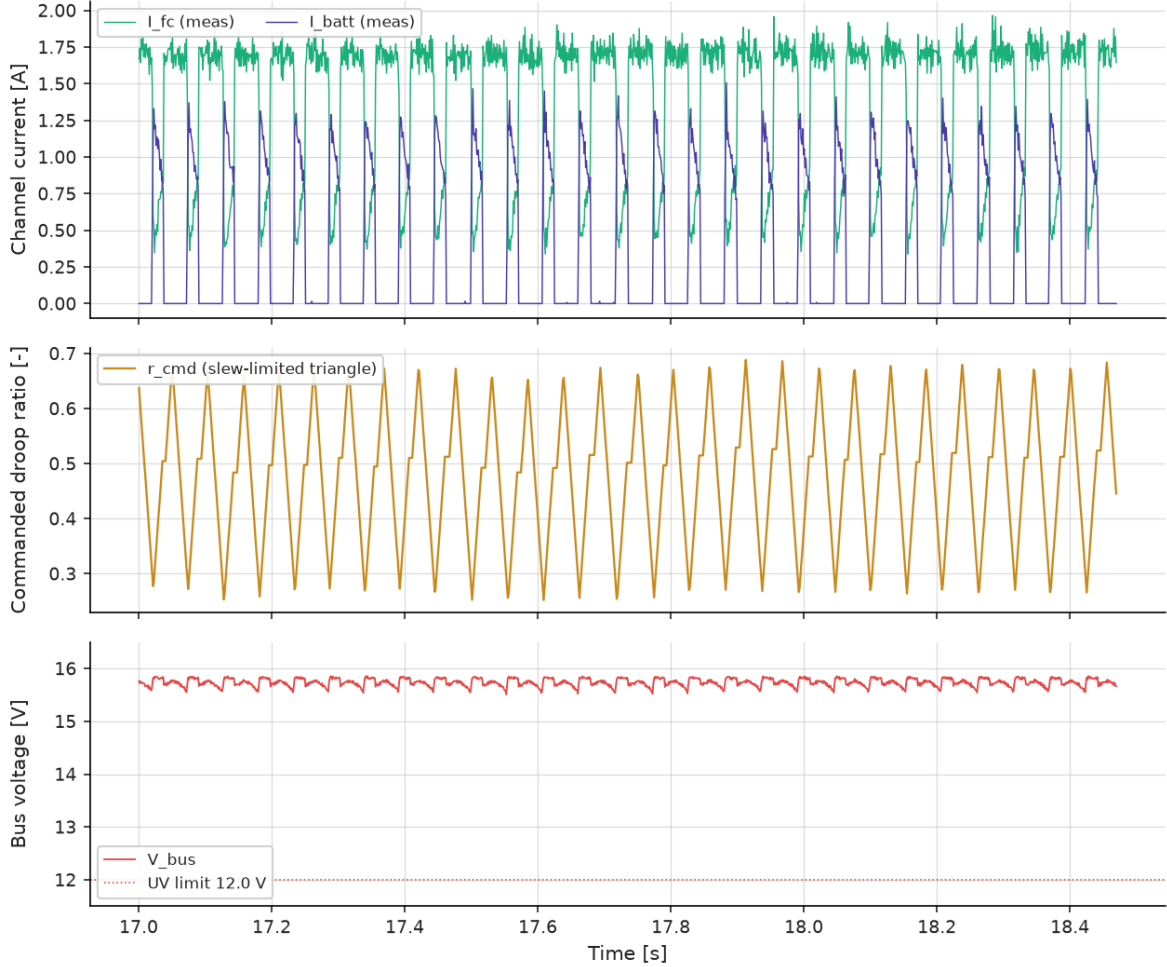
The limit cycle itself (Figure 16) is the classical minority-dropout topology of Section 3, with one new observation: its frequency is set by the slow limiter. The commanded ratio traverses a 0.48-wide triangle at 0.02 per tick — 27.9 ms per leg, a 55.8 ms period — matching the observed 53.9 ms. The firmware-v2 slow limit converts the original bang-bang instability into a bounded triangle oscillation; it does not suppress it.

**Figure 16:** WP0072 ( $b = 0.20$ ), final 1.5 s before truncation. Top: the battery channel drops and reconnects at 18.7 Hz while the fuel-cell channel absorbs the full load. Middle: the commanded droop ratio is a slew-rate-limited triangle — the 0.02-per-tick limit sets the 54 ms period. Bottom: the bus never leaves regulation (ripple 0.35 V, minimum 15.51 V); the MCU brownout that truncates the log is invisible on every logged channel.

The truncations themselves are the campaign’s most consequential result. In both runs the bus was in regulation at 15.7 V at the final record, `fault_flags` was zero throughout, the sample interval was nominal to the last sample, and the gains were still slewing — no fault latched, and no electrical precursor appears on any logged channel. The MCU (board-powered through the LM1084 from the battery source rail) browned out from an *upstream* collapse that the bus-referenced undervoltage fault is structurally incapable of observing. The reboot is confirmed by `start_millis`: WP0073 began 19.6 s after WP0072’s power cycle. Both deaths within 12 ms of the same region boundary — with the reconnect burst still 8–15 ms away — implicate the setpoint step itself, through a channel this log does not instrument. Two actions follow: instrument the source rails (the BT.VOLTAGE ADC input exists and is not logged) and consider a source-rail undervoltage fault; and scope VBT and the LM1084 input across an R6→R7 step before further  $b \leq 0.22$  runs.

11. **Extend fault coverage upstream and retune the UV filter.** The UV fault latched all six relay events but tolerated 1.0–1.3 s of 7–8 V excursions first (the 9 ms-under/51 ms-over duty evades the 10 ms window and 5 ms gap guard); a leaky-integrator dwell or a  $\gtrsim 60$  ms gap guard latches within a few cycles. More consequentially, two MCU brownouts occurred with the bus in regulation at 15.7 V: the source rail feeding the logic regulator is unobserved. Log BT\_VOLTAGE, consider a source-rail undervoltage fault, and scope VBT/LM1084 across the R6→R7 setpoint step before further  $b \leq 0.22$  runs.
